**Project Name:** GR51719\_CCTV  
**Project Description:** CCTV SURVEY  
**Project Number:** GR51719  
**Project Status:** Complete  
**Project Date:** 10/11/2022  
**Inspection Standard:** MSCC5 Sewers & Drainage GB (SRM5 Scoring)

**CCTV  
DRAINAGE  
SURVEYS**

**Street:** B1506, Forest Heath  
**Town or City:** Newmarket  
**County:** Suffolk  
**Post Code:** CB8 7QD

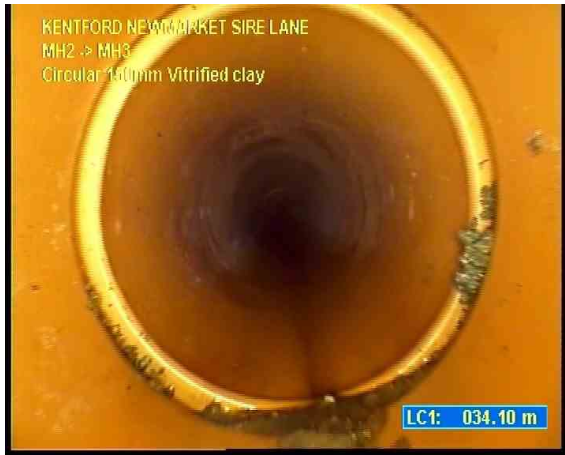
| Scale: 1:509 | Position [m] | Code | Observation | MPEG | Photo | Grade |
|---|---|---|---|---|---|---|
| | 34.60 | OJM | Open joint, medium | 00:05:48 | 1 | 1 |

1, 00:05:48, 34.60 m  
 Open joint, medium

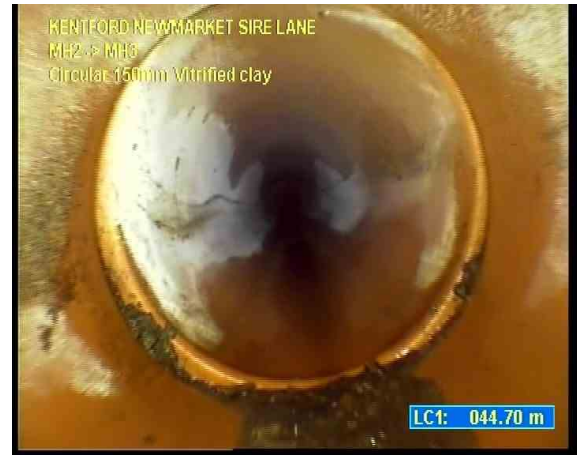
| Scale: 1:509 | Position [m] | Code | Observation | MPEG | Photo | Grade |
|---|---|---|---|---|---|---|
| | 44.70 | JDM | Joint displaced, medium | 00:07:38 | 2 | 1 / 3 |

2, 00:07:38, 44.70 m  
 Joint displaced, medium

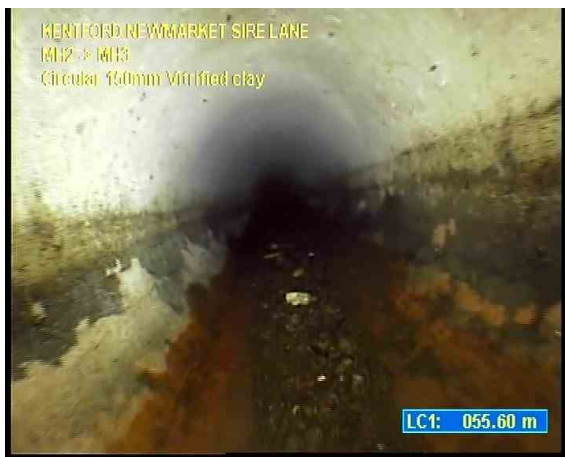
| Scale: 1:509 | Position [m] | Code | Observation | MPEG | Photo | Grade |
|---|---|---|---|---|---|---|
| | 55.60 | S01 DERJ | Settled deposits, coarse at joint, 5% cross-sectional area loss, start | 00:09:29 | 3 | |

3, 00:09:29, 55.60 m  
 Settled deposits, coarse at joint, 5% cross-sectional area loss, start

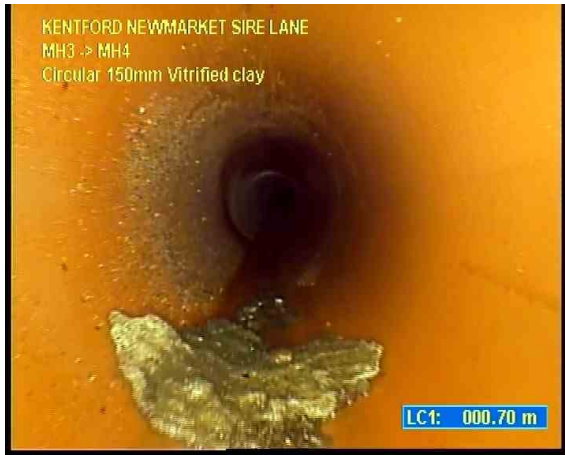
| Scale: 1:110 | Position [m] | Code | Observation | MPEG | Photo | Grade |
|---|---|---|---|---|---|---|
| 0.70 | DEC | Settled deposits, hard or compacted, 5% cross-sectional area loss | 00:00:18 | 1 | 3 | |

1, 00:00:18, 0.70 m  
 Settled deposits, hard or compacted, 5% cross-sectional area loss

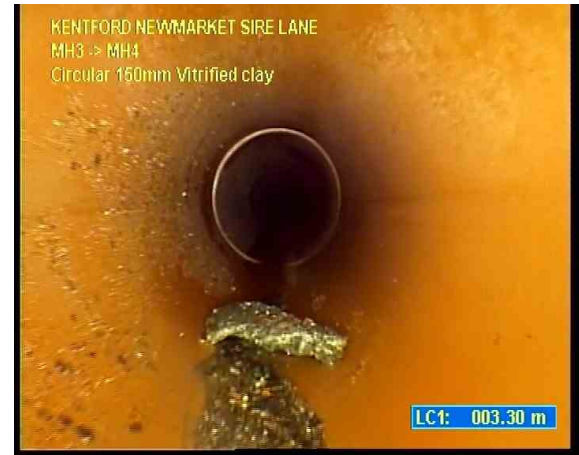
| Scale: 1:110 | Position [m] | Code | Observation | MPEG | Photo | Grade |
|---|---|---|---|---|---|---|
| 3.50 | DER | Settled deposits, coarse, 5% cross-sectional area loss | 00:00:46 | 2 | 3 | |

2, 00:00:46, 3.50 m  
 Settled deposits, coarse, 5% cross-sectional area loss

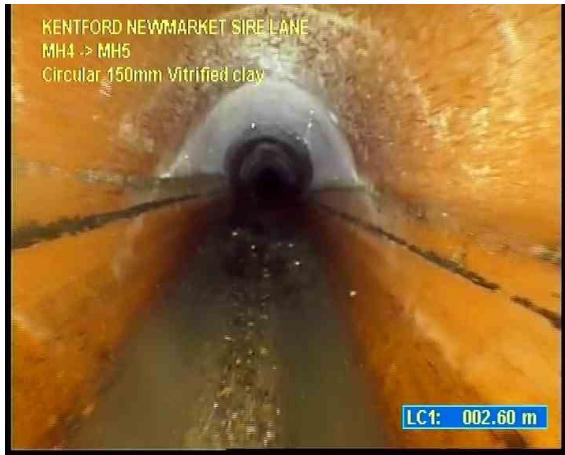
1, 00:00:35, 2.60 m  
 Settled deposits, fine at joint, 5% cross-sectional area loss,  
 start

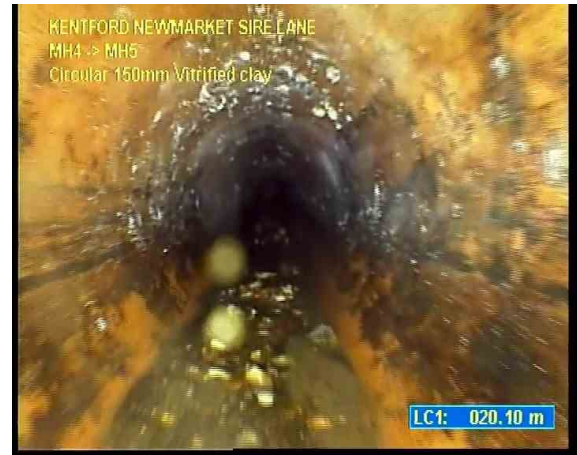
2, 00:04:12, 20.10 m  
 Settled deposits, coarse at joint, 5% cross-sectional area loss,  
 start

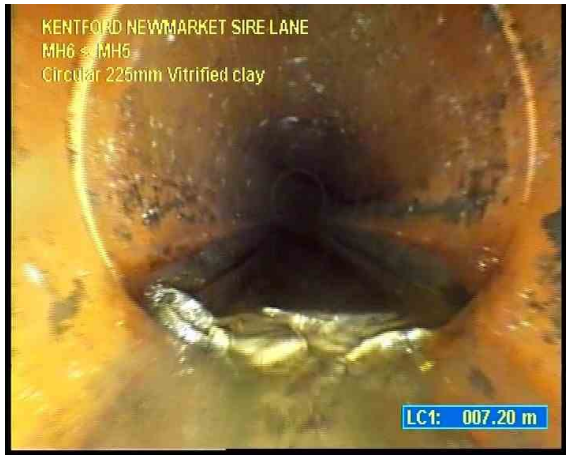
| Scale: | 1:617 | Position [m] | Code | Observation | MPEG | Photo | Grade |
|---|---|---|---|---|---|---|---|
| | | 7.30 | JDM | Joint displaced, medium | 00:01:04 | 1 | 1 / 3 |

1, 00:01:04, 7.30 m  
 Joint displaced, medium

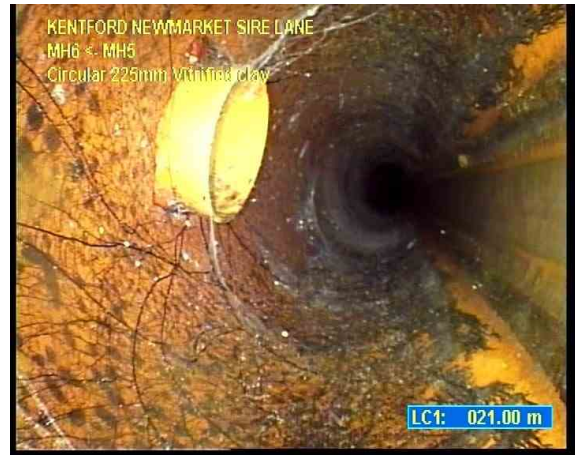
| Scale: | 1:617 | Position [m] | Code | Observation | MPEG | Photo | Grade |
|---|---|---|---|---|---|---|---|
| | | 21.00 | CXI | Connection defective, connecting pipe is intruding at 12 o'clock, 150mm dia, intrusion: 10% | 00:03:03 | 2 | 3 |

2, 00:03:03, 21.00 m  
 Connection defective, connecting pipe is intruding at 12 o'clock, 150mm dia, intrusion: 10%

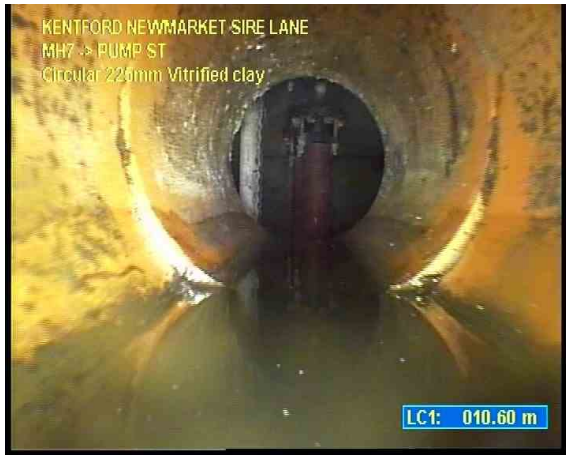
| Section | PLR | Grade | Description |
|---|---|---|---|
| 7 | MH7X | 3 | Joint displaced, medium |

1, 00:01:29, 10.90 m  
 Joint displaced, medium

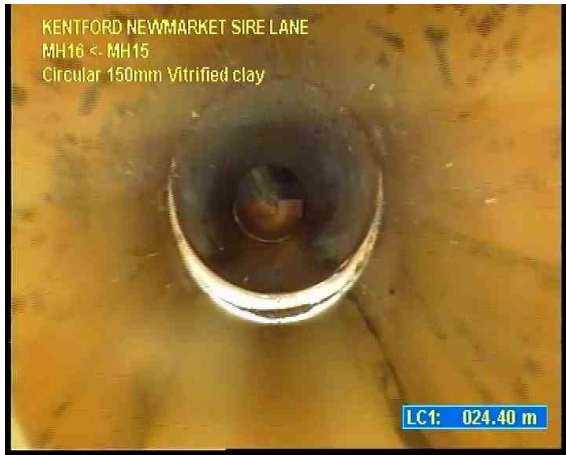
| Section | PLR | Grade | Description |
|---|---|---|---|
| 8 | MH16X | 3 | Joint displaced, medium |

1, 00:03:49, 25.20 m  
 Joint displaced, medium

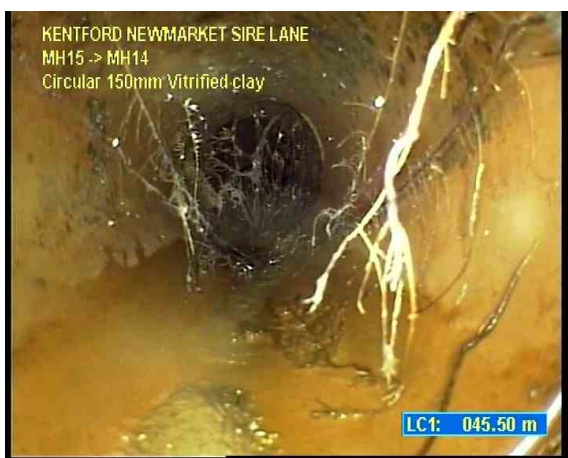
1, 00:05:52, 45.50 m  
Roots, fine, start

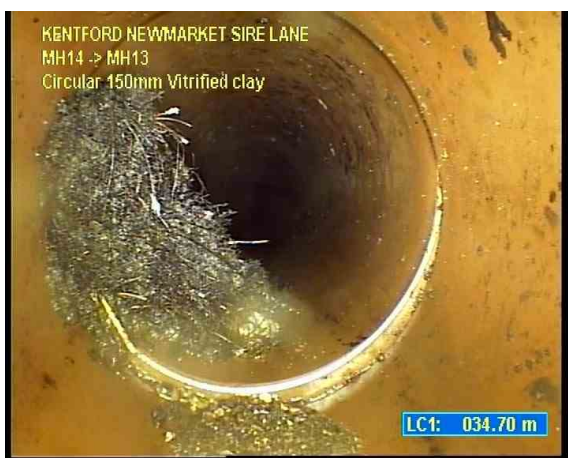
1, 00:07:01, 34.70 m

| Section | PLR | Grade | Description |
|---|---|---|---|
| 10 | MH14X | 5 | Roots, mass at joint, 20% cross-sectional area loss |

Roots, mass at joint, 20% cross-sectional area loss

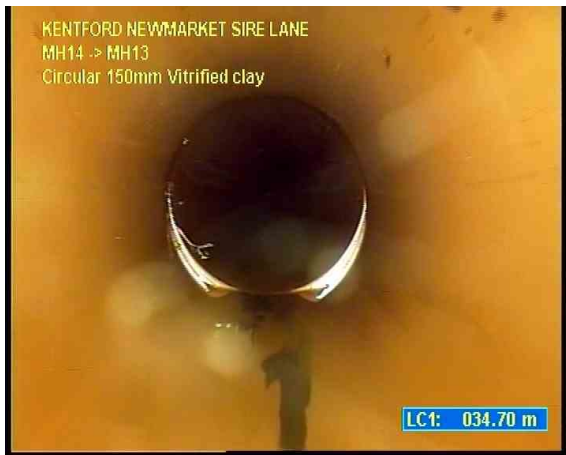
1, 00:05:38, 35.30 m  
 Joint displaced, medium

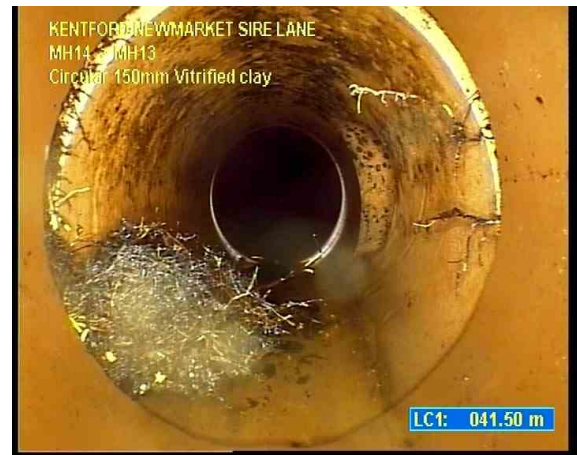
2, 00:06:42, 41.50 m  
 Roots, mass at joint, 5% cross-sectional area loss

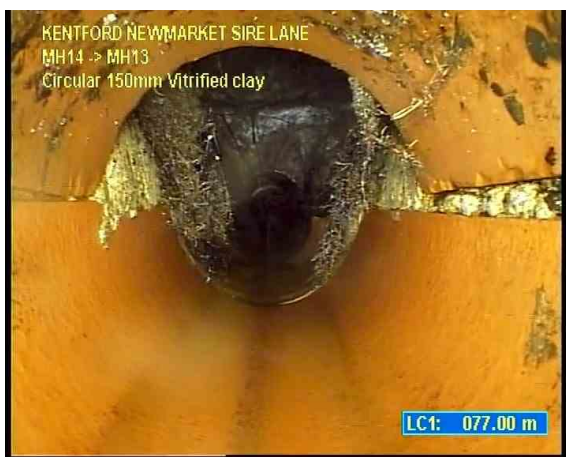
| Scale: 1:651 | Position [m] | Code | Observation | MPEG | Photo | Grade |
|---|---|---|---|---|---|---|
| | 74.00 S01 | FLJ | Fracture, longitudinal at joint at 3 o'clock, start | 00:22:26 | 3 | |
| | 75.50 F01 | FLJ | Fracture, longitudinal at joint at 3 o'clock, finish | 00:22:26 | | 3 / 2 |

3, 00:22:26, 74.00 m  
 Fracture, longitudinal at joint at 3 o'clock, start

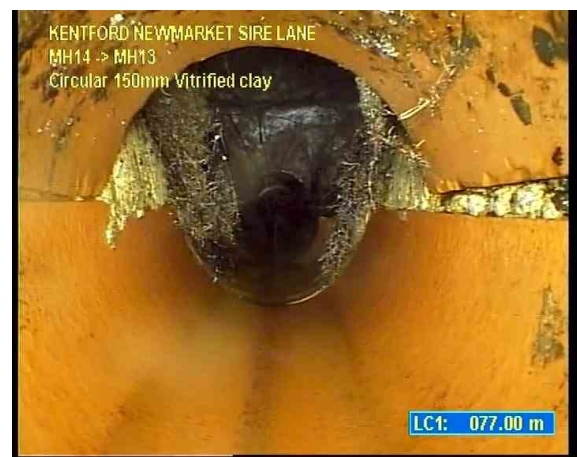
| Scale: 1:651 | Position [m] | Code | Observation | MPEG | Photo | Grade |
|---|---|---|---|---|---|---|
| | 74.00 S02 | FLJ | Fracture, longitudinal at joint at 9 o'clock, start | 00:22:26 | 4 | |
| | 75.50 F02 | FLJ | Fracture, longitudinal at joint at 9 o'clock, finish | 00:22:26 | | 3 / 2 |

4, 00:22:26, 74.00 m  
 Fracture, longitudinal at joint at 9 o'clock, start

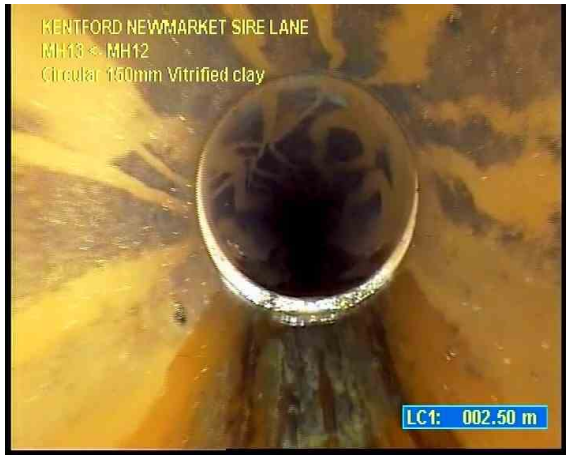
| Section | PLR | Grade | Description |
|---|---|---|---|
| 12 | MH13AX | 3 | Joint displaced, medium |

1, 00:00:25, 2.90 m  
Joint displaced, medium

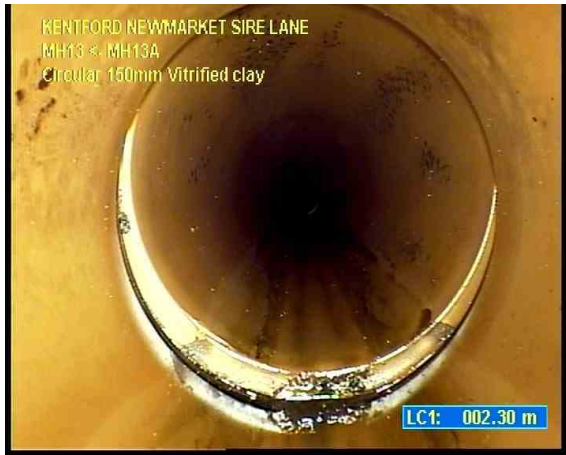
1, 00:00:27, 2.30 m  
 Joint displaced, medium

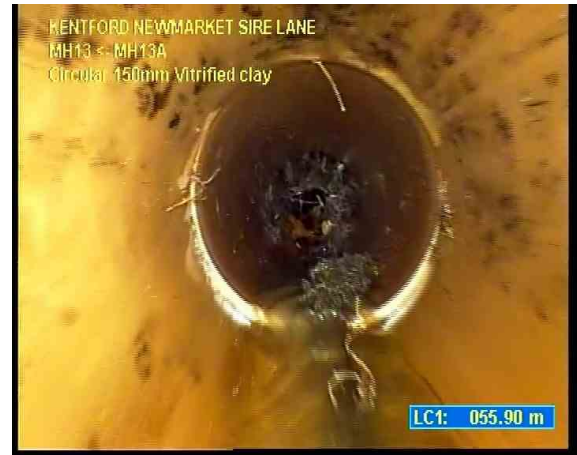
2, 00:14:30, 55.90 m  
 Roots, mass at joint, 10% cross-sectional area loss, start

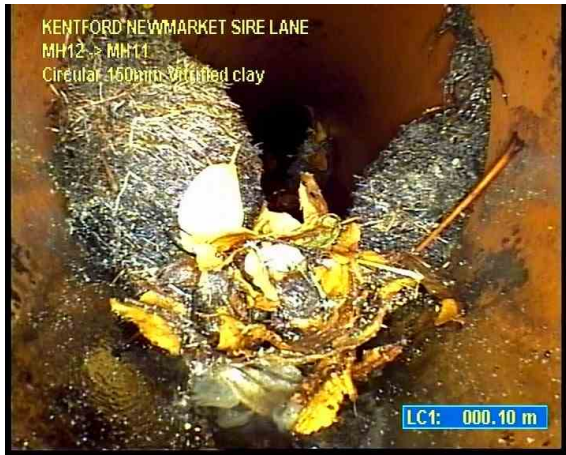
| Section | PLR | Grade | Description |
|---|---|---|---|
| 14 | MH12X | 5 | Roots, mass at joint, 30% cross-sectional area loss, finish |

1, 00:00:25, 0.10 m  
 Roots, mass at joint, 30% cross-sectional area loss, start

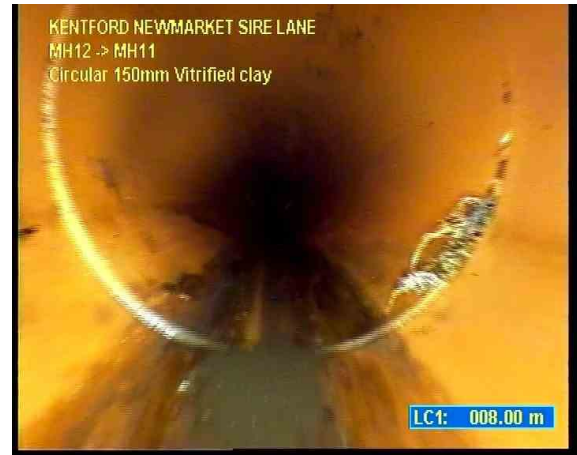
2, 00:01:29, 8.10 m  
 Roots, fine at joint

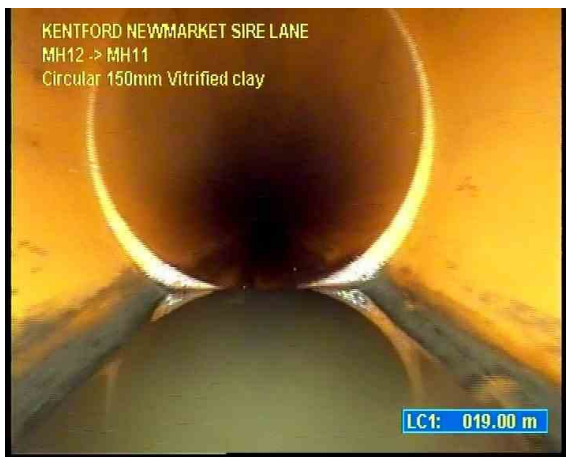
3, 00:02:33, 19.70 m  
 Joint displaced, medium

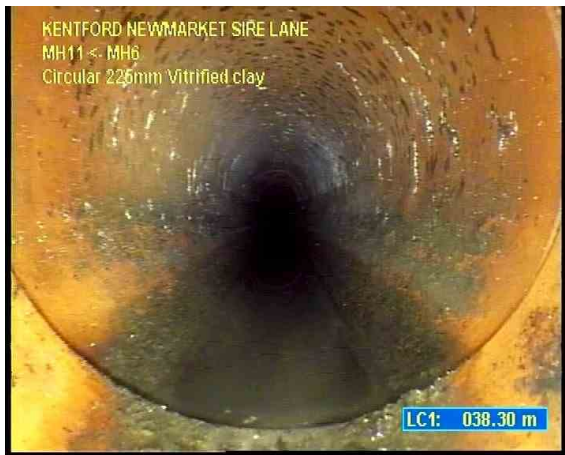
1, 00:10:13, 38.50 m  
 Joint displaced, medium

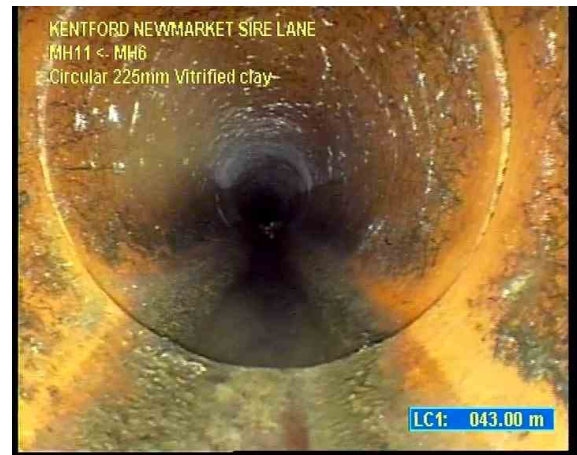
2, 00:14:56, 43.30 m  
 Joint displaced, medium

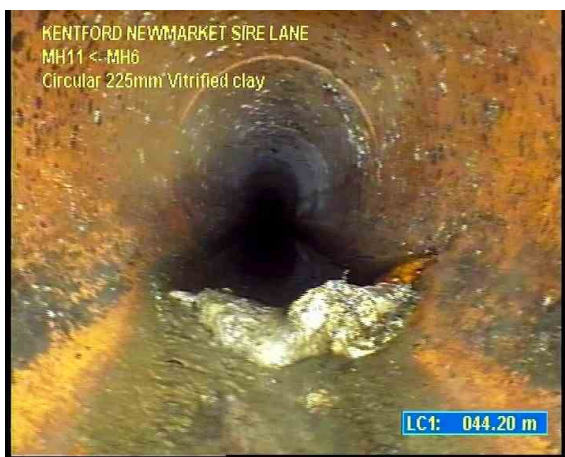
3, 00:16:41, 44.70 m  
 Settled deposits, hard or compacted, 10% cross-sectional area loss

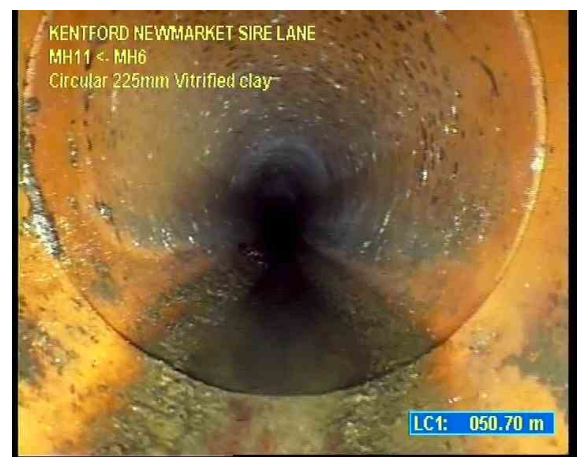
4, 00:22:02, 50.80 m  
 Joint displaced, medium

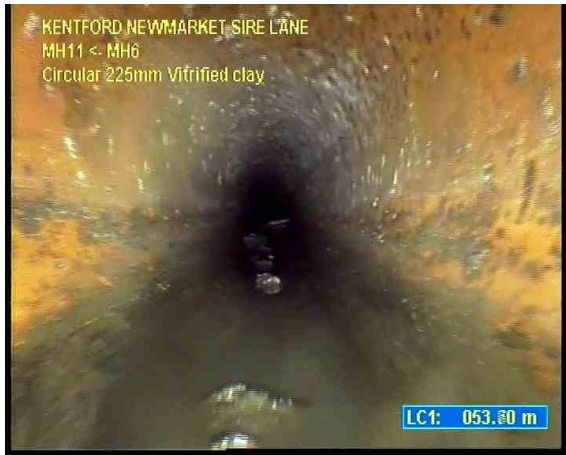
5, 00:25:34, 53.80 m  
 Settled deposits, coarse at joint, 5% cross-sectional area loss, start

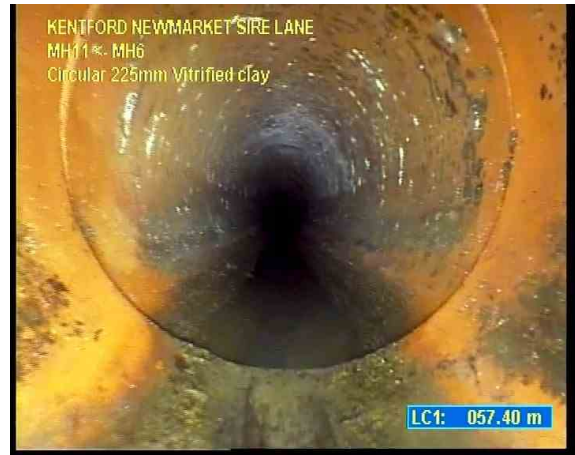
6, 00:26:07, 57.50 m  
 Joint displaced, medium
