**Project Number A-02000 (6724)**

**Refurbishment and Demolition  
Asbestos Survey Report**

**Small Animal Clinic  
Lanwades Park  
Newmarket  
CB8 7UA**

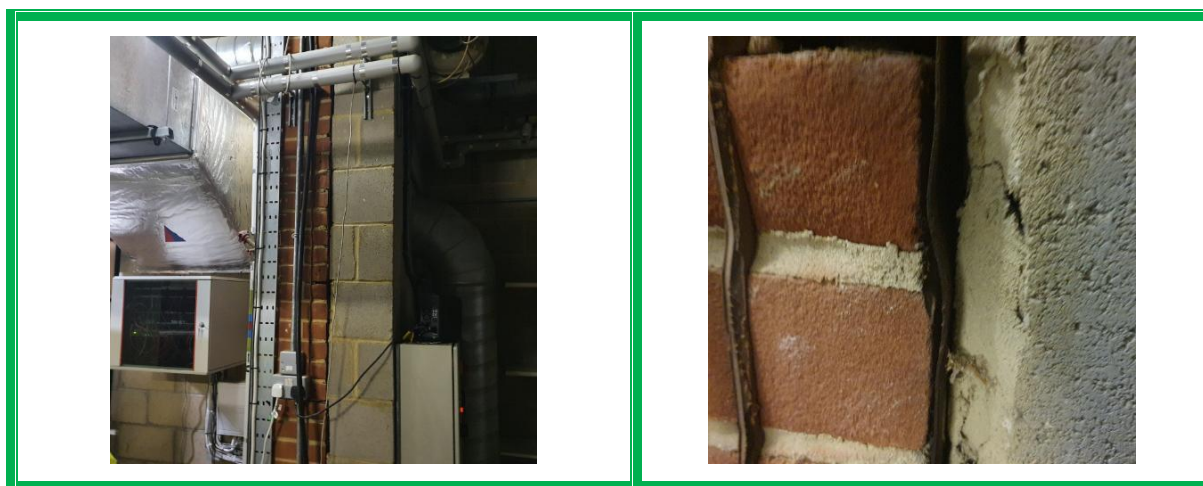
<b>Item No:</b>	<b>1</b>	<b>Sample No:</b>	<b>DK/01</b>
<b>Location:</b>	First Floor - Plant Room 001

<b>Material Description:</b>	DPC within Wall Cavity - Bituminous Product	
<b>Identification:</b>	Sampled - No Asbestos Found	
<b>Approx. quantity:</b>	N/A	
<b>Accessibility</b>	N/A	<i>Assessment Score</i>
<b>Product type:</b>	N/A	N/A
<b>Extent of Damage:</b>	N/A	N/A
<b>Surface Treatment:</b>	N/A	N/A
<b>Asbestos type:</b>	N/A	N/A
<b>Material Assessment Score:</b>		N/A
<b>Risk Assessment Score:</b>		N/A
<b>Action:</b>	N/A	
<b>Comments:</b>	Presume to be within walls throughout

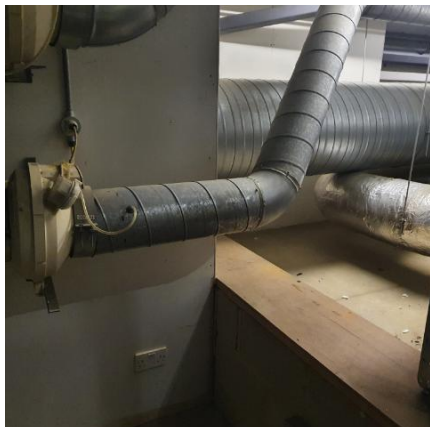
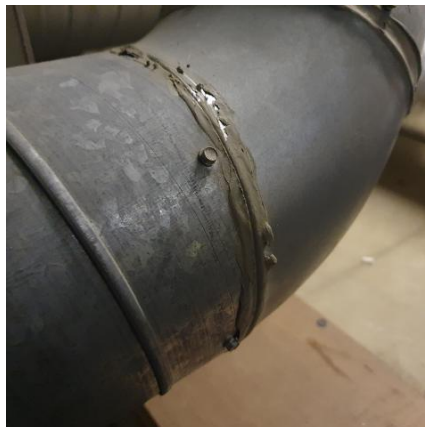
**Location:** First Floor - Plant Room 002

<b>Material Description:</b>	Putty to Ductwork Joints - PVC / Reinforced Plastics	
<b>Identification:</b>	Sampled - No Asbestos Found	
<b>Approx. quantity:</b>	N/A	
<b>Accessibility</b>	N/A	<i>Assessment Score</i>
<b>Product type:</b>	N/A	N/A
<b>Extent of Damage:</b>	N/A	N/A
<b>Surface Treatment:</b>	N/A	N/A
<b>Asbestos type:</b>	N/A	N/A
<b>Material Assessment Score:</b>		N/A
<b>Risk Assessment Score:</b>		N/A
<b>Action:</b>	N/A	
<b>Comments:</b>	Presume to be ductwork throughout. Plasterboard and solid walls. Modern electrics

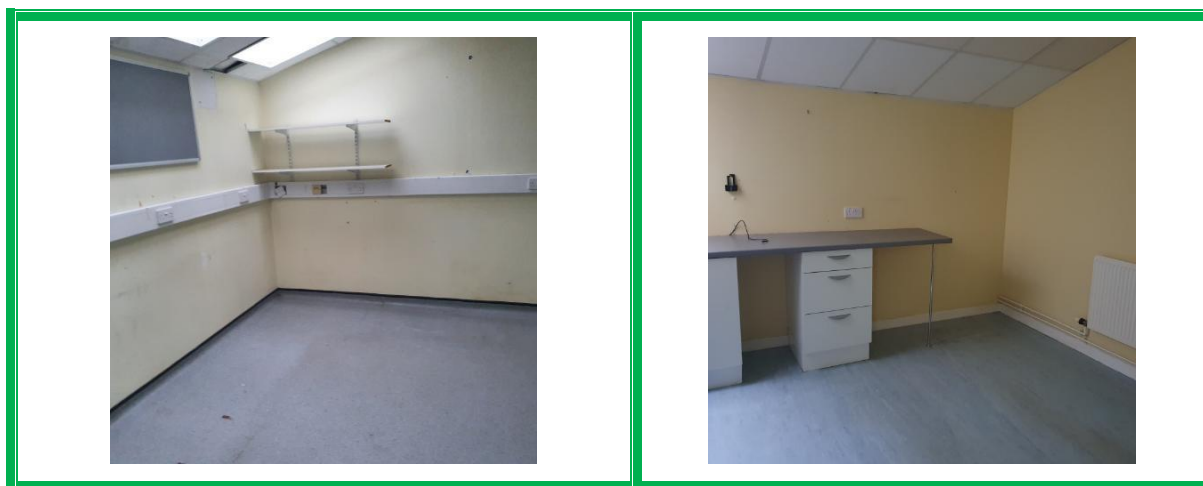
<b>Item No:</b>	<b>3</b>	<b>Sample No:</b>	<b>N/A</b>
<b>Location:</b>	First Floor - Offices x 2 003

<b>Material Description:</b>	No Suspect Materials Found	
<b>Identification:</b>	N/A	
<b>Approx. quantity:</b>	N/A	
<b>Accessibility</b>	N/A	<i>Assessment Score</i>
<b>Product type:</b>	N/A	N/A
<b>Extent of Damage:</b>	N/A	N/A
<b>Surface Treatment:</b>	N/A	N/A
<b>Asbestos type:</b>	N/A	N/A
<b>Material Assessment Score:</b>		N/A
<b>Risk Assessment Score:</b>		N/A
<b>Action:</b>	N/A	
<b>Comments:</b>	Plasterboard walls, metal above modern ceiling tiles

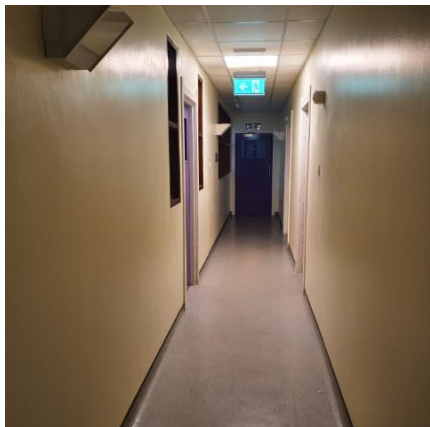
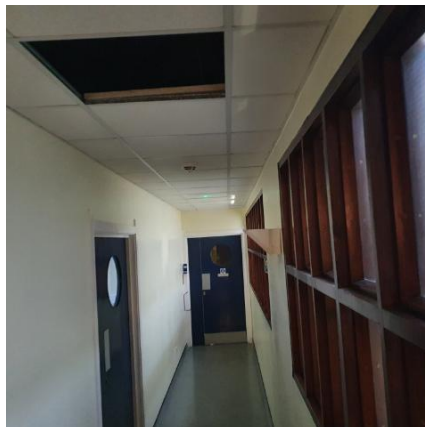
**Location:** First Floor - Corridor 004

<b>Material Description:</b>	No Suspect Materials Found	
<b>Identification:</b>	N/A	
<b>Approx. quantity:</b>	N/A	
<b>Accessibility</b>	N/A	<i>Assessment Score</i>
<b>Product type:</b>	N/A	N/A
<b>Extent of Damage:</b>	N/A	N/A
<b>Surface Treatment:</b>	N/A	N/A
<b>Asbestos type:</b>	N/A	N/A
<b>Material Assessment Score:</b>		N/A
<b>Risk Assessment Score:</b>		N/A
<b>Action:</b>	N/A	
<b>Comments:</b>	N/A

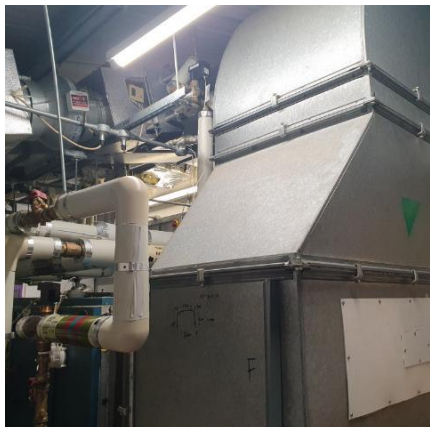
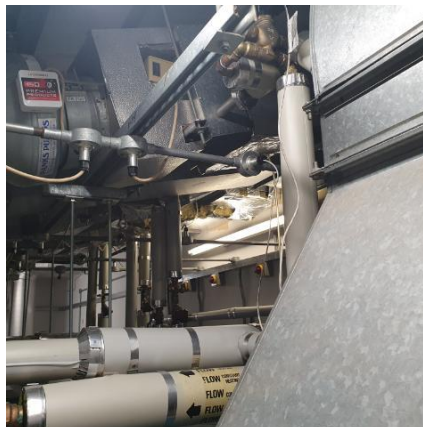
**Location:** First Floor - Plant Room 005

<b>Material Description:</b>	No Suspect Materials Found	
<b>Identification:</b>	N/A	
<b>Approx. quantity:</b>	N/A	
<b>Accessibility</b>	N/A	<i>Assessment Score</i>
<b>Product type:</b>	N/A	N/A
<b>Extent of Damage:</b>	N/A	N/A
<b>Surface Treatment:</b>	N/A	N/A
<b>Asbestos type:</b>	N/A	N/A
<b>Material Assessment Score:</b>		N/A
<b>Risk Assessment Score:</b>		N/A
<b>Action:</b>	N/A	
<b>Comments:</b>	Modern AHU and pipework throughout

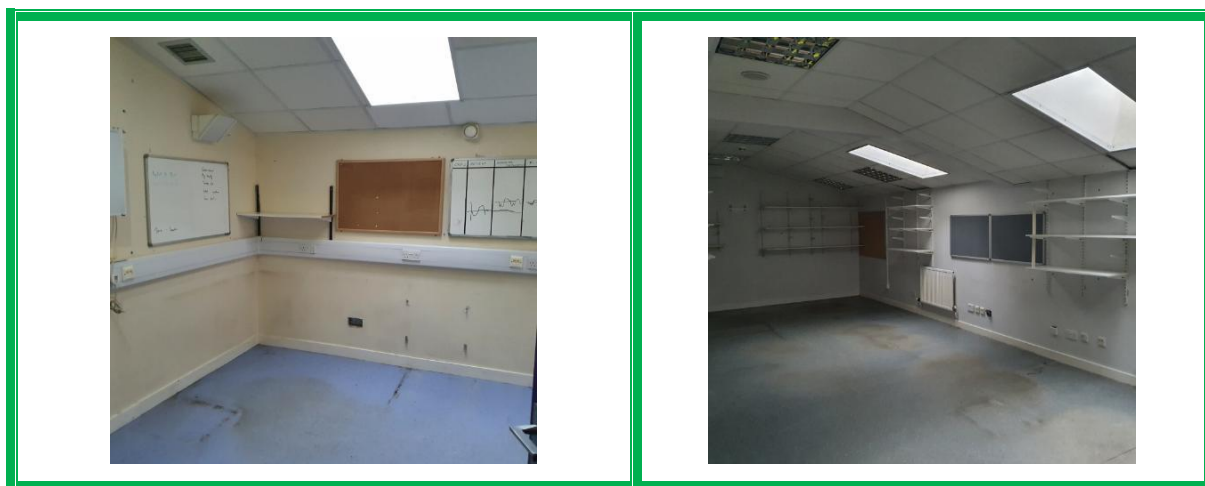
**Location:** First Floor - Offices x 3 006

<b>Material Description:</b>	No Suspect Materials Found	
<b>Identification:</b>	N/A	
<b>Approx. quantity:</b>	N/A	
<b>Accessibility</b>	N/A	<i>Assessment Score</i>
<b>Product type:</b>	N/A	N/A
<b>Extent of Damage:</b>	N/A	N/A
<b>Surface Treatment:</b>	N/A	N/A
<b>Asbestos type:</b>	N/A	N/A
<b>Material Assessment Score:</b>		N/A
<b>Risk Assessment Score:</b>		N/A
<b>Action:</b>	N/A	
<b>Comments:</b>	Plasterboard walls, metal above modern ceiling tiles

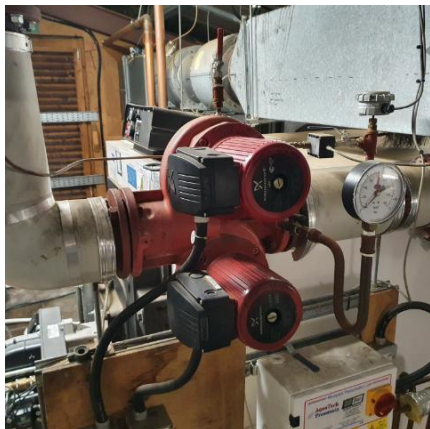
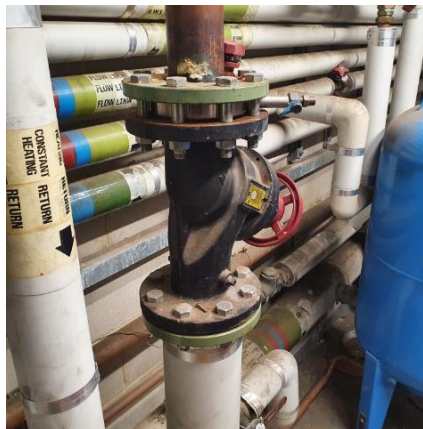
**Location:** First Floor - Plant Room 007

<b>Material Description:</b>	Gaskets - Gaskets (compressed)	
<b>Identification:</b>	Sampled - No Asbestos Found	
<b>Approx. quantity:</b>	N/A	
<b>Accessibility</b>	N/A	<i>Assessment Score</i>
<b>Product type:</b>	N/A	N/A
<b>Extent of Damage:</b>	N/A	N/A
<b>Surface Treatment:</b>	N/A	N/A
<b>Asbestos type:</b>	N/A	N/A
<b>Material Assessment Score:</b>		N/A
<b>Risk Assessment Score:</b>		N/A
<b>Action:</b>	N/A	
<b>Comments:</b>	Treat as uniform to gaskets throughout building. Modern pipework, ductwork and electrics

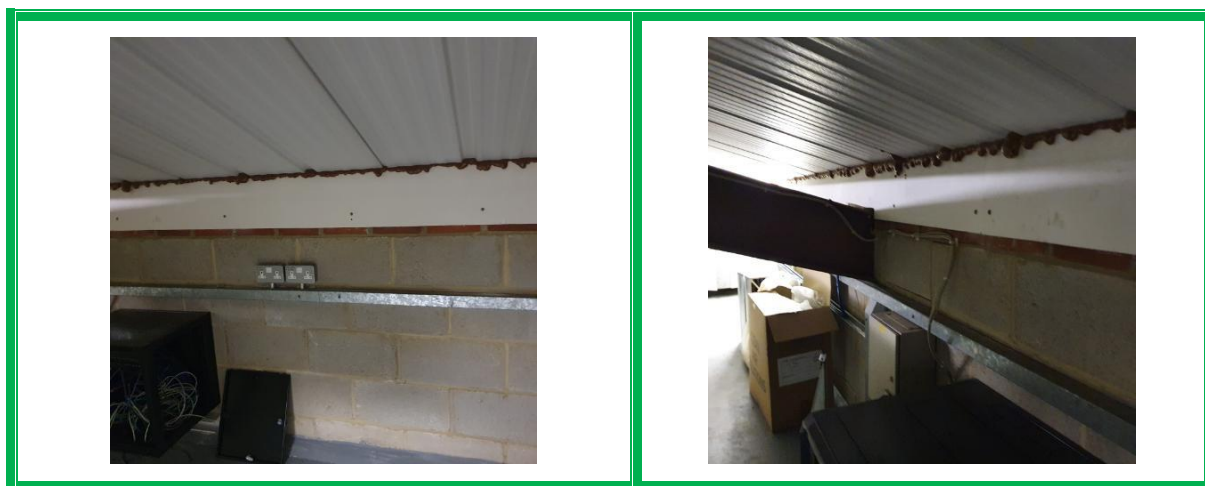
**Location:** First Floor - Plant Room 008

<b>Material Description:</b>	Wall Panels - Insulating Board	
<b>Identification:</b>	Sampled - No Asbestos Found	
<b>Approx. quantity:</b>	N/A	
<b>Accessibility</b>	N/A	<i>Assessment Score</i>
<b>Product type:</b>	N/A	N/A
<b>Extent of Damage:</b>	N/A	N/A
<b>Surface Treatment:</b>	N/A	N/A
<b>Asbestos type:</b>	N/A	N/A
<b>Material Assessment Score:</b>		N/A
<b>Risk Assessment Score:</b>		N/A
<b>Action:</b>	N/A	
<b>Comments:</b>	Panels are non-asbestos masterboard. Building was built in 1994 and no asbestos insulation board is present.

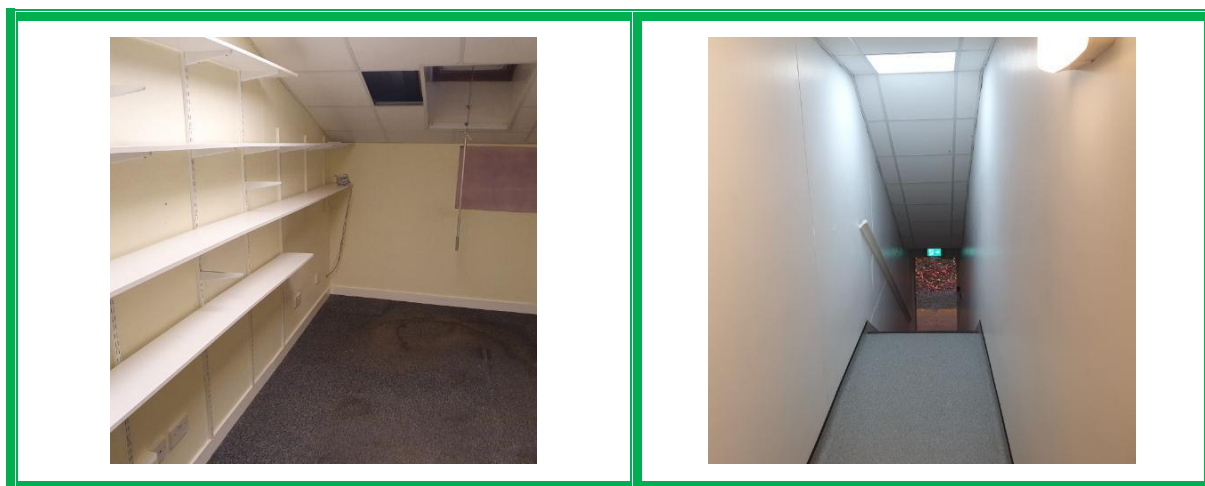
**Location:** First Floor - Stores x 2 and Corridor/Stairwell 009

<b>Material Description:</b>	No Suspect Materials Found	
<b>Identification:</b>	N/A	
<b>Approx. quantity:</b>	N/A	
<b>Accessibility</b>	N/A	<i>Assessment Score</i>
<b>Product type:</b>	N/A	N/A
<b>Extent of Damage:</b>	N/A	N/A
<b>Surface Treatment:</b>	N/A	N/A
<b>Asbestos type:</b>	N/A	N/A
<b>Material Assessment Score:</b>		N/A
<b>Risk Assessment Score:</b>		N/A
<b>Action:</b>	N/A	
<b>Comments:</b>	N/A

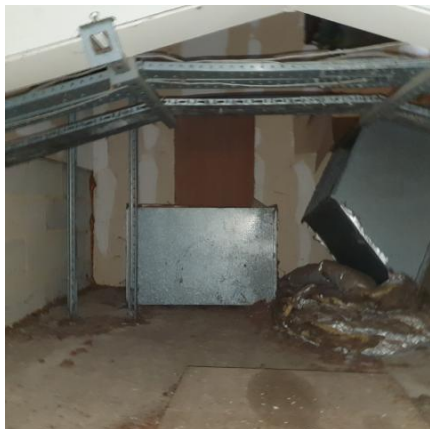
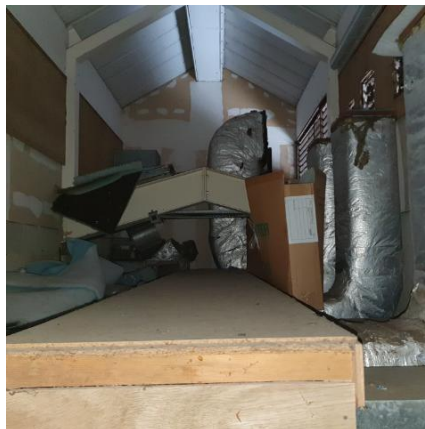
**Location:** First Floor - Loft Space 010

<b>Material Description:</b>	No Suspect Materials Found	
<b>Identification:</b>	N/A	
<b>Approx. quantity:</b>	N/A	
<b>Accessibility</b>	N/A	<i>Assessment Score</i>
<b>Product type:</b>	N/A	N/A
<b>Extent of Damage:</b>	N/A	N/A
<b>Surface Treatment:</b>	N/A	N/A
<b>Asbestos type:</b>	N/A	N/A
<b>Material Assessment Score:</b>		N/A
<b>Risk Assessment Score:</b>		N/A
<b>Action:</b>	N/A	
<b>Comments:</b>	Plasterboard walls. Modern ductwork

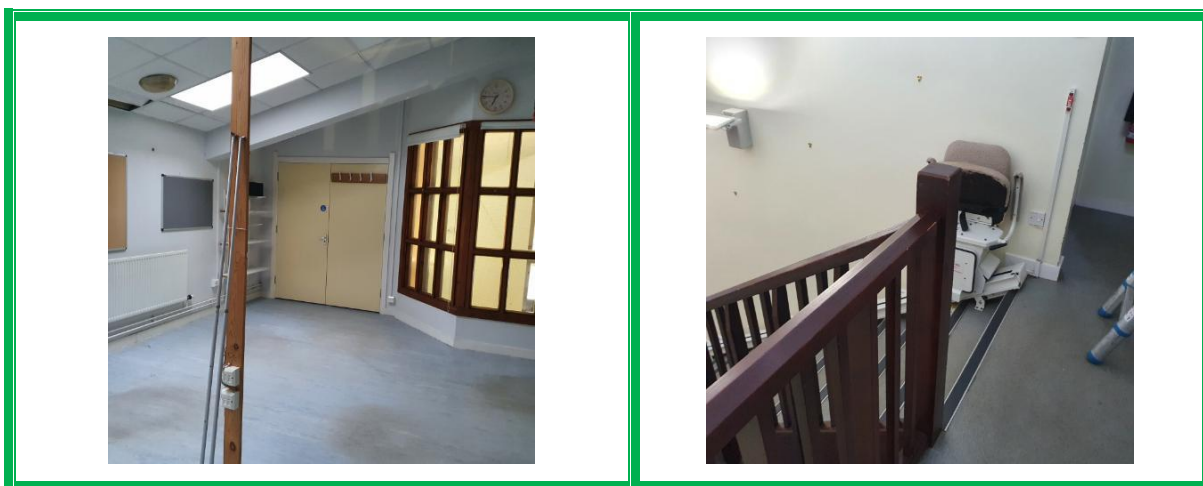
**Location:** First Floor - Office and Landing 011

<b>Material Description:</b>	No Suspect Materials Found	
<b>Identification:</b>	N/A	
<b>Approx. quantity:</b>	N/A	
<b>Accessibility</b>	N/A	<i>Assessment Score</i>
<b>Product type:</b>	N/A	N/A
<b>Extent of Damage:</b>	N/A	N/A
<b>Surface Treatment:</b>	N/A	N/A
<b>Asbestos type:</b>	N/A	N/A
<b>Material Assessment Score:</b>		N/A
<b>Risk Assessment Score:</b>		N/A
<b>Action:</b>	N/A	
<b>Comments:</b>	Plasterboard and solid walls. Concrete under modern lino

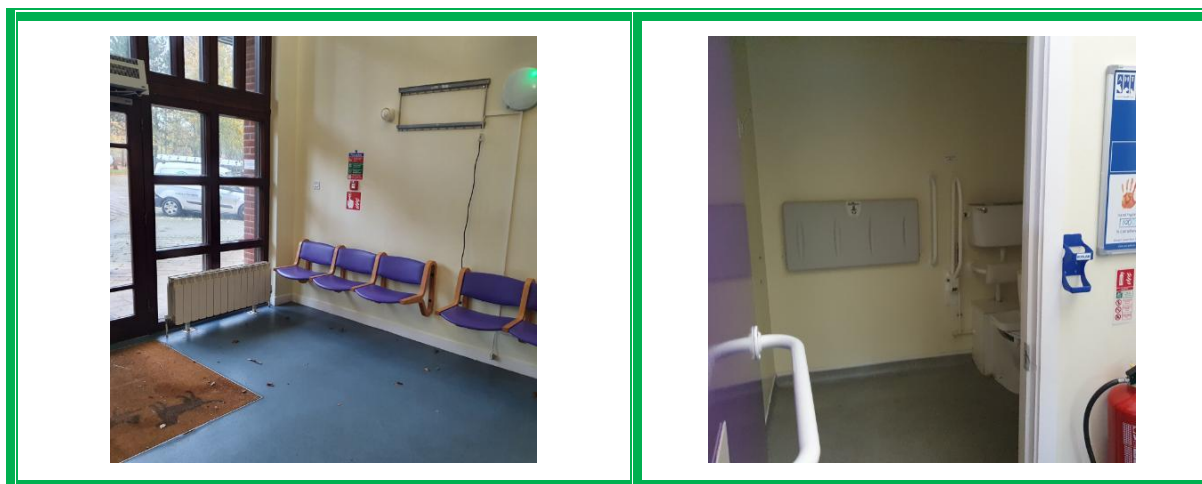
<b>Item No:</b>	<b>12</b>	<b>Sample No:</b>	<b>N/A</b>
<b>Location:</b>	First Floor - Entrance Hall, W.C and Cleaners Cupboard 012

<b>Material Description:</b>	No Suspect Materials Found	
<b>Identification:</b>	N/A	
<b>Approx. quantity:</b>	N/A	
<b>Accessibility</b>	N/A	<i>Assessment Score</i>
<b>Product type:</b>	N/A	N/A
<b>Extent of Damage:</b>	N/A	N/A
<b>Surface Treatment:</b>	N/A	N/A
<b>Asbestos type:</b>	N/A	N/A
<b>Material Assessment Score:</b>		N/A
<b>Risk Assessment Score:</b>		N/A
<b>Action:</b>	N/A	
<b>Comments:</b>	Metal and concrete above modern ceiling tiles. Concrete under modern lino. Solid walls.

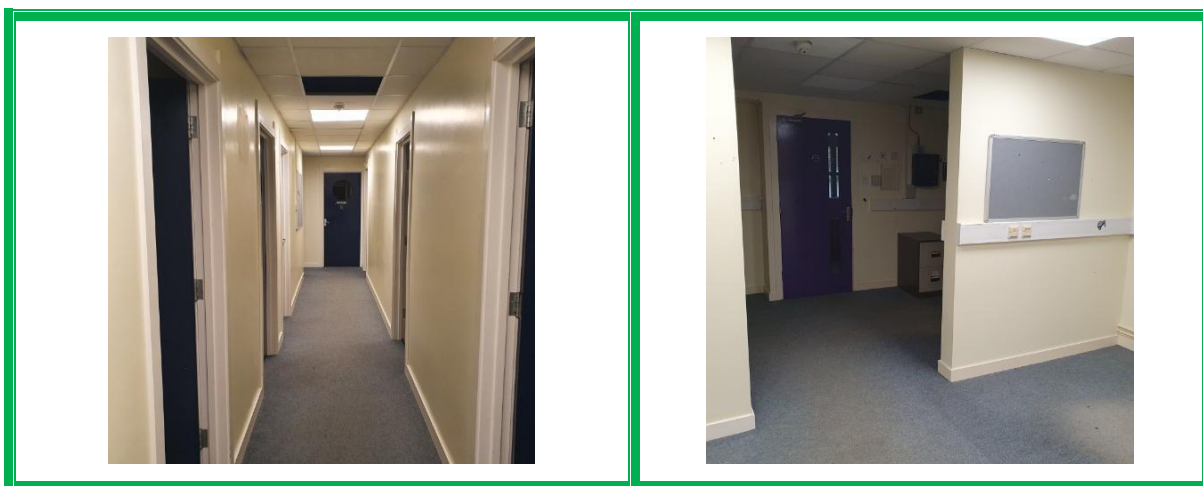
**Location:** First Floor - Offices x 10 and Corridor 013

<b>Material Description:</b>	No Suspect Materials Found	
<b>Identification:</b>	N/A	
<b>Approx. quantity:</b>	N/A	
<b>Accessibility</b>	N/A	<i>Assessment Score</i>
<b>Product type:</b>	N/A	N/A
<b>Extent of Damage:</b>	N/A	N/A
<b>Surface Treatment:</b>	N/A	N/A
<b>Asbestos type:</b>	N/A	N/A
<b>Material Assessment Score:</b>		N/A
<b>Risk Assessment Score:</b>		N/A
<b>Action:</b>	N/A	
<b>Comments:</b>	Metal and concrete above modern ceiling tiles. Concrete under modern lino and carpet. Timber boxings. Modern MMMF pipework throughout

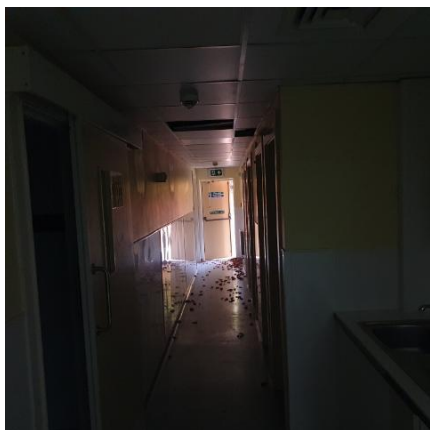
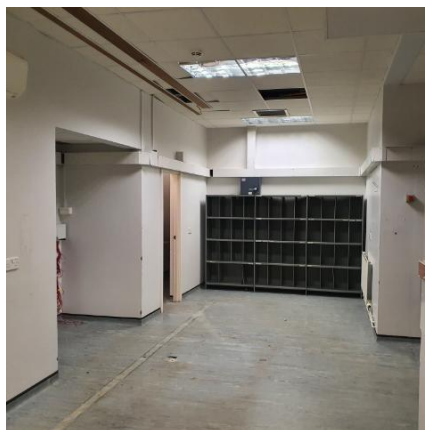
**Location:** First Floor - Offices x 3, Corridor, Stores, WC's and Changing Rooms 014

<b>Material Description:</b>	No Suspect Materials Found	
<b>Identification:</b>	N/A	
<b>Approx. quantity:</b>	N/A	
<b>Accessibility</b>	N/A	<i>Assessment Score</i>
<b>Product type:</b>	N/A	N/A
<b>Extent of Damage:</b>	N/A	N/A
<b>Surface Treatment:</b>	N/A	N/A
<b>Asbestos type:</b>	N/A	N/A
<b>Material Assessment Score:</b>		N/A
<b>Risk Assessment Score:</b>		N/A
<b>Action:</b>	N/A	
<b>Comments:</b>	Concrete above modern ceiling tiles. Concrete under modern lino and carpet. Ceramic floor tiles in changing rooms. Modern pipework and electrical boxes. Modern sink pad.

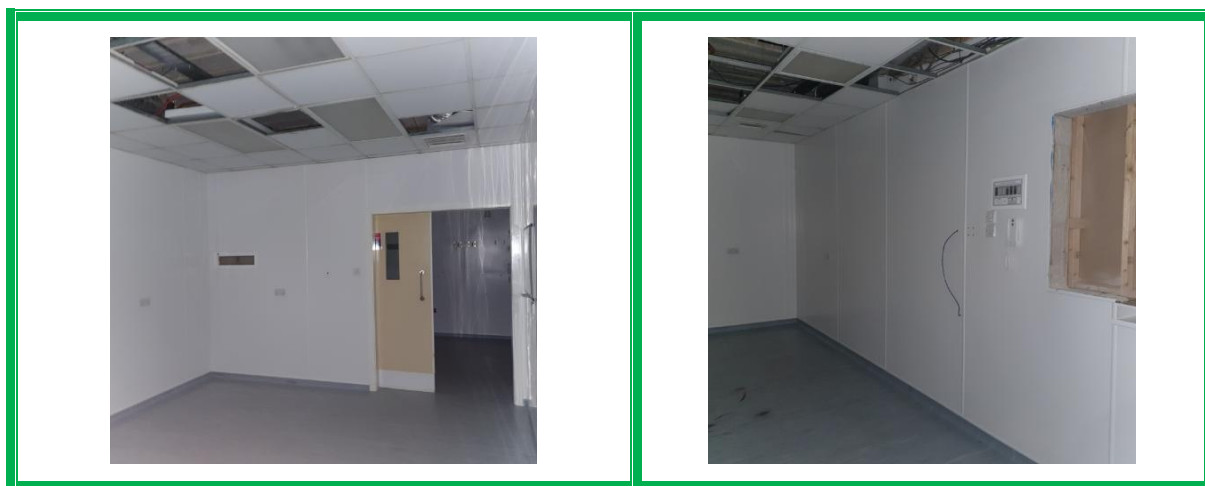
**Location:** First Floor - Offices x 6 015

<b>Material Description:</b>	No Suspect Materials Found	
<b>Identification:</b>	N/A	
<b>Approx. quantity:</b>	N/A	
<b>Accessibility</b>	N/A	<i>Assessment Score</i>
<b>Product type:</b>	N/A	N/A
<b>Extent of Damage:</b>	N/A	N/A
<b>Surface Treatment:</b>	N/A	N/A
<b>Asbestos type:</b>	N/A	N/A
<b>Material Assessment Score:</b>		N/A
<b>Risk Assessment Score:</b>		N/A
<b>Action:</b>	N/A	
<b>Comments:</b>	Concrete and metal roof above modern ceiling tiles. Concrete under modern lino. Plasterboard and solid walls. Modern MMMF pipework throughout

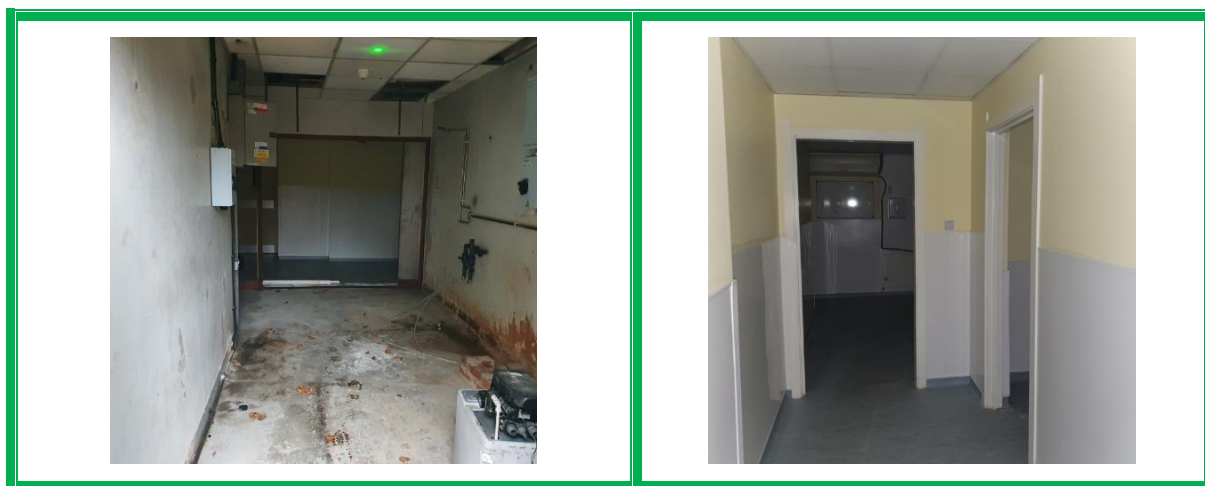
**Location:** First Floor - Offices x 4, Switchroom and Store 016

<b>Material Description:</b>	No Suspect Materials Found	
<b>Identification:</b>	N/A	
<b>Approx. quantity:</b>	N/A	
<b>Accessibility</b>	N/A	<i>Assessment Score</i>
<b>Product type:</b>	N/A	N/A
<b>Extent of Damage:</b>	N/A	N/A
<b>Surface Treatment:</b>	N/A	N/A
<b>Asbestos type:</b>	N/A	N/A
<b>Material Assessment Score:</b>		N/A
<b>Risk Assessment Score:</b>		N/A
<b>Action:</b>	N/A	
<b>Comments:</b>	Concrete above modern ceiling tiles. Concrete under modern lino. Modern MMMF pipework throughout. Modern electrics

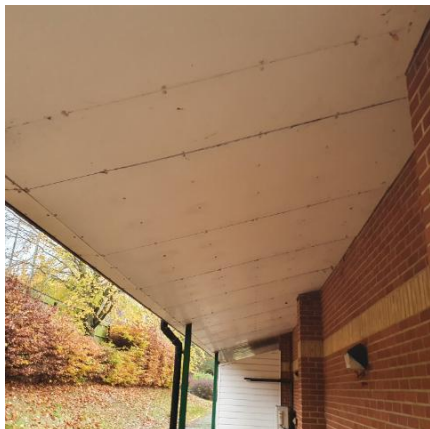
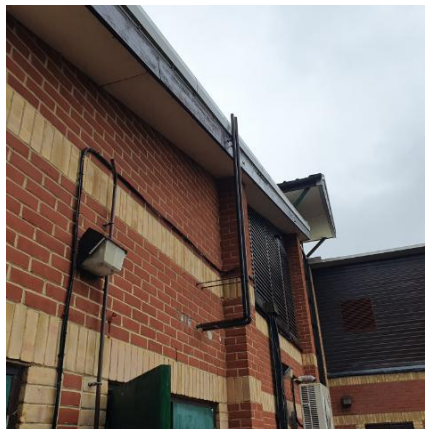
**Location:** External - Soffits 017

<b>Material Description:</b>	Soffits - Insulating Board	
<b>Identification:</b>	Sampled - No Asbestos Found	
<b>Approx. quantity:</b>	N/A	
<b>Accessibility</b>	N/A	<i>Assessment Score</i>
<b>Product type:</b>	N/A	N/A
<b>Extent of Damage:</b>	N/A	N/A
<b>Surface Treatment:</b>	N/A	N/A
<b>Asbestos type:</b>	N/A	N/A
<b>Material Assessment Score:</b>		N/A
<b>Risk Assessment Score:</b>		N/A
<b>Action:</b>	N/A	
<b>Comments:</b>	To all externals

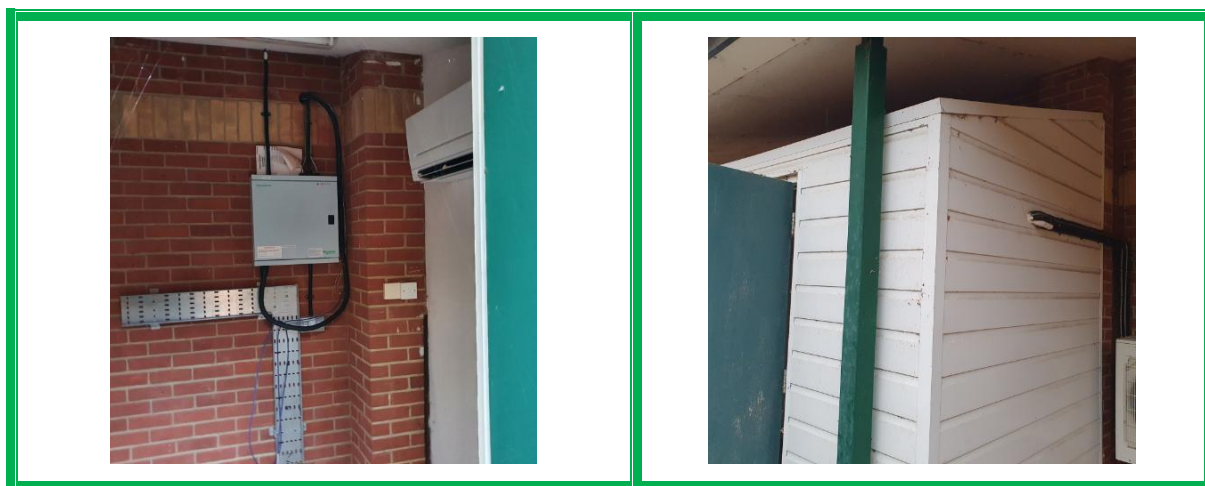
**Location:** External - Electric Room 018

<b>Material Description:</b>	No Suspect Materials Found	
<b>Identification:</b>	N/A	
<b>Approx. quantity:</b>	N/A	
<b>Accessibility</b>	N/A	<i>Assessment Score</i>
<b>Product type:</b>	N/A	N/A
<b>Extent of Damage:</b>	N/A	N/A
<b>Surface Treatment:</b>	N/A	N/A
<b>Asbestos type:</b>	N/A	N/A
<b>Material Assessment Score:</b>		N/A
<b>Risk Assessment Score:</b>		N/A
<b>Action:</b>	N/A	
<b>Comments:</b>	Modern constructed building

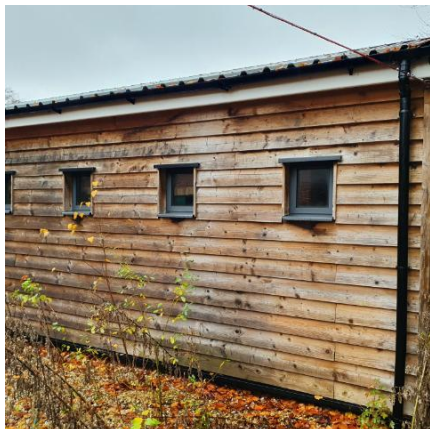
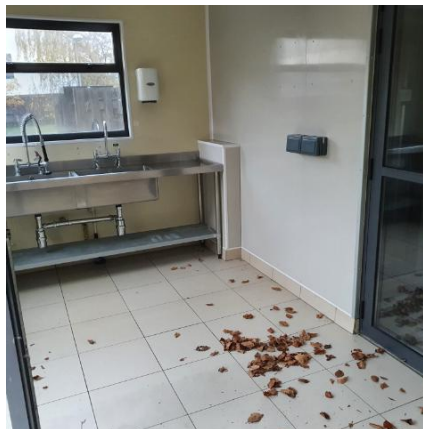
**Location:** Ground Floor - Hut 019

<b>Material Description:</b>	No Suspect Materials Found	
<b>Identification:</b>	N/A	
<b>Approx. quantity:</b>	N/A	
<b>Accessibility</b>	N/A	<i>Assessment Score</i>
<b>Product type:</b>	N/A	N/A
<b>Extent of Damage:</b>	N/A	N/A
<b>Surface Treatment:</b>	N/A	N/A
<b>Asbestos type:</b>	N/A	N/A
<b>Material Assessment Score:</b>		N/A
<b>Risk Assessment Score:</b>		N/A
<b>Action:</b>	N/A	
<b>Comments:</b>	Built within the last few years - No asbestos present

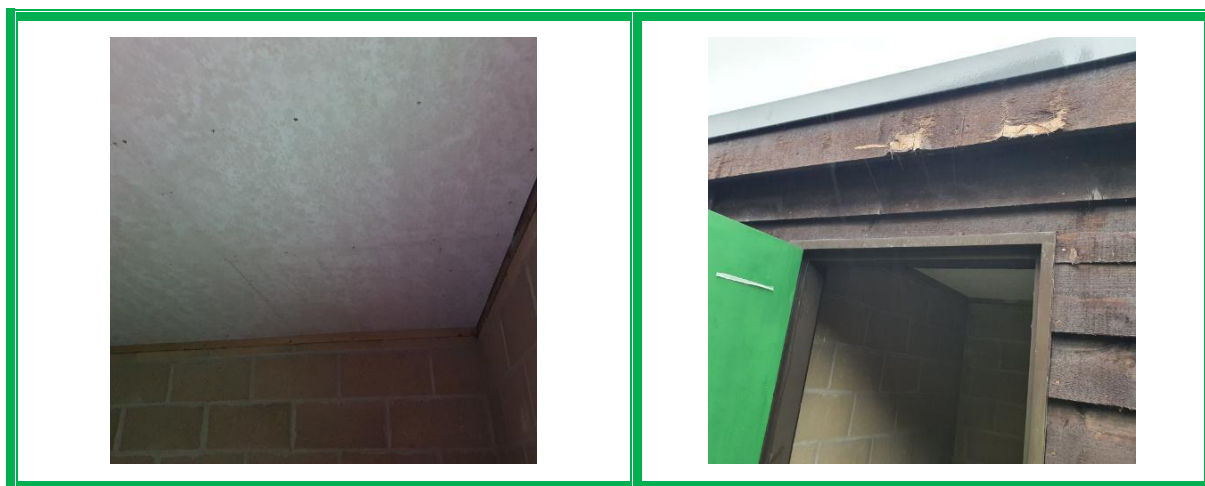
**Location:** Ground Floor - Hut 020

<b>Material Description:</b>	Ceiling Panels - Insulating Board	
<b>Identification:</b>	Sampled - No Asbestos Found	
<b>Approx. quantity:</b>	N/A	
<b>Accessibility</b>	N/A	<i>Assessment Score</i>
<b>Product type:</b>	N/A	N/A
<b>Extent of Damage:</b>	N/A	N/A
<b>Surface Treatment:</b>	N/A	N/A
<b>Asbestos type:</b>	N/A	N/A
<b>Material Assessment Score:</b>		N/A
<b>Risk Assessment Score:</b>		N/A
<b>Action:</b>	N/A	
<b>Comments:</b>	Blockwork and timber walls

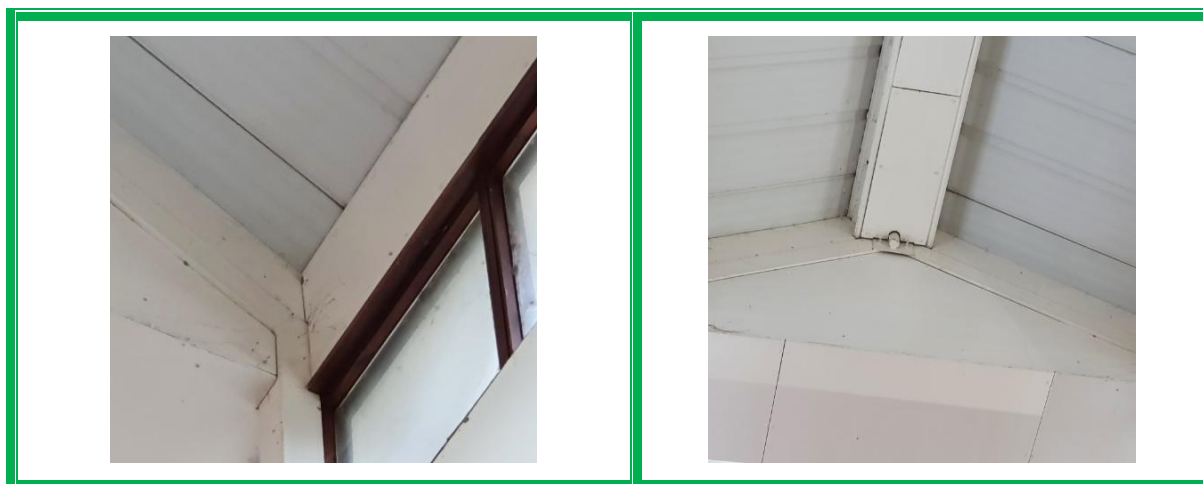
<b>Item No:</b>	<b>21</b>	<b>Sample No:</b>	<b>N/A</b>
<b>Location:</b>	Ground Floor - Entrance Hall and Central Corridor 021

<b>Material Description:</b>	High Level Bulkhead Panels and Boxing - Insulating Board	
<b>Identification:</b>	As per sample DK/05 - No Asbestos Found	
<b>Approx. quantity:</b>	N/A	
<b>Accessibility</b>	N/A	<i>Assessment Score</i>
<b>Product type:</b>	N/A	N/A
<b>Extent of Damage:</b>	N/A	N/A
<b>Surface Treatment:</b>	N/A	N/A
<b>Asbestos type:</b>	N/A	N/A
<b>Material Assessment Score:</b>		N/A
<b>Risk Assessment Score:</b>		N/A
<b>Action:</b>	N/A	
<b>Comments:</b>	Found high level throughout roof apex to bulkheads and to apex boxing. Same panels as soffits

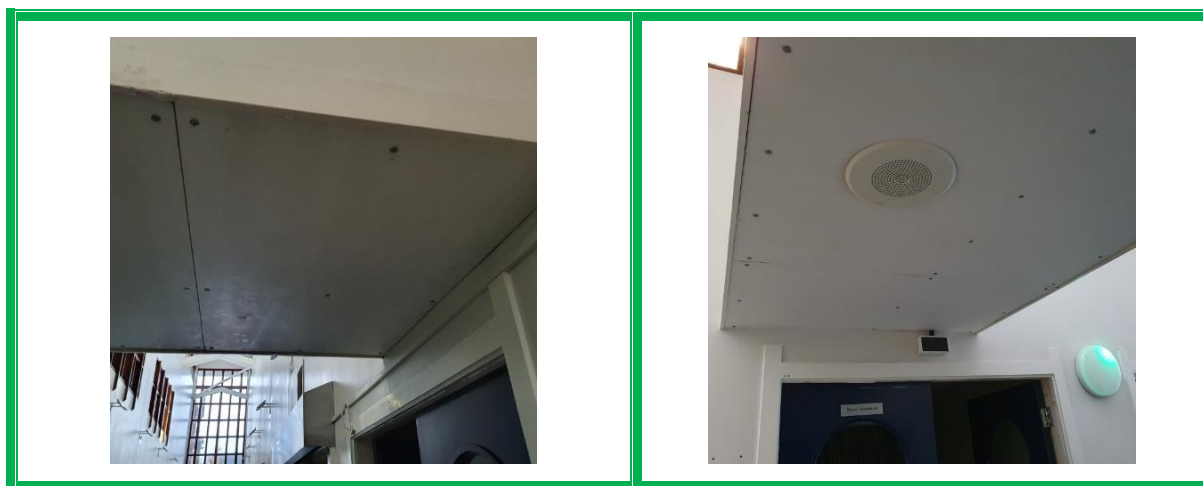
<b>Item No:</b>	<b>22</b>	<b>Sample No:</b>	<b>N/A</b>
<b>Location:</b>	Ground Floor - Central Corridor 022

<b>Material Description:</b>	Ceiling below Walkway - Insulating Board	
<b>Identification:</b>	As per sample DK/05 - No Asbestos Found	
<b>Approx. quantity:</b>	N/A	
<b>Accessibility</b>	N/A	<i>Assessment Score</i>
<b>Product type:</b>	N/A	N/A
<b>Extent of Damage:</b>	N/A	N/A
<b>Surface Treatment:</b>	N/A	N/A
<b>Asbestos type:</b>	N/A	N/A
<b>Material Assessment Score:</b>		N/A
<b>Risk Assessment Score:</b>		N/A
<b>Action:</b>	N/A	
<b>Comments:</b>	Same panels and high-level bulkhead panels. Modern electrics

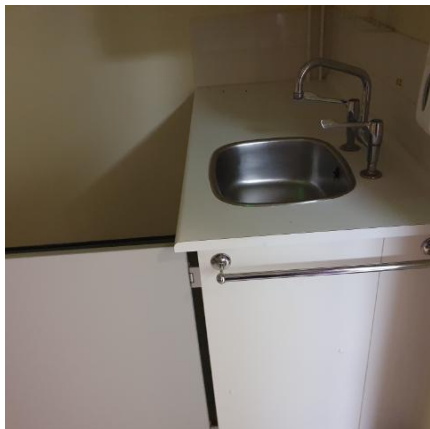
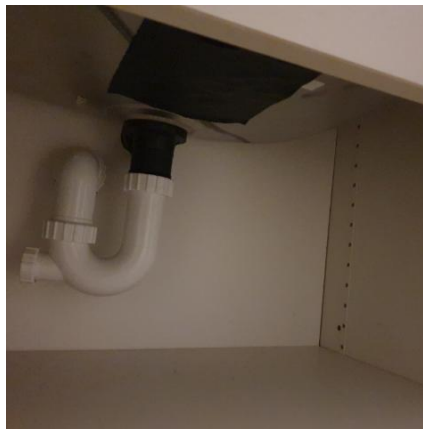
**Location:** Ground Floor - Consulting Rooms x 6 023

<b>Material Description:</b>	Sink Pads - Bituminous Product	
<b>Identification:</b>	Sampled - No Asbestos Found	
<b>Approx. quantity:</b>	N/A	
<b>Accessibility</b>	N/A	<i>Assessment Score</i>
<b>Product type:</b>	N/A	N/A
<b>Extent of Damage:</b>	N/A	N/A
<b>Surface Treatment:</b>	N/A	N/A
<b>Asbestos type:</b>	N/A	N/A
<b>Material Assessment Score:</b>		N/A
<b>Risk Assessment Score:</b>		N/A
<b>Action:</b>	N/A	
<b>Comments:</b>	Solid walls, Concrete and Metal roof above modern ceiling tiles. Concrete under lino

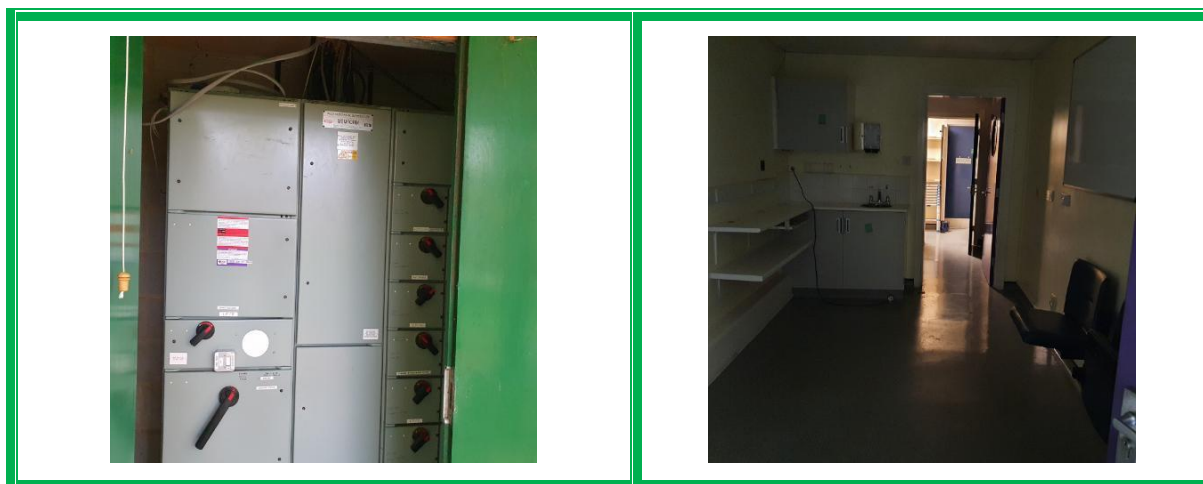
<b>Item No:</b>	<b>24</b>	<b>Sample No:</b>	<b>N/A</b>
<b>Location:</b>	Ground Floor - Consulting Rooms x 2, WC and Switchroom 024

<b>Material Description:</b>	No Suspect Materials Found	
<b>Identification:</b>	N/A	
<b>Approx. quantity:</b>	N/A	
<b>Accessibility</b>	N/A	<i>Assessment Score</i>
<b>Product type:</b>	N/A	N/A
<b>Extent of Damage:</b>	N/A	N/A
<b>Surface Treatment:</b>	N/A	N/A
<b>Asbestos type:</b>	N/A	N/A
<b>Material Assessment Score:</b>		N/A
<b>Risk Assessment Score:</b>		N/A
<b>Action:</b>	N/A	
<b>Comments:</b>	Modern electrics

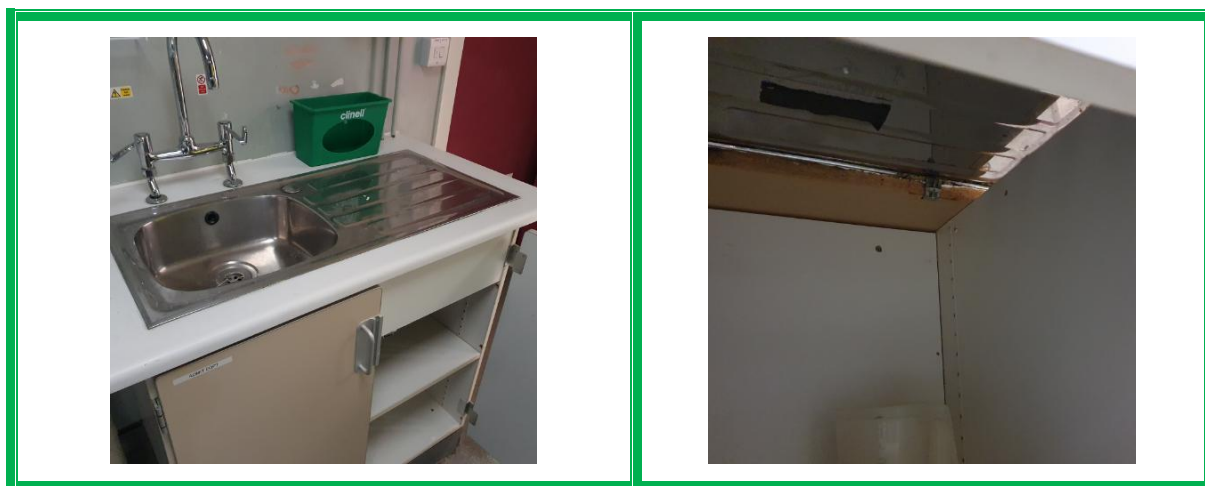
**Location:** Ground Floor - Ward and Store 025

<b>Material Description:</b>	Sink Pads - Bituminous Product	
<b>Identification:</b>	As per sample DK/07 - No Asbestos Found	
<b>Approx. quantity:</b>	N/A	
<b>Accessibility</b>	N/A	<i>Assessment Score</i>
<b>Product type:</b>	N/A	N/A
<b>Extent of Damage:</b>	N/A	N/A
<b>Surface Treatment:</b>	N/A	N/A
<b>Asbestos type:</b>	N/A	N/A
<b>Material Assessment Score:</b>		N/A
<b>Risk Assessment Score:</b>		N/A
<b>Action:</b>	N/A	
<b>Comments:</b>	Solid walls, Concrete and Metal roof above modern ceiling tiles. Concrete under lino

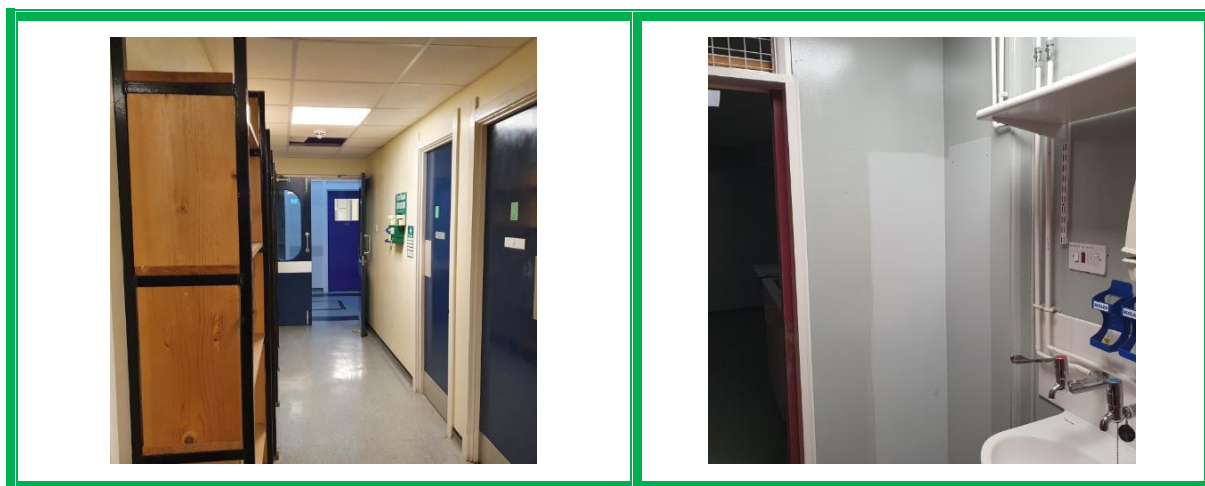
**Location:** Ground Floor - Corridor and Stores x 5 026

<b>Material Description:</b>	No Suspect Materials Found	
<b>Identification:</b>	N/A	
<b>Approx. quantity:</b>	N/A	
<b>Accessibility</b>	N/A	<i>Assessment Score</i>
<b>Product type:</b>	N/A	N/A
<b>Extent of Damage:</b>	N/A	N/A
<b>Surface Treatment:</b>	N/A	N/A
<b>Asbestos type:</b>	N/A	N/A
<b>Material Assessment Score:</b>		N/A
<b>Risk Assessment Score:</b>		N/A
<b>Action:</b>	N/A	
<b>Comments:</b>	N/A

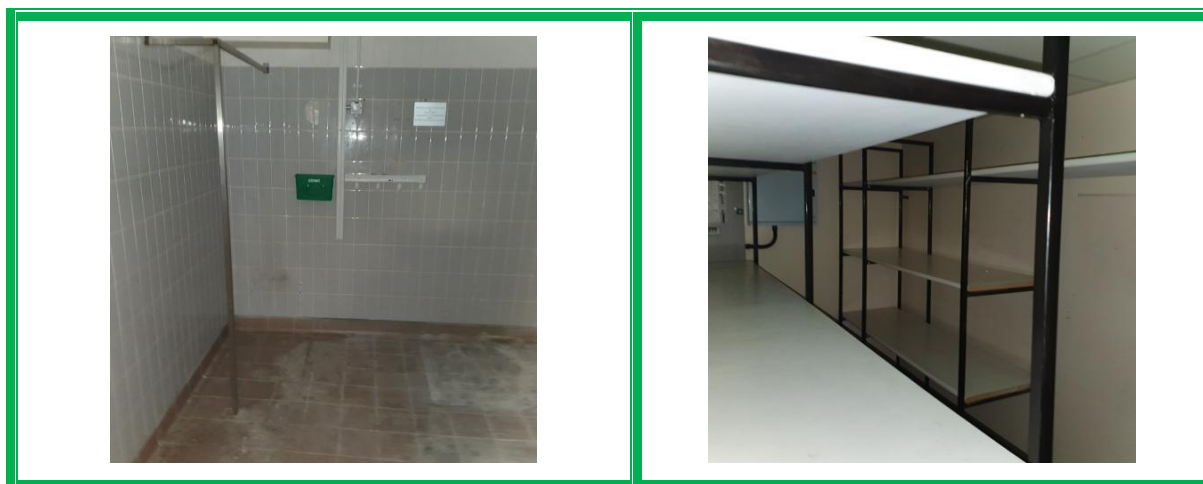
<b>Item No:</b>	<b>27</b>	<b>Sample No:</b>	<b>N/A</b>
<b>Location:</b>	Ground Floor - Stores x 3, Corridor and Shower Room 027

<b>Material Description:</b>	No Suspect Materials Found	
<b>Identification:</b>	N/A	
<b>Approx. quantity:</b>	N/A	
<b>Accessibility</b>	N/A	<i>Assessment Score</i>
<b>Product type:</b>	N/A	N/A
<b>Extent of Damage:</b>	N/A	N/A
<b>Surface Treatment:</b>	N/A	N/A
<b>Asbestos type:</b>	N/A	N/A
<b>Material Assessment Score:</b>		N/A
<b>Risk Assessment Score:</b>		N/A
<b>Action:</b>	N/A	
<b>Comments:</b>	N/A

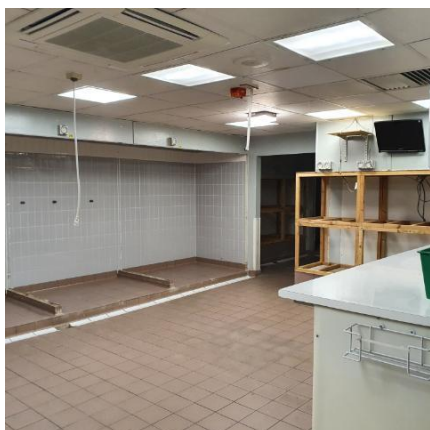
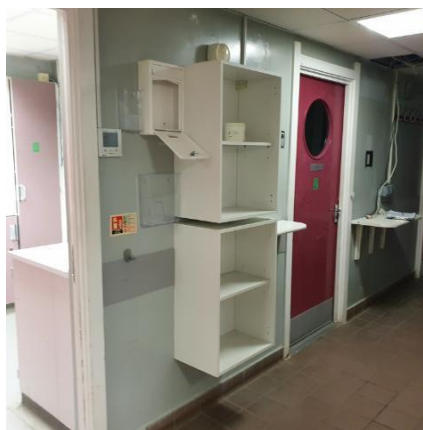
**Location:** Ground Floor - Showers, Kitchen, Office and Lab 028

<b>Material Description:</b>	No Suspect Materials Found	
<b>Identification:</b>	N/A	
<b>Approx. quantity:</b>	N/A	
<b>Accessibility</b>	N/A	<i>Assessment Score</i>
<b>Product type:</b>	N/A	N/A
<b>Extent of Damage:</b>	N/A	N/A
<b>Surface Treatment:</b>	N/A	N/A
<b>Asbestos type:</b>	N/A	N/A
<b>Material Assessment Score:</b>		N/A
<b>Risk Assessment Score:</b>		N/A
<b>Action:</b>	N/A	
<b>Comments:</b>	Concrete and metal rood above ceiling tiles. Ceramic floor tiles

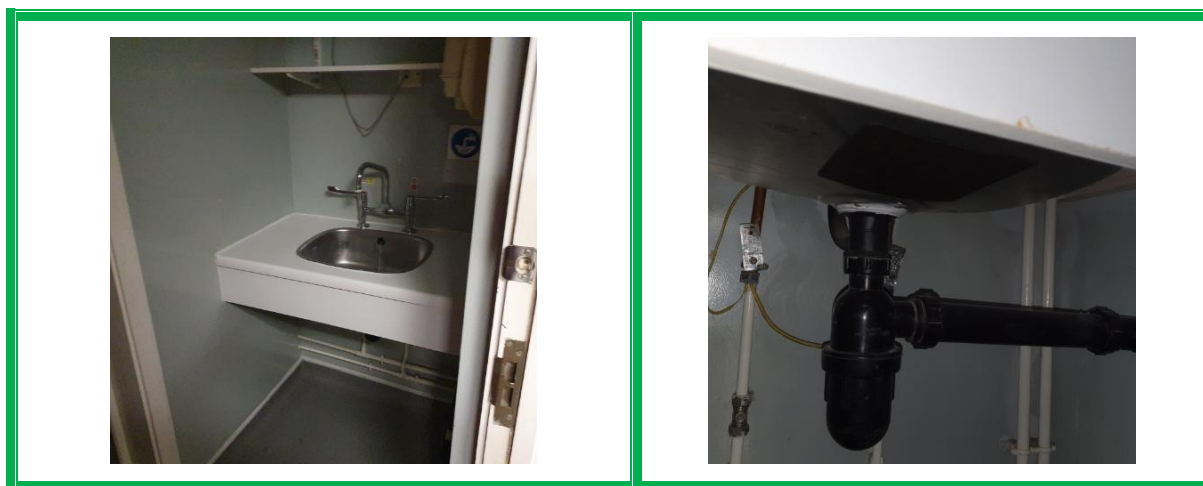
<b>Item No:</b>	<b>29</b>	<b>Sample No:</b>	<b>N/A</b>
<b>Location:</b>	Ground Floor - Store 029

<b>Material Description:</b>	Sink Pad - Bituminous Product	
<b>Identification:</b>	As per sample DK/07 - No Asbestos Found	
<b>Approx. quantity:</b>	N/A	
<b>Accessibility</b>	N/A	<i>Assessment Score</i>
<b>Product type:</b>	N/A	N/A
<b>Extent of Damage:</b>	N/A	N/A
<b>Surface Treatment:</b>	N/A	N/A
<b>Asbestos type:</b>	N/A	N/A
<b>Material Assessment Score:</b>		N/A
<b>Risk Assessment Score:</b>		N/A
<b>Action:</b>	N/A	
<b>Comments:</b>	N/A

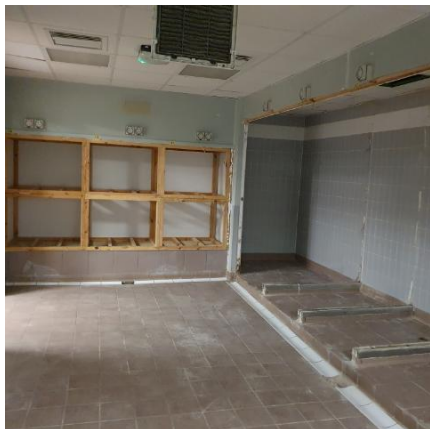
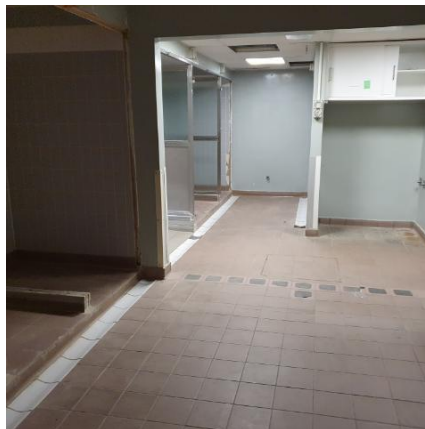
**Location:** Ground Floor - Showers 030

<b>Material Description:</b>	No Suspect Materials Found	
<b>Identification:</b>	N/A	
<b>Approx. quantity:</b>	N/A	
<b>Accessibility</b>	N/A	<i>Assessment Score</i>
<b>Product type:</b>	N/A	N/A
<b>Extent of Damage:</b>	N/A	N/A
<b>Surface Treatment:</b>	N/A	N/A
<b>Asbestos type:</b>	N/A	N/A
<b>Material Assessment Score:</b>		N/A
<b>Risk Assessment Score:</b>		N/A
<b>Action:</b>	N/A	
<b>Comments:</b>	N/A

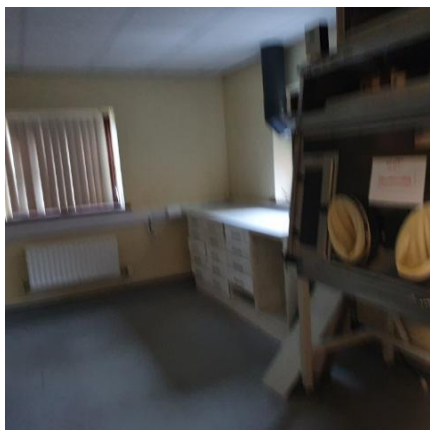
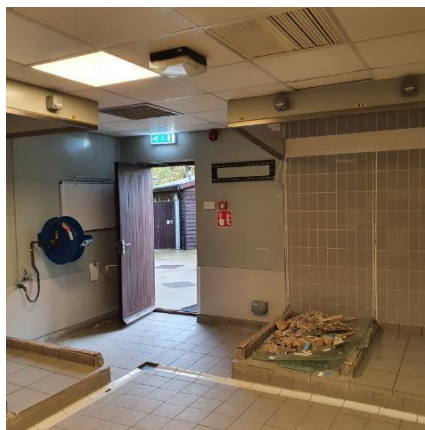
**Location:** Ground Floor - Showers, Quiet Room, Chemotherapy Room 031

<b>Material Description:</b>	No Suspect Materials Found	
<b>Identification:</b>	N/A	
<b>Approx. quantity:</b>	N/A	
<b>Accessibility</b>	N/A	<i>Assessment Score</i>
<b>Product type:</b>	N/A	N/A
<b>Extent of Damage:</b>	N/A	N/A
<b>Surface Treatment:</b>	N/A	N/A
<b>Asbestos type:</b>	N/A	N/A
<b>Material Assessment Score:</b>		N/A
<b>Risk Assessment Score:</b>		N/A
<b>Action:</b>	N/A	
<b>Comments:</b>	N/A

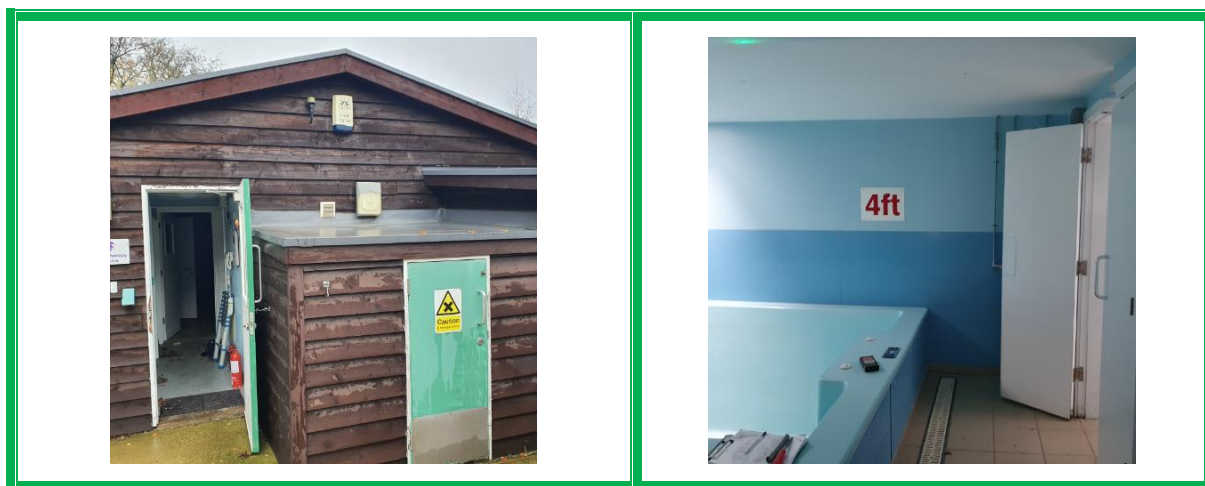
**Location:** Ground Floor - Hydrotherapy Centre 032

<b>Material Description:</b>	No Suspect Materials Found	
<b>Identification:</b>	N/A	
<b>Approx. quantity:</b>	N/A	
<b>Accessibility</b>	N/A	<i>Assessment Score</i>
<b>Product type:</b>	N/A	N/A
<b>Extent of Damage:</b>	N/A	N/A
<b>Surface Treatment:</b>	N/A	N/A
<b>Asbestos type:</b>	N/A	N/A
<b>Material Assessment Score:</b>		N/A
<b>Risk Assessment Score:</b>		N/A
<b>Action:</b>	N/A	
<b>Comments:</b>	Plasterboard walls and ceilings, timber to underside of roof, modern pipework and water heater, ceramic tile and modern lino floors. Chemical stores are timber

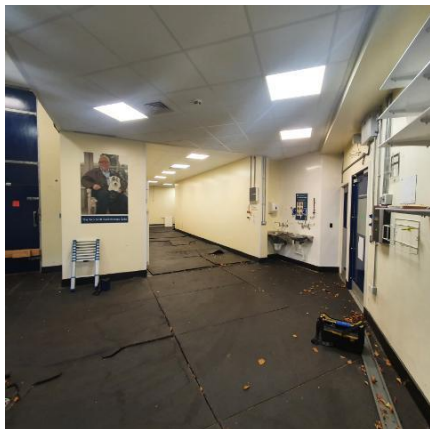
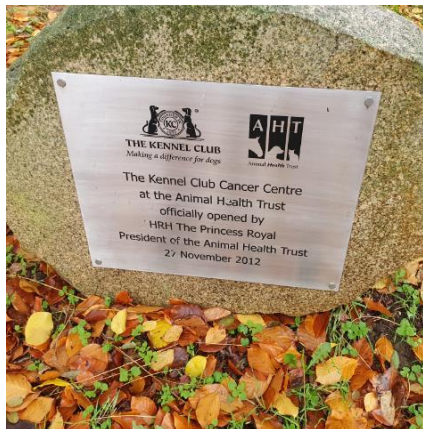
**Location:** Ground Floor - Cancer Unit - All Rooms 033

<b>Material Description:</b>	No Suspect Materials Found	
<b>Identification:</b>	N/A	
<b>Approx. quantity:</b>	N/A	
<b>Accessibility</b>	N/A	<i>Assessment Score</i>
<b>Product type:</b>	N/A	N/A
<b>Extent of Damage:</b>	N/A	N/A
<b>Surface Treatment:</b>	N/A	N/A
<b>Asbestos type:</b>	N/A	N/A
<b>Material Assessment Score:</b>		N/A
<b>Risk Assessment Score:</b>		N/A
<b>Action:</b>	N/A	
<b>Comments:</b>	Building was built in 2012 and does not contain asbestos. Timber walls, modern soffits, metal roof, internal solid walls, modern ceiling tiles, modern electrics, modern sink pads, modern ductwork and pipework
