**Project Number A-01998 (6724)**

**Refurbishment and Demolition  
Asbestos Survey Report**

**Entrance Building/Workshop  
Lanwades Park  
Newmarket  
CBU 7UA**

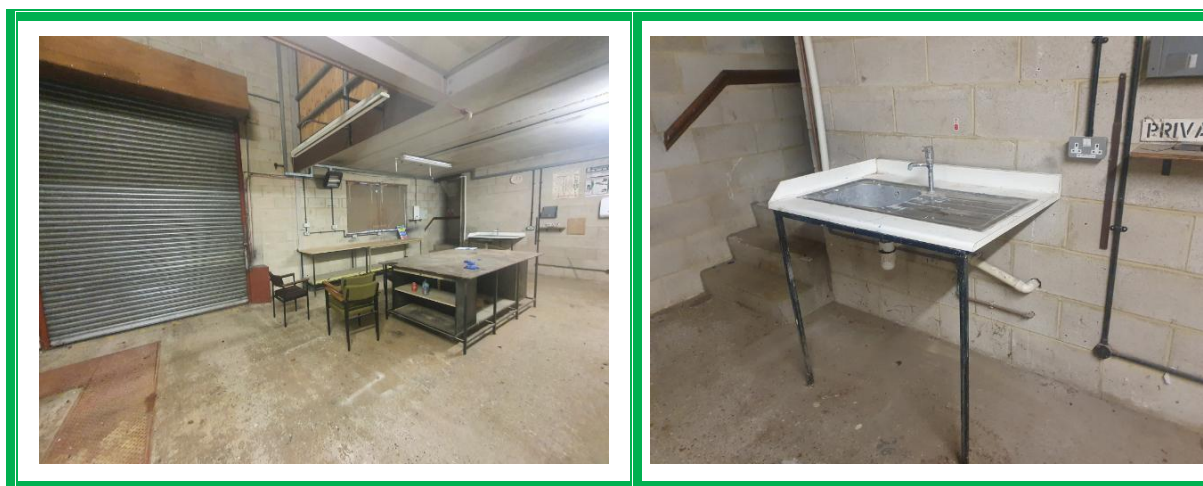
<b>Item No:</b>	<b>1</b>	<b>Sample No:</b>	<b>JH/01</b>
<b>Location:</b>	Ground Floor - Entrance 001

<b>Material Description:</b>	Sink Pad - Bituminous Product	
<b>Identification:</b>	Sampled - No Asbestos Found	
<b>Approx. quantity:</b>	N/A	
<b>Accessibility</b>	N/A	<i>Assessment Score</i>
<b>Product type:</b>	N/A	N/A
<b>Extent of Damage:</b>	N/A	N/A
<b>Surface Treatment:</b>	N/A	N/A
<b>Asbestos type:</b>	N/A	N/A
<b>Material Assessment Score:</b>		N/A
<b>Risk Assessment Score:</b>		N/A
<b>Action:</b>	N/A	
<b>Comments:</b>	Concrete ceiling, block walls, metal shutter, timber door and frame, plastic pipework, modern electrical units, concrete floor. Sink pad to metal sink.

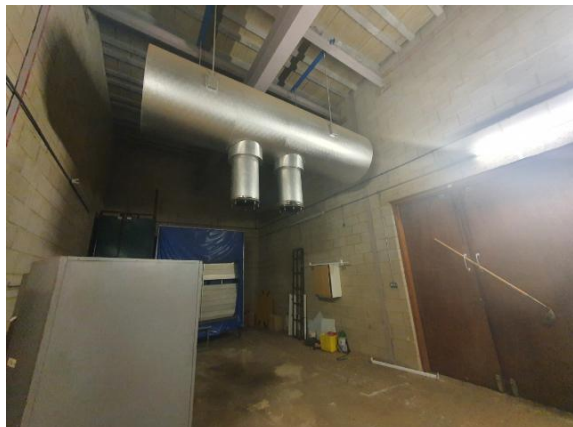
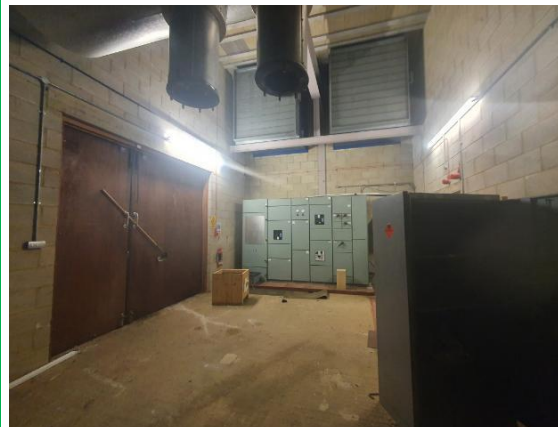
**Location:** Ground Floor - Plant Room 002

<b>Material Description:</b>	No Suspect Materials Found	
<b>Identification:</b>	N/A	
<b>Approx. quantity:</b>	N/A	
<b>Accessibility</b>	N/A	<i>Assessment Score</i>
<b>Product type:</b>	N/A	N/A
<b>Extent of Damage:</b>	N/A	N/A
<b>Surface Treatment:</b>	N/A	N/A
<b>Asbestos type:</b>	N/A	N/A
<b>Material Assessment Score:</b>		N/A
<b>Risk Assessment Score:</b>		N/A
<b>Action:</b>	N/A	
<b>Comments:</b>	Concrete ceiling, metal ductwork, metal door, timber door and frame, modern distribution boards, block walls, modern plant, concrete floor.

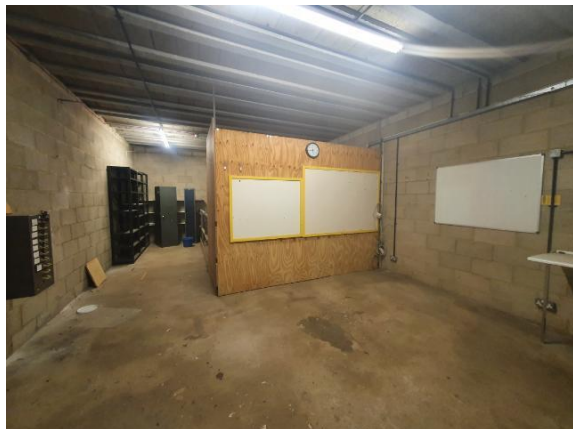
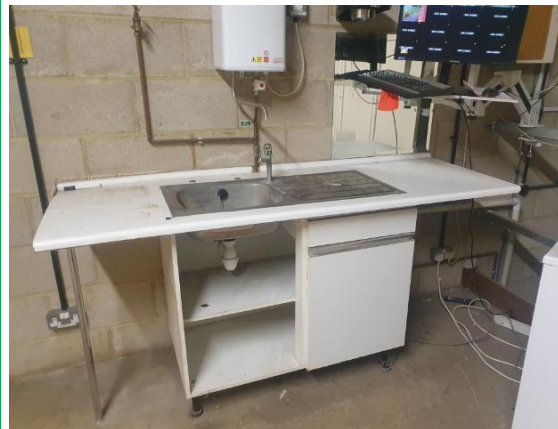
**Location:** First Floor - Mezzanine Floor 003

<b>Material Description:</b>	Sink Pad - Bituminous Product	
<b>Identification:</b>	As per sample JH/01 - No Asbestos Found	
<b>Approx. quantity:</b>	N/A	
<b>Accessibility</b>	N/A	<i>Assessment Score</i>
<b>Product type:</b>	N/A	N/A
<b>Extent of Damage:</b>	N/A	N/A
<b>Surface Treatment:</b>	N/A	N/A
<b>Asbestos type:</b>	N/A	N/A
<b>Material Assessment Score:</b>		N/A
<b>Risk Assessment Score:</b>		N/A
<b>Action:</b>	N/A	
<b>Comments:</b>	<p>Concrete ceiling, block walls, timber partitions, metal railings, plastic pipework, concrete floor.</p> <p>Sink pad to metal sink on first floor, cross referenced with sampled number 1 due to being visually similar.</p>

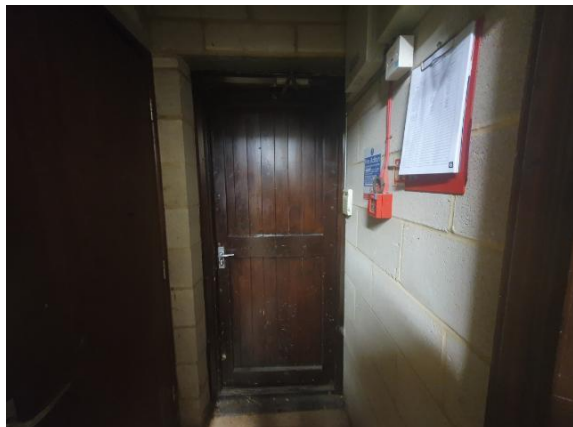
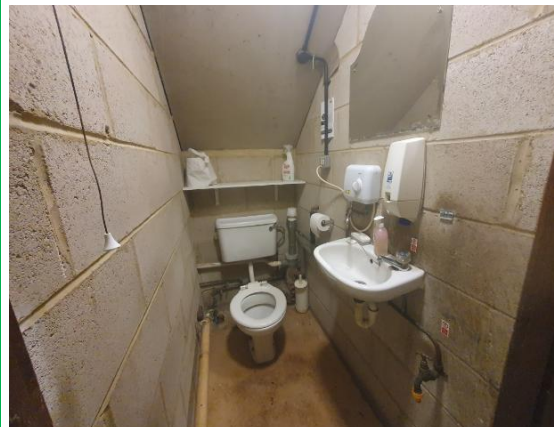
**Location:** Ground Floor - Lobby & Toilet 004

<b>Material Description:</b>	No Suspect Materials Found	
<b>Identification:</b>	N/A	
<b>Approx. quantity:</b>	N/A	
<b>Accessibility</b>	N/A	<i>Assessment Score</i>
<b>Product type:</b>	N/A	N/A
<b>Extent of Damage:</b>	N/A	N/A
<b>Surface Treatment:</b>	N/A	N/A
<b>Asbestos type:</b>	N/A	N/A
<b>Material Assessment Score:</b>		N/A
<b>Risk Assessment Score:</b>		N/A
<b>Action:</b>	N/A	
<b>Comments:</b>	Concrete ceiling, block walls, metal door, timber door and frame, modern facilities, metal and plastic pipework, concrete floor.

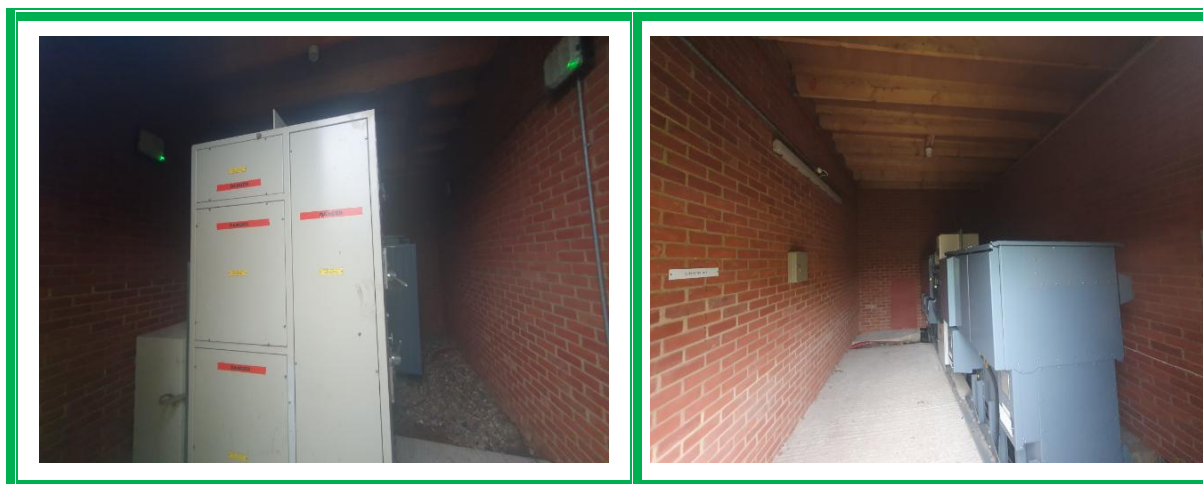
<b>Item No:</b>	<b>5</b>	<b>Sample No:</b>	<b>N/A</b>
<b>Location:</b>	Ground Floor - Substation Rooms x 2, & Diesel Store 005

<b>Material Description:</b>	No Suspect Materials Found	
<b>Identification:</b>	N/A	
<b>Approx. quantity:</b>	N/A	
<b>Accessibility</b>	N/A	<i>Assessment Score</i>
<b>Product type:</b>	N/A	N/A
<b>Extent of Damage:</b>	N/A	N/A
<b>Surface Treatment:</b>	N/A	N/A
<b>Asbestos type:</b>	N/A	N/A
<b>Material Assessment Score:</b>		N/A
<b>Risk Assessment Score:</b>		N/A
<b>Action:</b>	N/A	
<b>Comments:</b>	Timber ceilings, brick walls, non-ACM electrical units, timber door and frame, concrete floor.

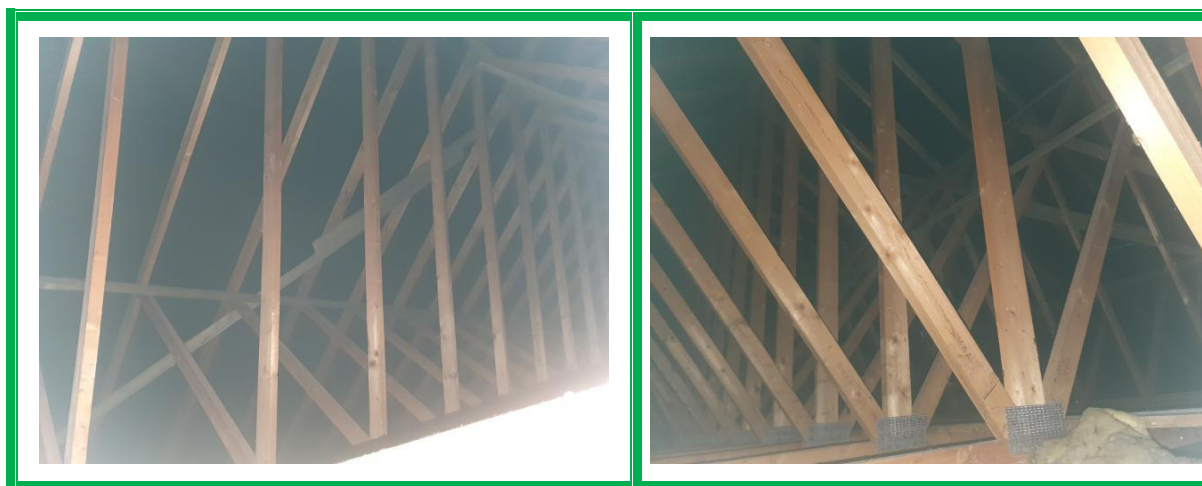
<b>Item No:</b>	<b>6</b>	<b>Sample No:</b>	<b>N/A</b>
<b>Location:</b>	Ground Floor - Roof Void 006

<b>Material Description:</b>	No Suspect Materials Found	
<b>Identification:</b>	N/A	
<b>Approx. quantity:</b>	N/A	
<b>Accessibility</b>	N/A	<i>Assessment Score</i>
<b>Product type:</b>	N/A	N/A
<b>Extent of Damage:</b>	N/A	N/A
<b>Surface Treatment:</b>	N/A	N/A
<b>Asbestos type:</b>	N/A	N/A
<b>Material Assessment Score:</b>		N/A
<b>Risk Assessment Score:</b>		N/A
<b>Action:</b>	N/A	
<b>Comments:</b>	Non-ACM roof felt, timber batons, modern insulation.

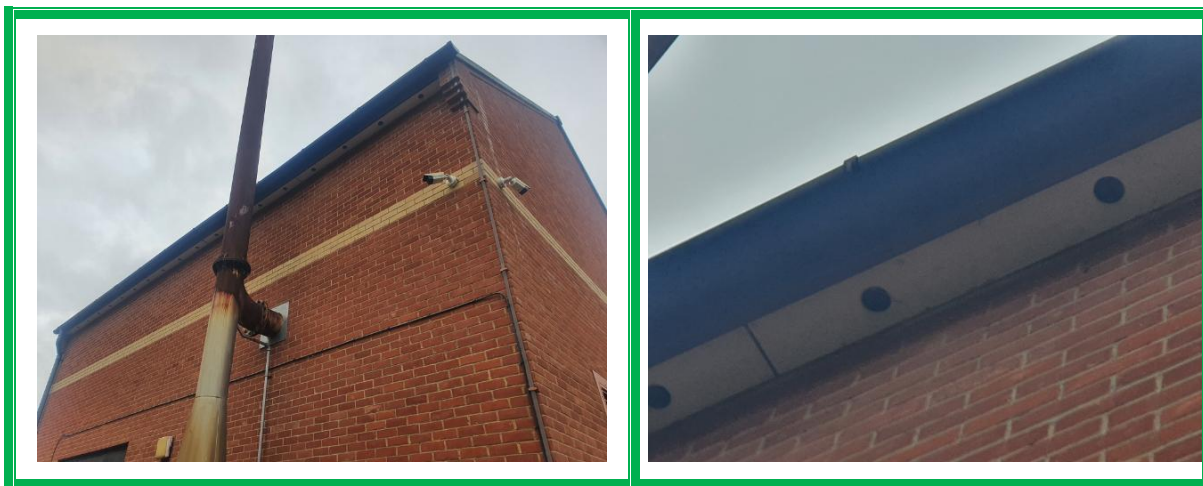
**Location:** External - Roof 007

<b>Material Description:</b>	Soffit - Insulating Board	
<b>Identification:</b>	Sampled - No Asbestos Found	
<b>Approx. quantity:</b>	N/A	
<b>Accessibility</b>	N/A	<i>Assessment Score</i>
<b>Product type:</b>	N/A	N/A
<b>Extent of Damage:</b>	N/A	N/A
<b>Surface Treatment:</b>	N/A	N/A
<b>Asbestos type:</b>	N/A	N/A
<b>Material Assessment Score:</b>		N/A
<b>Risk Assessment Score:</b>		N/A
<b>Action:</b>	N/A	
<b>Comments:</b>	Soffits to high level exterior.

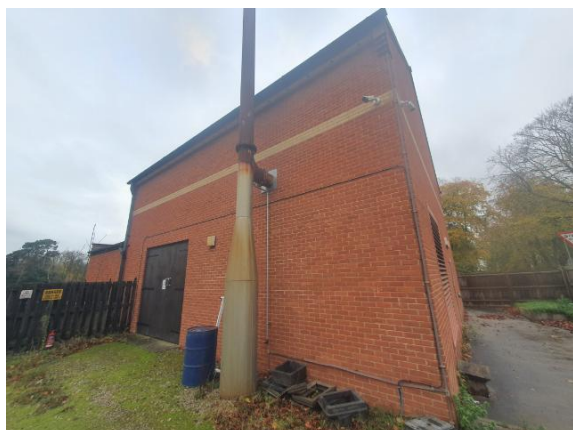
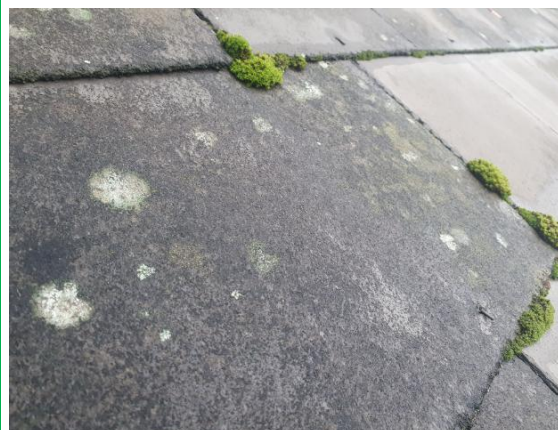
**Location:** External - Roof 008

<b>Material Description:</b>	Roof Tiles - Cement Product	
<b>Identification:</b>	Sampled - No Asbestos Found	
<b>Approx. quantity:</b>	N/A	
<b>Accessibility</b>	N/A	<i>Assessment Score</i>
<b>Product type:</b>	N/A	N/A
<b>Extent of Damage:</b>	N/A	N/A
<b>Surface Treatment:</b>	N/A	N/A
<b>Asbestos type:</b>	N/A	N/A
<b>Material Assessment Score:</b>		N/A
<b>Risk Assessment Score:</b>		N/A
<b>Action:</b>	N/A	
<b>Comments:</b>	Roof Tiles high level exterior.
