**Project Number A-01926 (6724)**

**Refurbishment and Demolition  
Asbestos Survey Report**

**Equine Barns  
Lanwades Park  
Newmarket  
CB8 7UA**

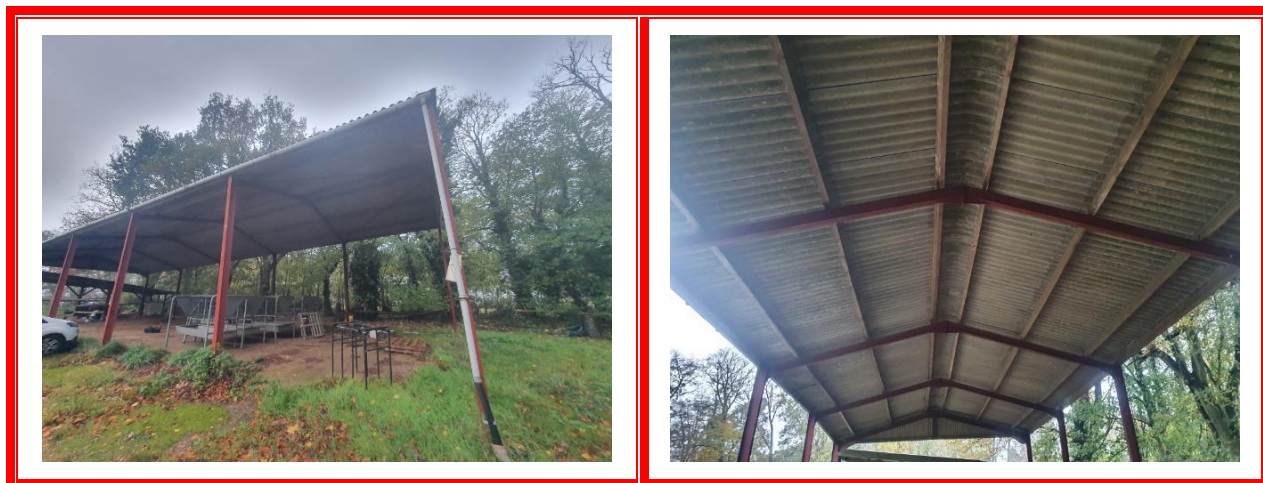
| <b>Item No:</b> | <b>1</b> | <b>Sample No:</b> | <b>JH/01</b> |

| <b>Location:</b> | External - Barn 001 | | |

| <b>Material Description:</b> | Cement Roof Sheets & Cladding - Cement Product | |
| <b>Identification:</b> | Sampled - Asbestos Detected | |
| <b>Approx. quantity:</b> | 120 m <sup>2</sup> | |
| <b>Extent of Damage:</b> | Slight / minor damage | 1 |
| <b>Asbestos type:</b> | Chrysotile | 1 |
| <b>Material Assessment Score:</b> | | 4 |
| <b>Risk Assessment Score:</b> | | Negligible |
| <b>Comments:</b> | Sampled cement roof, metal structure, plastic gutters and downpipes, concrete floor<br>Corrugated roof sheets to external barn | |

| <b>Action:</b> | Remove if likely to be disturbed by works | |

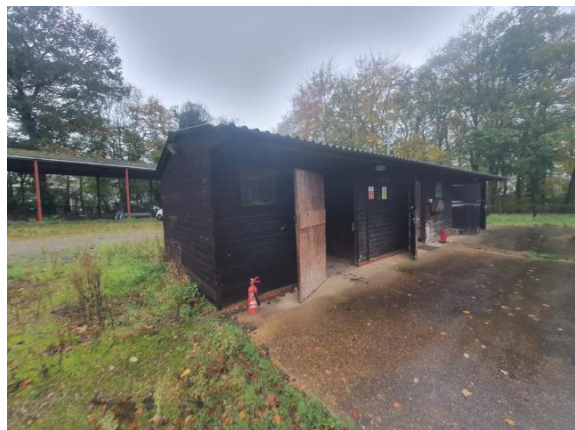
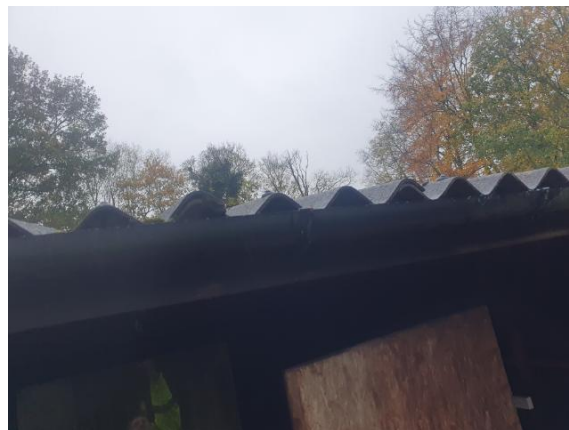
**Item No:** 3

**Location:** External - Small Stables 003

| <b>Material Description:</b> | Cement Roof Sheets - Cement Product | |
| <b>Identification:</b> | Sampled - Asbestos Detected | |
| <b>Approx. quantity:</b> | 39 m <sup>2</sup> | |
| <b>Extent of Damage:</b> | Slight / minor damage | 1 |
| <b>Asbestos type:</b> | Chrysotile | 1 |
| <b>Material Assessment Score:</b> | | 4 |
| <b>Risk Assessment Score:</b> | | Negligible |
| <b>Comments:</b> | Samples cement roof, timber construction, plastic gutters and downpipes, plastic windows, concrete floor<br>Cement roof sheets to pitched roof of small stable | |

| <b>Action:</b> | Remove if likely to be disturbed by works | |

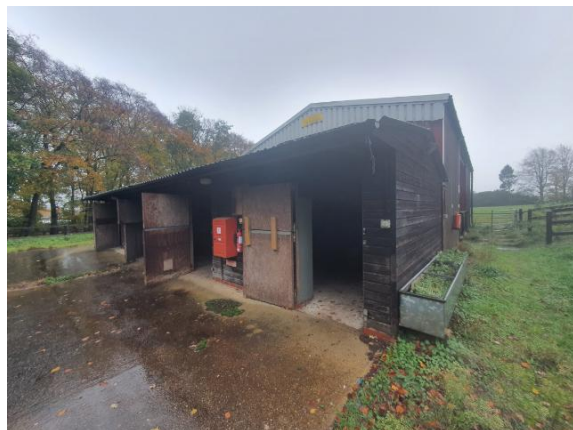
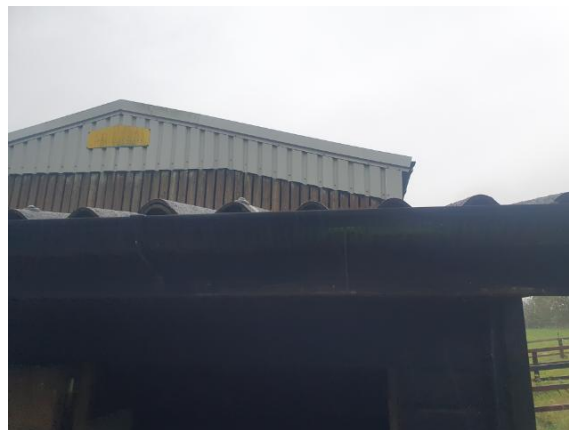
**Item No:** 8

**Location:** External - Small Stables 008

| <b>Material Description:</b> | Cement Roof Sheets - Cement Product | |
| <b>Identification:</b> | Sampled - Asbestos Detected | |
| <b>Approx. quantity:</b> | 39 m <sup>2</sup> | |
| <b>Extent of Damage:</b> | Slight / minor damage | 1 |
| <b>Asbestos type:</b> | Chrysotile | 1 |
| <b>Material Assessment Score:</b> | | 4 |
| <b>Risk Assessment Score:</b> | | Negligible |
| <b>Comments:</b> | Samples cement roof, timber construction, plastic gutters and downpipes, plastic windows, concrete floor<br>Cement roof sheets to pitched roof of small stable | |

| <b>Action:</b> | Remove if likely to be disturbed by works | |

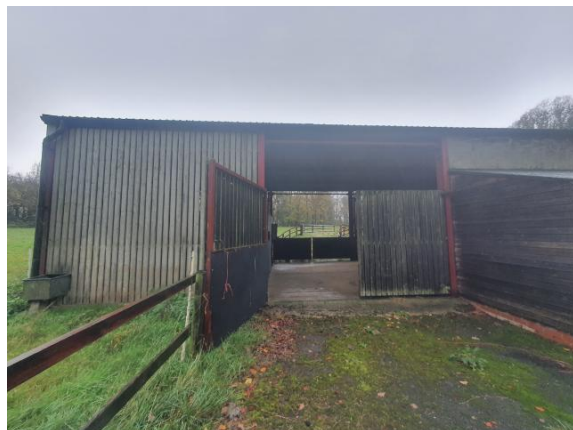
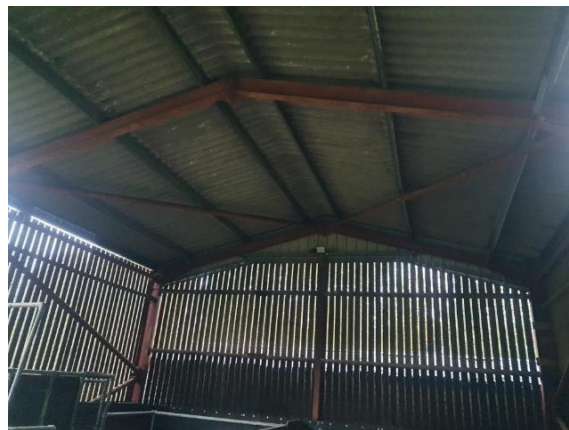
**Item No:** 12

**Location:** External - Large Stable 012

| <b>Material Description:</b> | Cement Roof Sheet - Cement Product | |
| <b>Identification:</b> | Sampled - Asbestos Detected | |
| <b>Approx. quantity:</b> | 90 m <sup>2</sup> | |
| <b>Accessibility</b> | Difficult | Assessment Score |
| <b>Extent of Damage:</b> | Slight / minor damage | 1 |
| <b>Asbestos type:</b> | Chrysotile | 1 |
| <b>Material Assessment Score:</b> | | 4 |
| <b>Risk Assessment Score:</b> | | Negligible |
| <b>Comments:</b> | Sampled roof, metal frame, timber panels to walls, timber walls, metal and timber door, concrete floor<br>Cement roof sheets to entirety of the stable | |

| <b>Action:</b> | Remove if likely to be disturbed by works | |

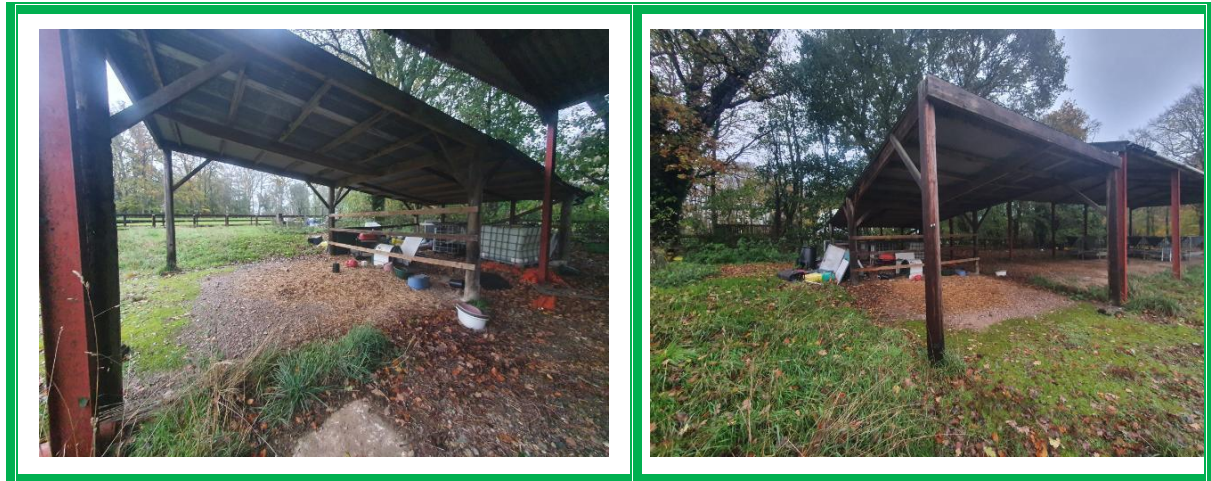
| <b>Item No:</b> | <b>2</b> | <b>Sample No:</b> | <b>N/A</b> |

| <b>Material Description:</b> | No Suspect Materials Found | |
| <b>Comments:</b> | Corrugated sheet metal roof, timber structural frame, timber fencing, plastic gutter and downpipes, stone floor | |

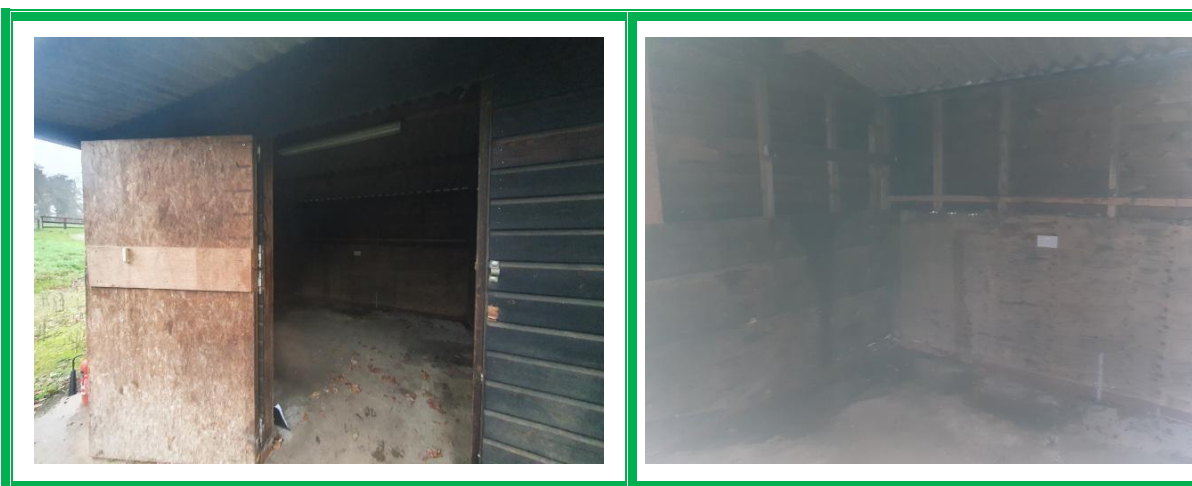
| <b>Item No:</b> | <b>4</b> | <b>Sample No:</b> | <b>N/A</b> |

| <b>Material Description:</b> | No Suspect Materials Found | |
| <b>Comments:</b> | sampled ceiling, timber walls, timber wall fascia, concrete floor | |

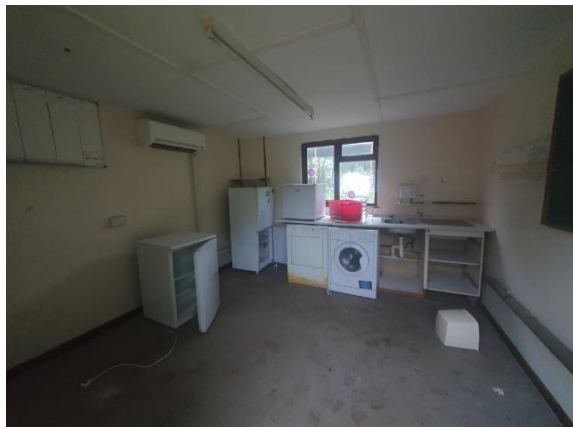
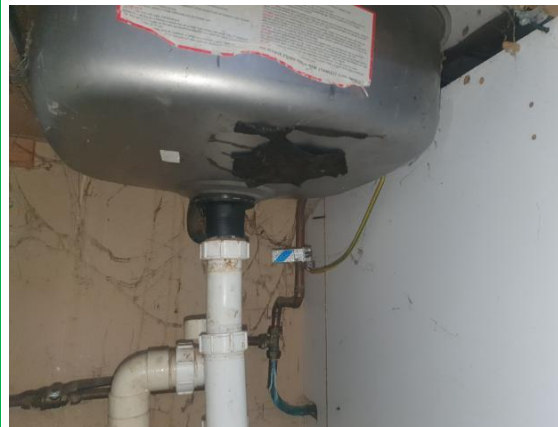
**Item No:** 5

| <b>Material Description:</b> | Sink Pad - Bituminous Product | |
| <b>Identification:</b> | Sampled - No Asbestos Found | |
| <b>Comments:</b> | Plasterboard walls and ceiling, timber cabinets, plastic and metal pipework, timber window frame and sill, concrete floor<br>Sink pad located below metal sink within stable | |

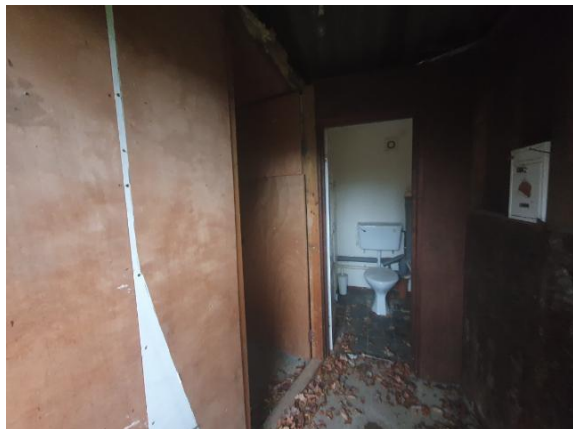
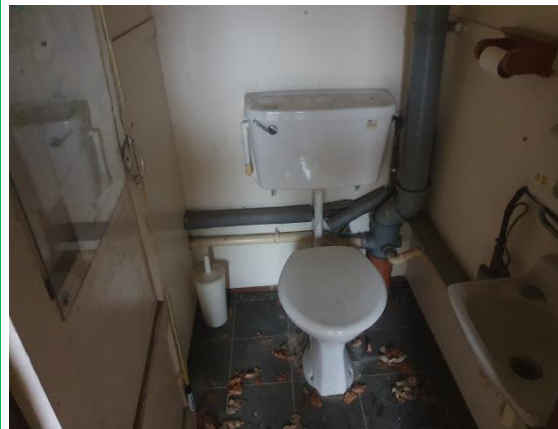
**Item No:** 6

| <b>Material Description:</b> | No Suspect Materials Found | |
| <b>Comments:</b> | Sampled ceiling, timber partitions and walls, timber doors and frames, modern facilities, plastic and metal pipework, tiled and concrete floor. | |

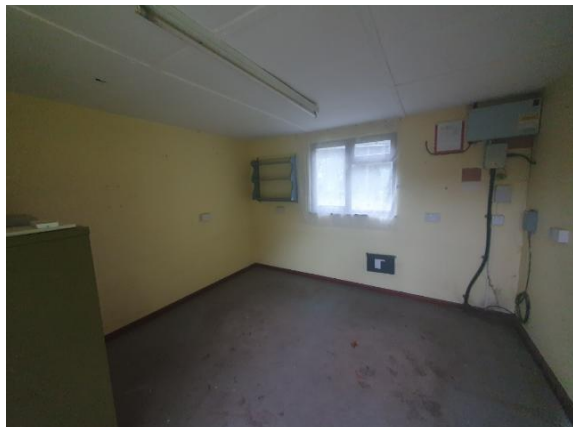
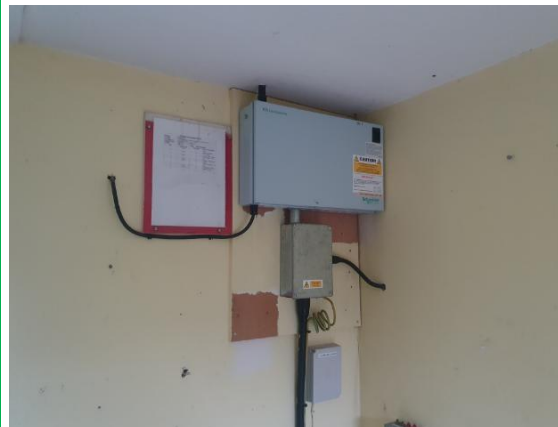
**Item No:** 7

| <b>Material Description:</b> | No Suspect Materials Found | |
| <b>Comments:</b> | Plasterboard ceiling and walls, timber window frame, modern electrical units, timber door and frame, timber window frame and sill, laminate floor to concrete | |

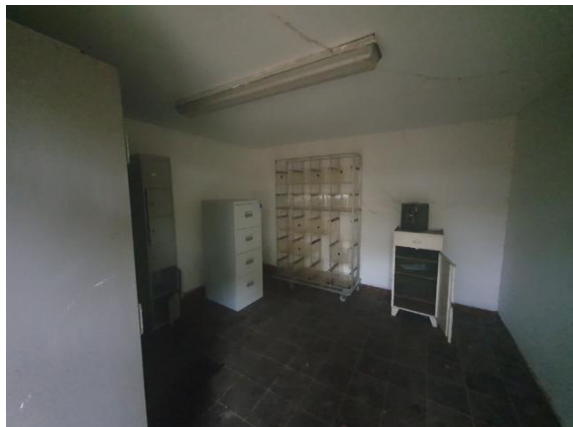
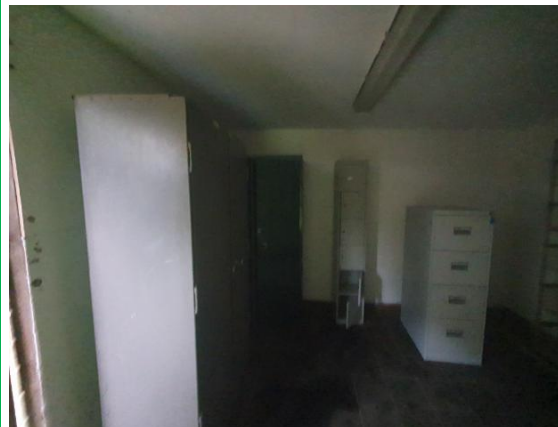
**Item No:** 9

| <b>Material Description:</b> | No Suspect Materials Found | |
| <b>Comments:</b> | Timber ceiling and walls, timber window frame, timber door and frame, timber window frame and sill, lino floor to concrete | |

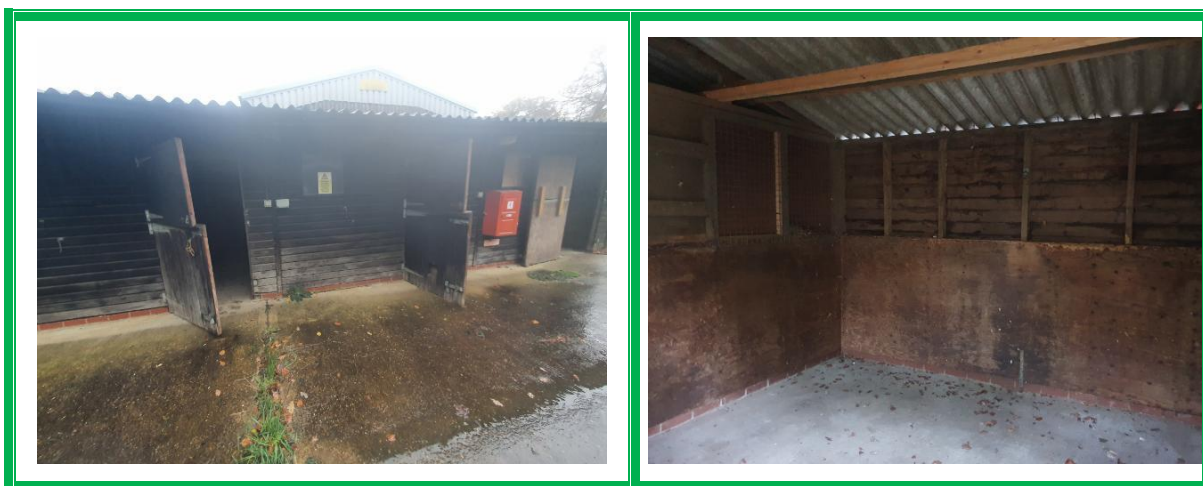
**Item No:** 10

| <b>Material Description:</b> | No Suspect Materials Found | |
| <b>Comments:</b> | sampled ceiling, timber walls, timber wall fascia, concrete floor | |

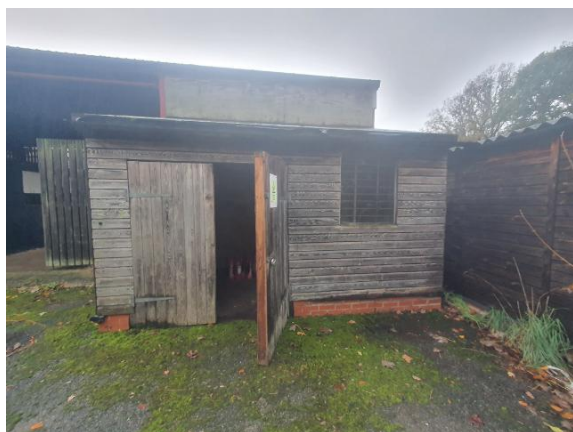
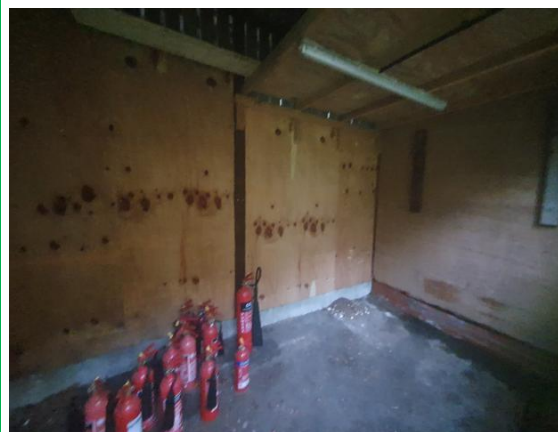
**Item No:** 11

| <b>Material Description:</b> | No Suspect Materials Found | |
| <b>Comments:</b> | Timber construction shed store, pitched felt roof, plastic gutters and downpipes, concrete floor | |

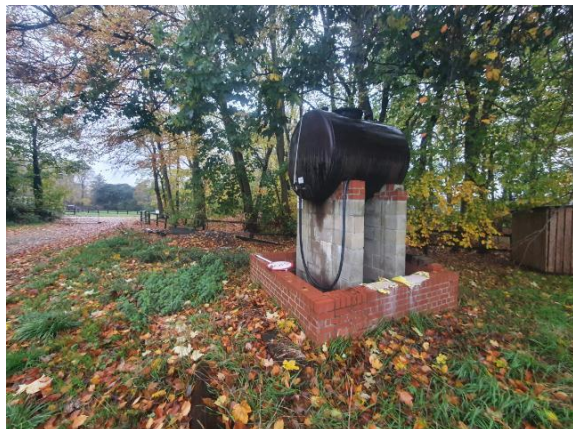
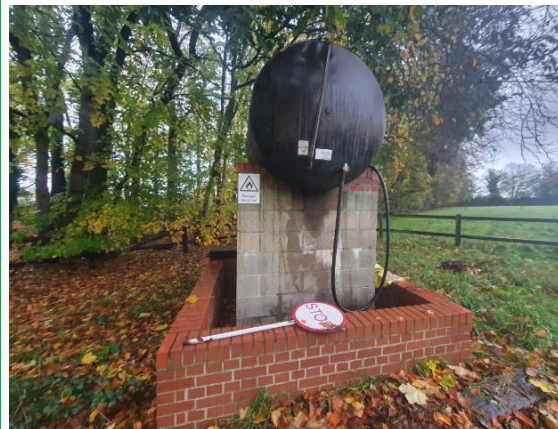
**Item No:** 13

| <b>Material Description:</b> | No Suspect Materials Found | |
| <b>Comments:</b> | Metal tank, brick and block construction, plastic hose | |

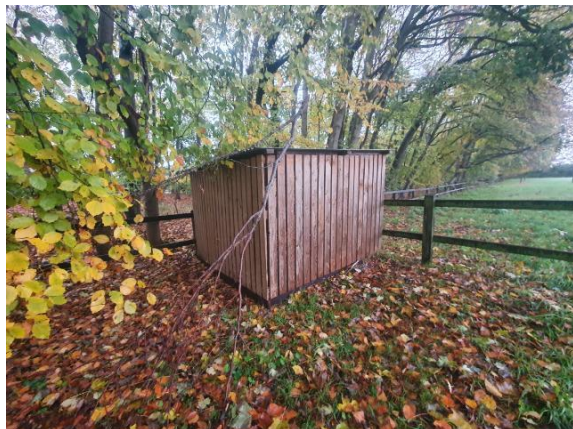
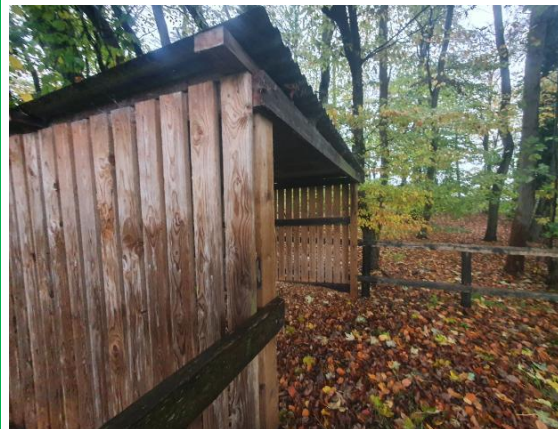
**Item No:** 14

| <b>Material Description:</b> | No Suspect Materials Found | |
| <b>Comments:</b> | Metal roof sheets, timber construction store | |
