Project Number A-01994

Refurbishment and Demolition
Asbestos Survey Report

**Equine Clinic
Lanwades Park
Newmarket
CB8 7UA**

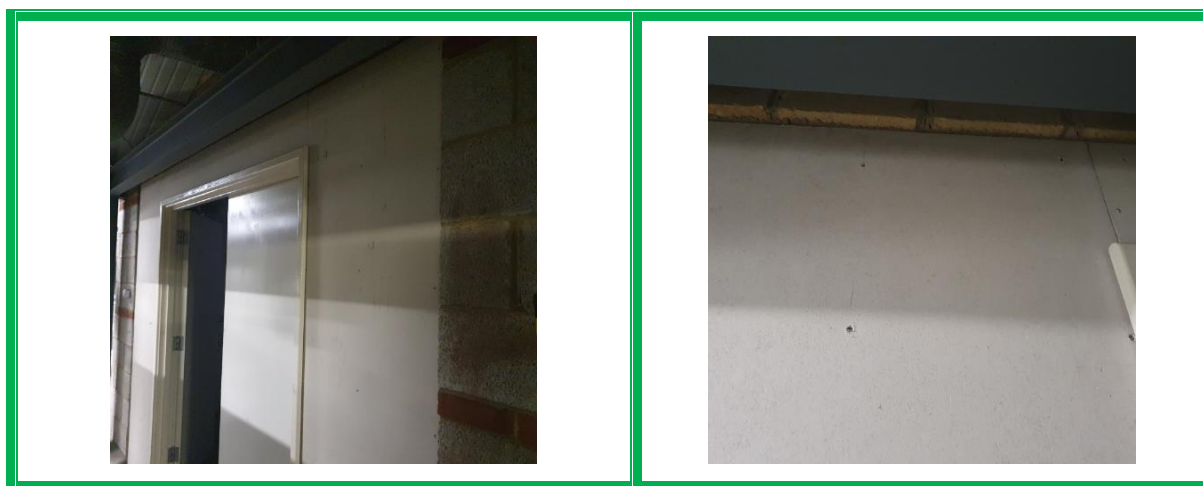
Item No:	1	Sample No:	DK/01
Location:	Second Floor - Plant Room 001

Material Description:	Wall Panels - Insulating Board	
Identification:	Sampled - No Asbestos Found	
Approx. quantity:	N/A	
Accessibility	N/A	<i>Assessment Score</i>
Product type:	N/A	N/A
Extent of Damage:	N/A	N/A
Surface Treatment:	N/A	N/A
Asbestos type:	N/A	N/A
Material Assessment Score:		N/A
Risk Assessment Score:		N/A
Action:	N/A	
Comments:	Modern AHU, ductwork, pipework insulation and electrics.

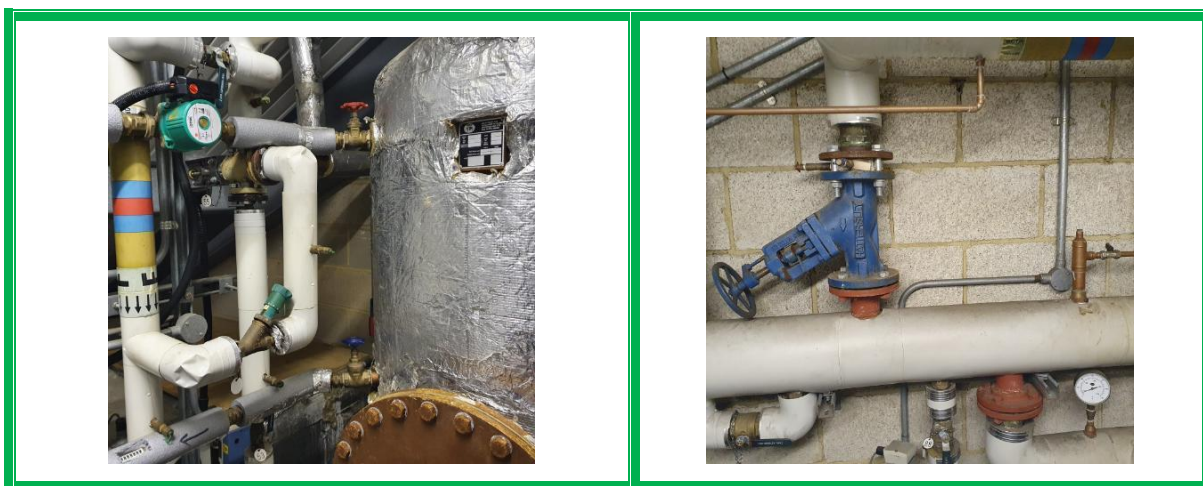
Location: Second Floor - Plant Room 002

Material Description:	Gaskets - Gaskets (compressed)	
Identification:	Sampled - No Asbestos Found	
Approx. quantity:	N/A	
Accessibility	N/A	<i>Assessment Score</i>
Product type:	N/A	N/A
Extent of Damage:	N/A	N/A
Surface Treatment:	N/A	N/A
Asbestos type:	N/A	N/A
Material Assessment Score:		N/A
Risk Assessment Score:		N/A
Action:	N/A	
Comments:	To pipework and calorifier

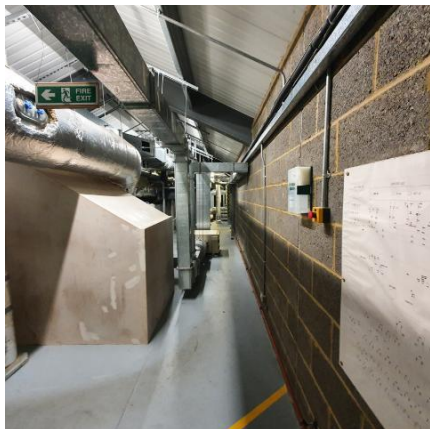
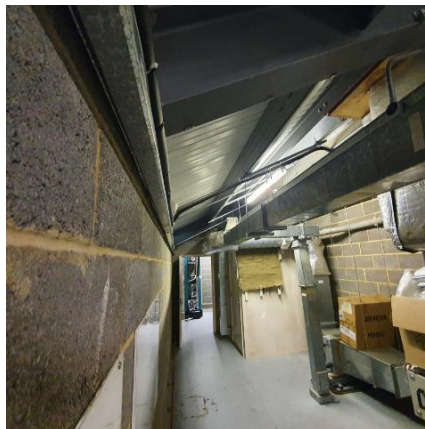
Location: Second Floor - Plant Room 003

Material Description:	No Suspect Materials Found	
Identification:	N/A	
Approx. quantity:	N/A	
Accessibility	N/A	<i>Assessment Score</i>
Product type:	N/A	N/A
Extent of Damage:	N/A	N/A
Surface Treatment:	N/A	N/A
Asbestos type:	N/A	N/A
Material Assessment Score:		N/A
Risk Assessment Score:		N/A
Action:	N/A	
Comments:	Modern ductwork, plasterboard, and blockwork walls. Modern lift shaft

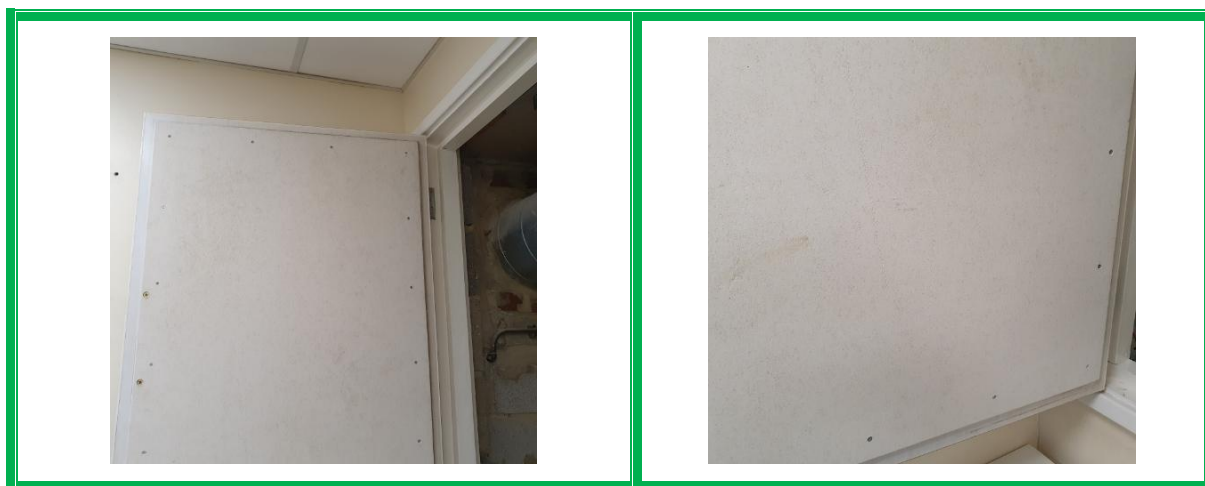
Location: First Floor - Riser Cupboard 004

Material Description:	Panel to Door - Insulating Board	
Identification:	Sampled - No Asbestos Found	
Approx. quantity:	N/A	
Accessibility	N/A	<i>Assessment Score</i>
Product type:	N/A	N/A
Extent of Damage:	N/A	N/A
Surface Treatment:	N/A	N/A
Asbestos type:	N/A	N/A
Material Assessment Score:		N/A
Risk Assessment Score:		N/A
Action:	N/A	
Comments:	Modern ductwork and pipework insulation

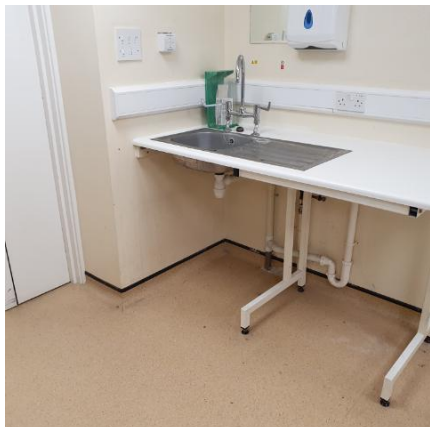
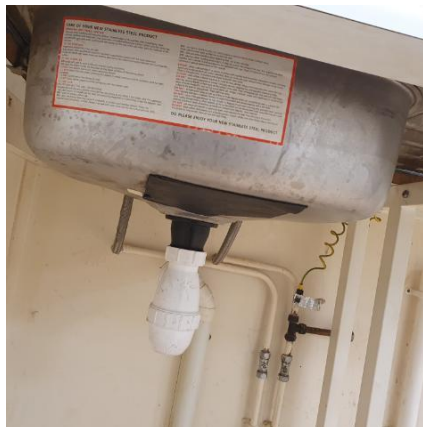
Location: First Floor - Laboratory 005

Material Description:	Sink Pad - Bituminous Product	
Identification:	Sampled - No Asbestos Found	
Approx. quantity:	N/A	
Accessibility	N/A	<i>Assessment Score</i>
Product type:	N/A	N/A
Extent of Damage:	N/A	N/A
Surface Treatment:	N/A	N/A
Asbestos type:	N/A	N/A
Material Assessment Score:		N/A
Risk Assessment Score:		N/A
Action:	N/A	
Comments:	One suspect sink, all others are non-asbestos

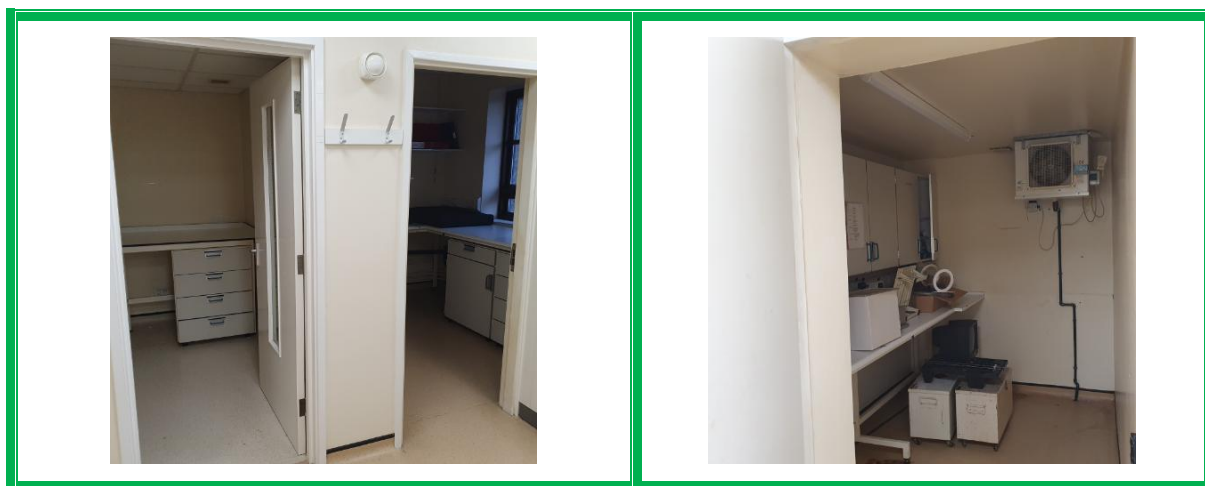
Location: First Floor - Lab Stores x 5 006

Material Description:	No Suspect Materials Found	
Identification:	N/A	
Approx. quantity:	N/A	
Accessibility	N/A	<i>Assessment Score</i>
Product type:	N/A	N/A
Extent of Damage:	N/A	N/A
Surface Treatment:	N/A	N/A
Asbestos type:	N/A	N/A
Material Assessment Score:		N/A
Risk Assessment Score:		N/A
Action:	N/A	
Comments:	Solid and plasterboard walls. Modern lino on concrete

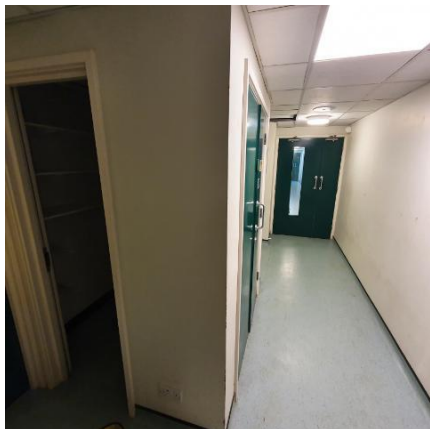
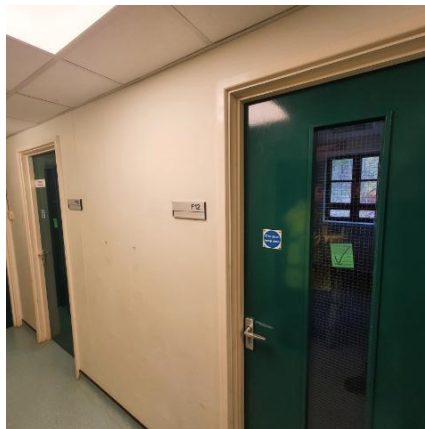
Location: First Floor - Rooms x 4 and Corridor 007

Material Description:	No Suspect Materials Found	
Identification:	N/A	
Approx. quantity:	N/A	
Accessibility	N/A	<i>Assessment Score</i>
Product type:	N/A	N/A
Extent of Damage:	N/A	N/A
Surface Treatment:	N/A	N/A
Asbestos type:	N/A	N/A
Material Assessment Score:		N/A
Risk Assessment Score:		N/A
Action:	N/A	
Comments:	Solid walls. Concrete floor. Metal roof and timber ceiling above modern ceiling tiles. Modern electrics

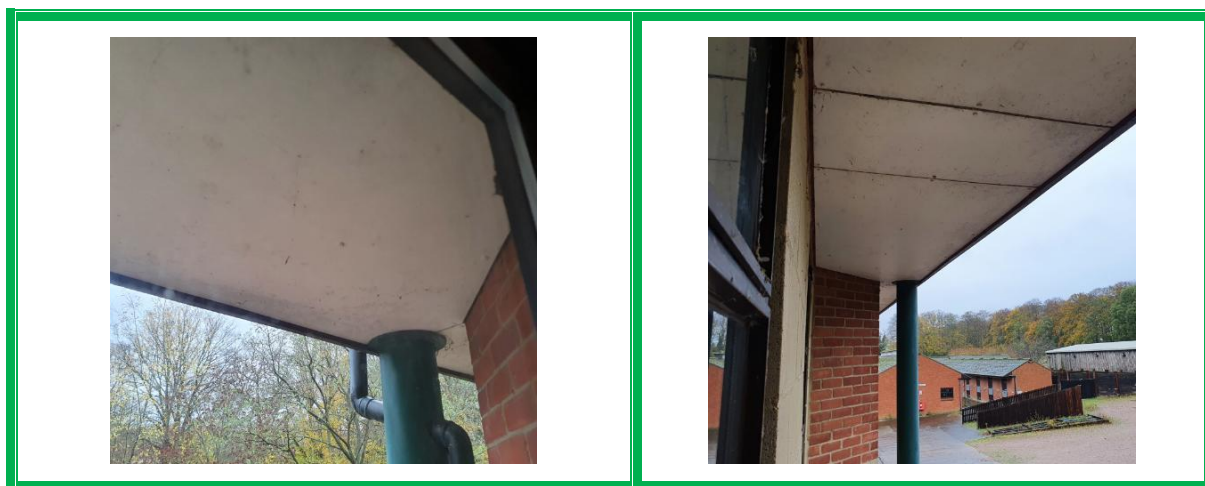
Location: External - Roof 008

Material Description:	Soffits - Insulating Board	
Identification:	Sampled - No Asbestos Found	
Approx. quantity:	N/A	
Accessibility	N/A	<i>Assessment Score</i>
Product type:	N/A	N/A
Extent of Damage:	N/A	N/A
Surface Treatment:	N/A	N/A
Asbestos type:	N/A	N/A
Material Assessment Score:		N/A
Risk Assessment Score:		N/A
Action:	N/A	
Comments:	To all roof areas

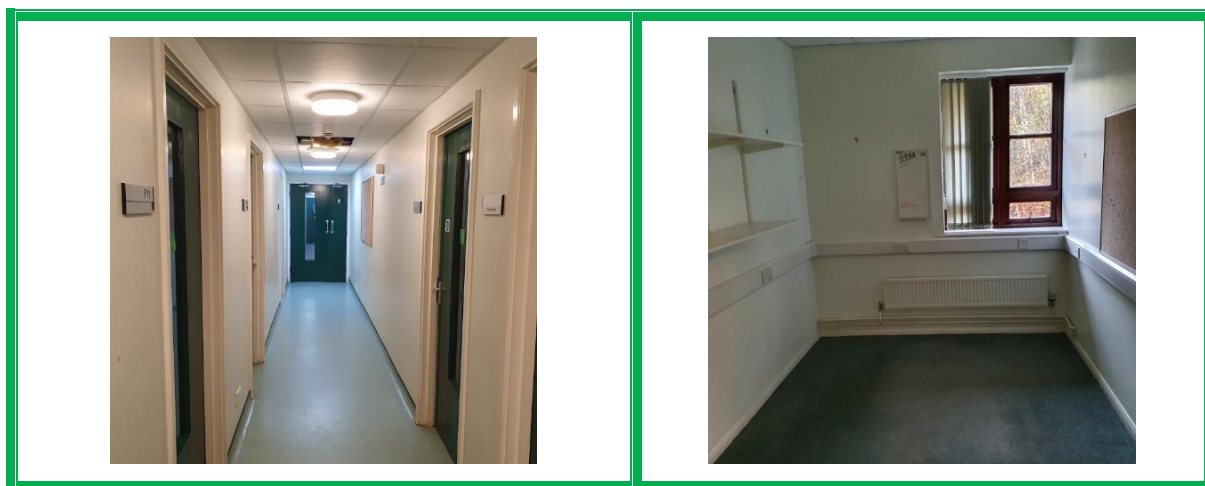
Location: First Floor - Rooms x 5 and Corridor 009

Material Description:	No Suspect Materials Found	
Identification:	N/A	
Approx. quantity:	N/A	
Accessibility	N/A	<i>Assessment Score</i>
Product type:	N/A	N/A
Extent of Damage:	N/A	N/A
Surface Treatment:	N/A	N/A
Asbestos type:	N/A	N/A
Material Assessment Score:		N/A
Risk Assessment Score:		N/A
Action:	N/A	
Comments:	Solid walls. Concrete floor. Metal roof and timber ceiling above modern ceiling tiles

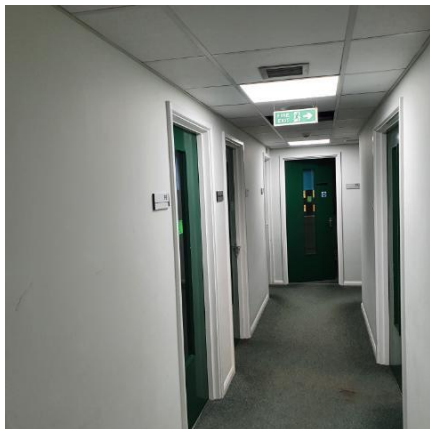
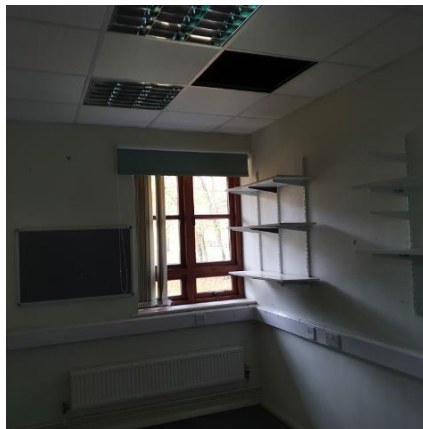
Location: First Floor - Rooms x 8 and Corridor 010

Material Description:	No Suspect Materials Found	
Identification:	N/A	
Approx. quantity:	N/A	
Accessibility	N/A	<i>Assessment Score</i>
Product type:	N/A	N/A
Extent of Damage:	N/A	N/A
Surface Treatment:	N/A	N/A
Asbestos type:	N/A	N/A
Material Assessment Score:		N/A
Risk Assessment Score:		N/A
Action:	N/A	
Comments:	Solid walls. Concrete floor. Metal roof and timber ceiling above modern ceiling tiles

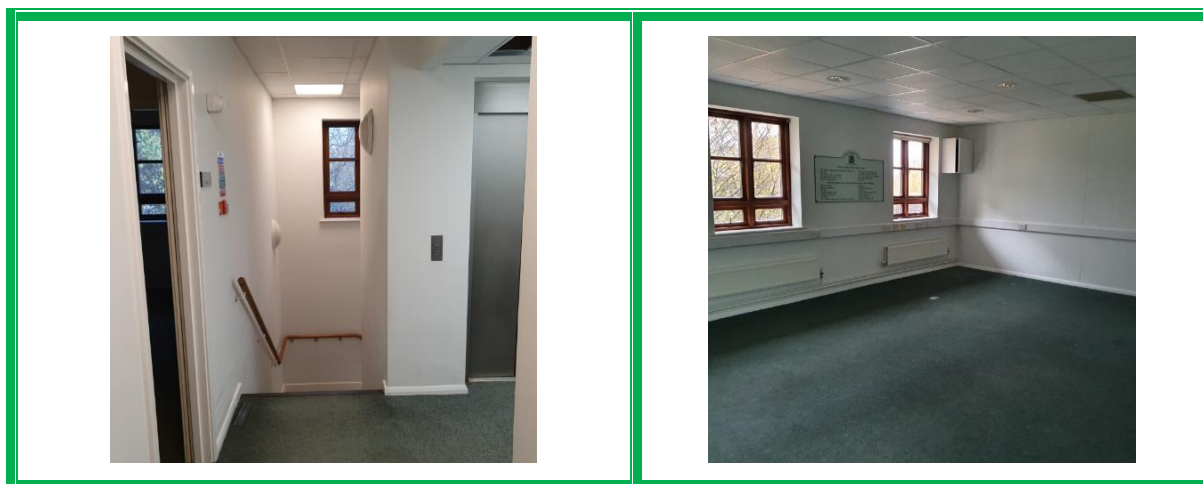
Item No:	11	Sample No:	N/A
Location:	First Floor - Room, WC's x 2, Landing and Stairwell 011

Material Description:	No Suspect Materials Found	
Identification:	N/A	
Approx. quantity:	N/A	
Accessibility	N/A	<i>Assessment Score</i>
Product type:	N/A	N/A
Extent of Damage:	N/A	N/A
Surface Treatment:	N/A	N/A
Asbestos type:	N/A	N/A
Material Assessment Score:		N/A
Risk Assessment Score:		N/A
Action:	N/A	
Comments:	Solid walls. Concrete floor. Metal roof and timber ceiling above modern ceiling tiles. Modern lift

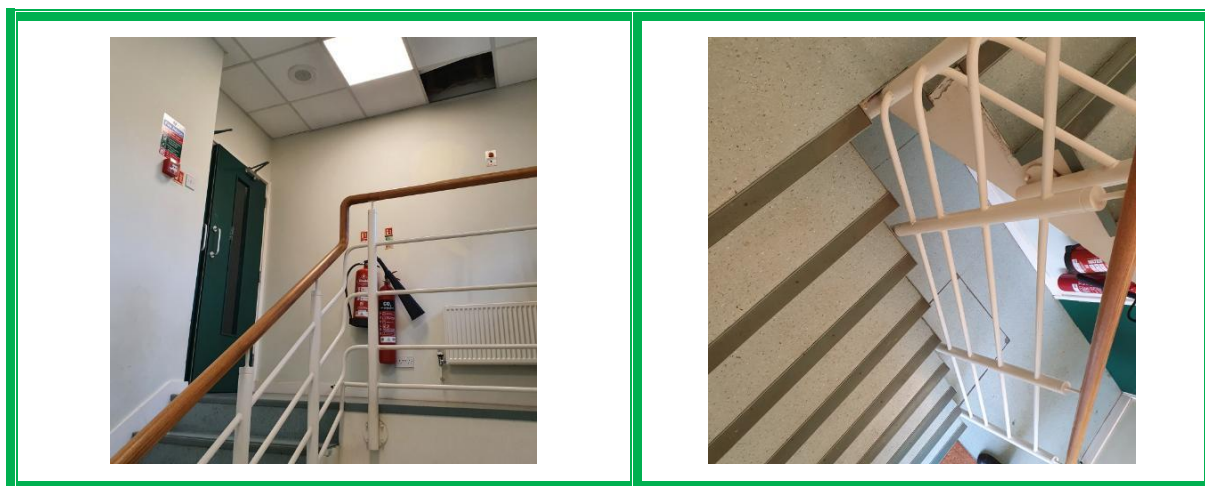
Location: First Floor - Stairwell 012

Material Description:	No Suspect Materials Found	
Identification:	N/A	
Approx. quantity:	N/A	
Accessibility	N/A	<i>Assessment Score</i>
Product type:	N/A	N/A
Extent of Damage:	N/A	N/A
Surface Treatment:	N/A	N/A
Asbestos type:	N/A	N/A
Material Assessment Score:		N/A
Risk Assessment Score:		N/A
Action:	N/A	
Comments:	Rubber stair nosing

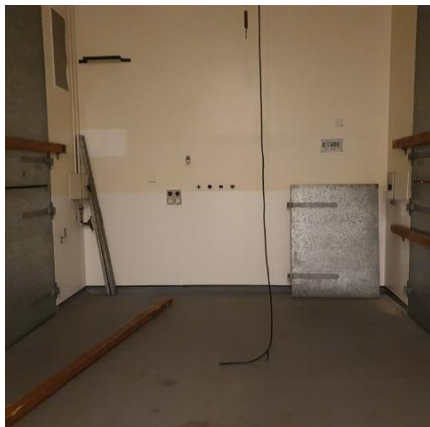
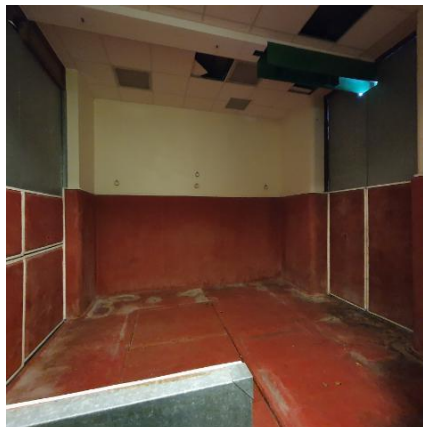
Location: Ground Floor - Equine X-ray Areas 013

Material Description:	No Suspect Materials Found	
Identification:	N/A	
Approx. quantity:	N/A	
Accessibility	N/A	<i>Assessment Score</i>
Product type:	N/A	N/A
Extent of Damage:	N/A	N/A
Surface Treatment:	N/A	N/A
Asbestos type:	N/A	N/A
Material Assessment Score:		N/A
Risk Assessment Score:		N/A
Action:	N/A	
Comments:	Concrete above ceiling tiles. Solid walls.

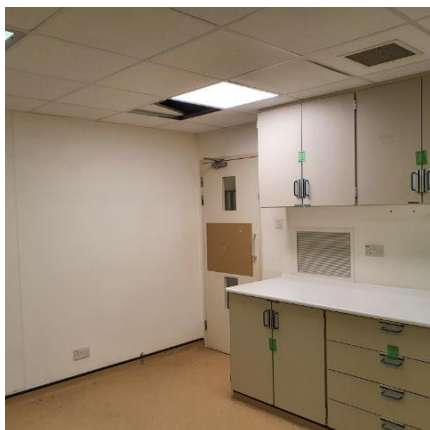
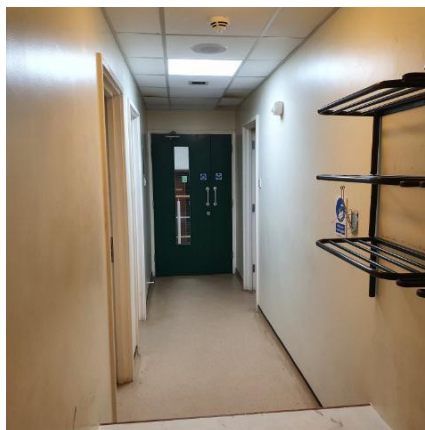
Location: Ground Floor – X-ray/Machinery Rooms, Changing Rooms, and Corridor 014

Material Description:	No Suspect Materials Found	
Identification:	N/A	
Approx. quantity:	N/A	
Accessibility	N/A	<i>Assessment Score</i>
Product type:	N/A	N/A
Extent of Damage:	N/A	N/A
Surface Treatment:	N/A	N/A
Asbestos type:	N/A	N/A
Material Assessment Score:		N/A
Risk Assessment Score:		N/A
Action:	N/A	
Comments:	Concrete above ceiling tiles. Solid walls. Timber and plasterboard boxings.

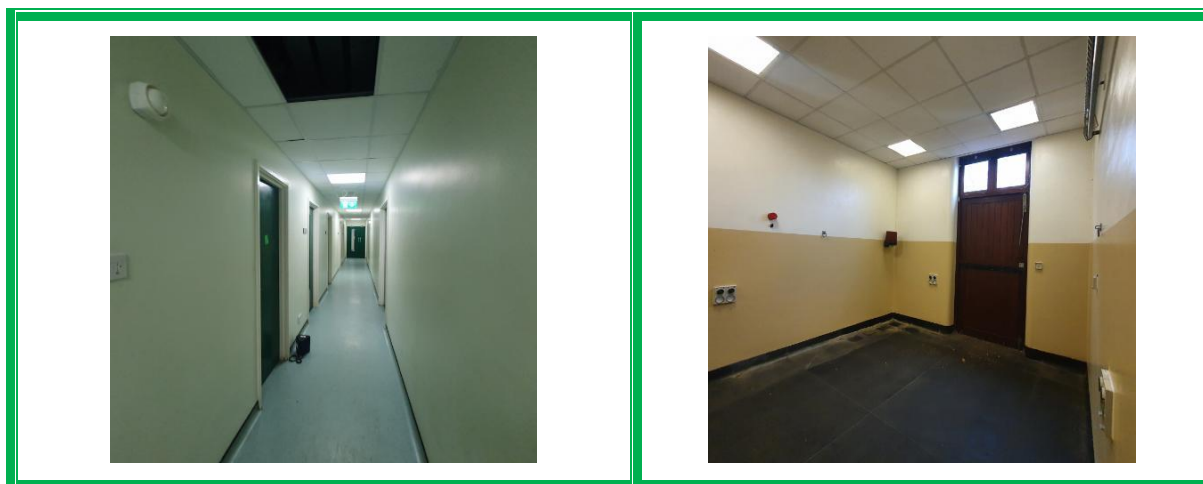
Item No:	15	Sample No:	N/A
Location:	Ground Floor - Corridor, Rooms, Stores and Stables 015

Material Description:	No Suspect Materials Found	
Identification:	N/A	
Approx. quantity:	N/A	
Accessibility	N/A	<i>Assessment Score</i>
Product type:	N/A	N/A
Extent of Damage:	N/A	N/A
Surface Treatment:	N/A	N/A
Asbestos type:	N/A	N/A
Material Assessment Score:		N/A
Risk Assessment Score:		N/A
Action:	N/A	
Comments:	Concrete above ceiling tiles. Solid walls. Timber and plasterboard boxings. Timber doors

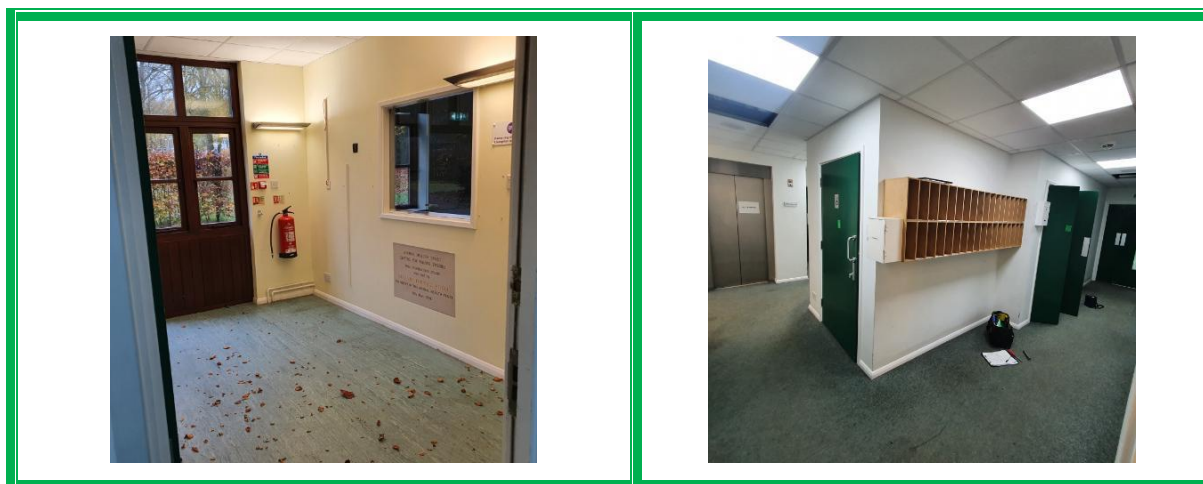
Item No:	16	Sample No:	N/A
Location:	Ground Floor - Corridor, Rooms, WC's, and Lobby 016

Material Description:	No Suspect Materials Found	
Identification:	N/A	
Approx. quantity:	N/A	
Accessibility	N/A	<i>Assessment Score</i>
Product type:	N/A	N/A
Extent of Damage:	N/A	N/A
Surface Treatment:	N/A	N/A
Asbestos type:	N/A	N/A
Material Assessment Score:		N/A
Risk Assessment Score:		N/A
Action:	N/A	
Comments:	Concrete above ceiling tiles. Solid walls. Timber and plasterboard boxings. Timber doors Modern electrics

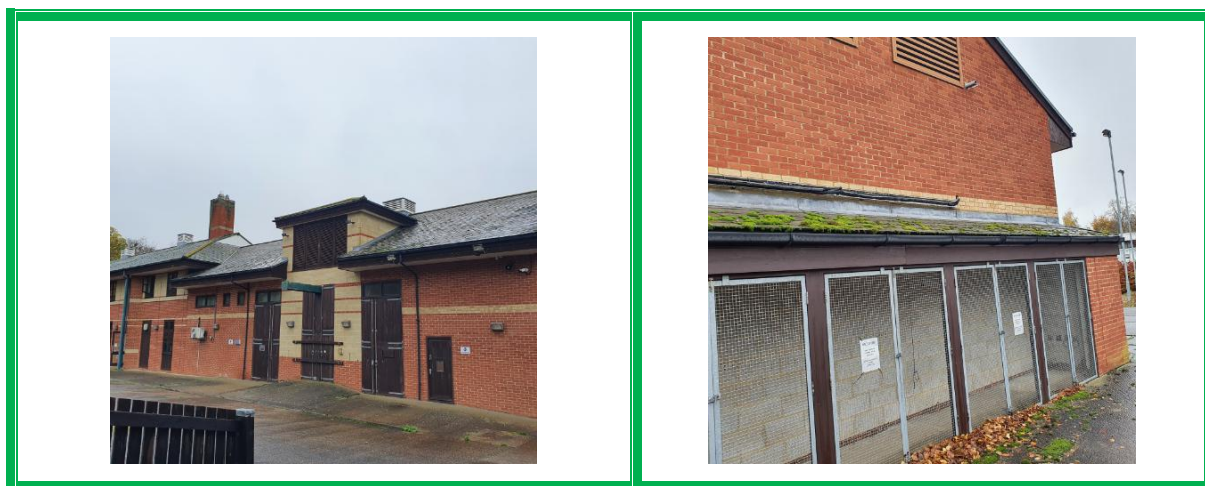
Location: External - Roof 017

Material Description:	Roof Tiles - Cement Product	
Identification:	Sampled - No Asbestos Found	
Approx. quantity:	N/A	
Accessibility	N/A	<i>Assessment Score</i>
Product type:	N/A	N/A
Extent of Damage:	N/A	N/A
Surface Treatment:	N/A	N/A
Asbestos type:	N/A	N/A
Material Assessment Score:		N/A
Risk Assessment Score:		N/A
Action:	N/A	
Comments:	To all high- and low-level roofs

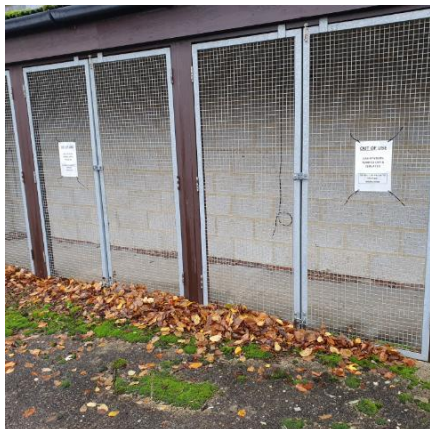
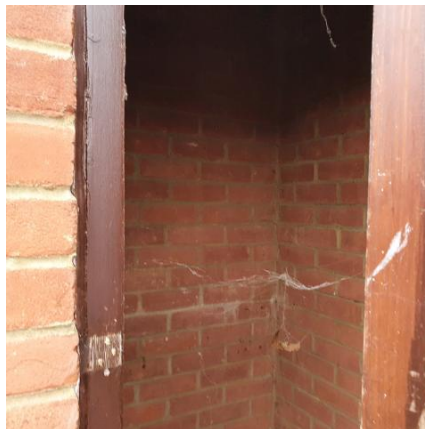
Location: Ground Floor - Cages and Store 018

Material Description:	No Suspect Materials Found	
Identification:	N/A	
Approx. quantity:	N/A	
Accessibility	N/A	<i>Assessment Score</i>
Product type:	N/A	N/A
Extent of Damage:	N/A	N/A
Surface Treatment:	N/A	N/A
Asbestos type:	N/A	N/A
Material Assessment Score:		N/A
Risk Assessment Score:		N/A
Action:	N/A	
Comments:	N/A

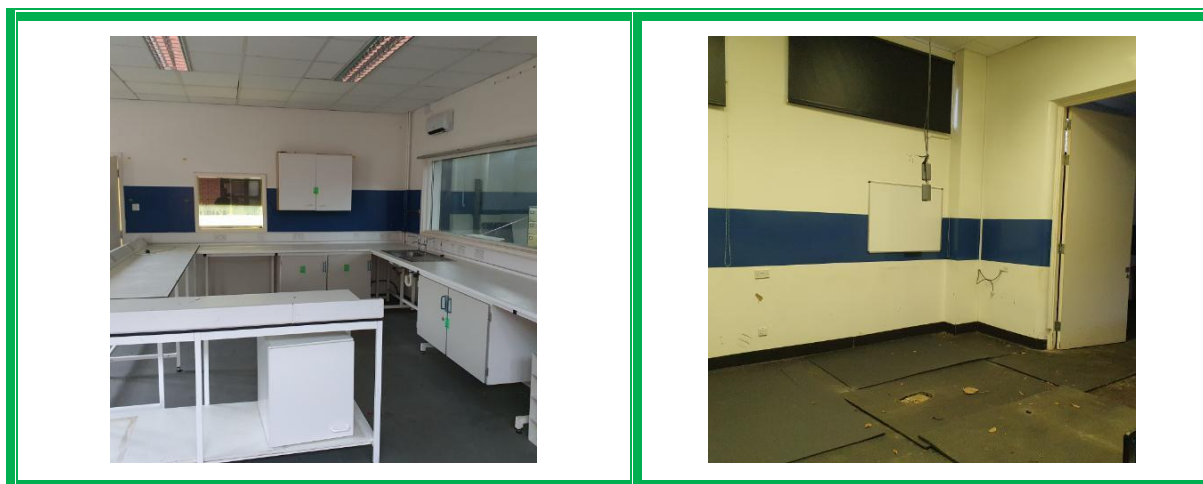
Item No:	19	Sample No:	N/A
Location:	Ground Floor - Treadmill Building - Office and Lobby 019

Material Description:	No Suspect Materials Found	
Identification:	N/A	
Approx. quantity:	N/A	
Accessibility	N/A	<i>Assessment Score</i>
Product type:	N/A	N/A
Extent of Damage:	N/A	N/A
Surface Treatment:	N/A	N/A
Asbestos type:	N/A	N/A
Material Assessment Score:		N/A
Risk Assessment Score:		N/A
Action:	N/A	
Comments:	Solid walls. Metal roof above ceiling tiles

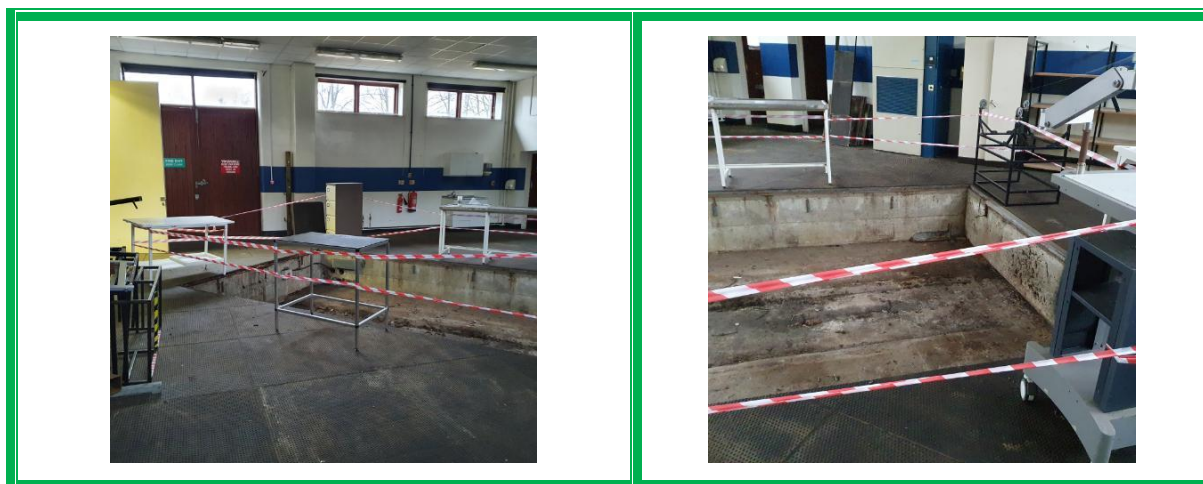
Item No:	20	Sample No:	N/A
Location:	Ground Floor - Treadmill Building - Treadmill Mill 020

Material Description:	No Suspect Materials Found	
Identification:	N/A	
Approx. quantity:	N/A	
Accessibility	N/A	<i>Assessment Score</i>
Product type:	N/A	N/A
Extent of Damage:	N/A	N/A
Surface Treatment:	N/A	N/A
Asbestos type:	N/A	N/A
Material Assessment Score:		N/A
Risk Assessment Score:		N/A
Action:	N/A	
Comments:	Solid walls. Metal roof above ceiling tiles

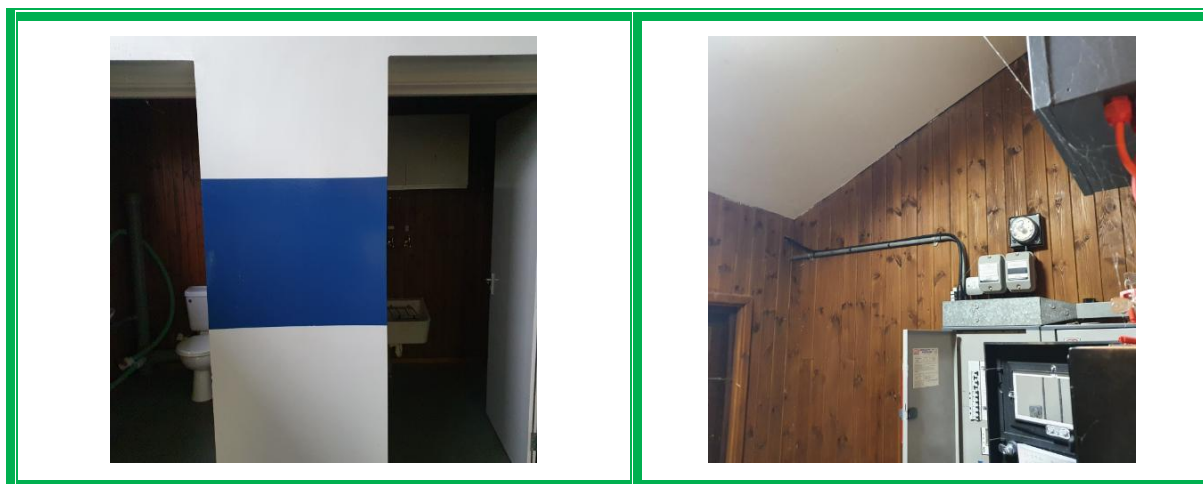
Item No:	21	Sample No:	N/A
Location:	Ground Floor - Treadmill Building - Lobby, WC, and Store 021

Material Description:	No Suspect Materials Found	
Identification:	N/A	
Approx. quantity:	N/A	
Accessibility	N/A	<i>Assessment Score</i>
Product type:	N/A	N/A
Extent of Damage:	N/A	N/A
Surface Treatment:	N/A	N/A
Asbestos type:	N/A	N/A
Material Assessment Score:		N/A
Risk Assessment Score:		N/A
Action:	N/A	
Comments:	Timber walls, plasterboard ceilings

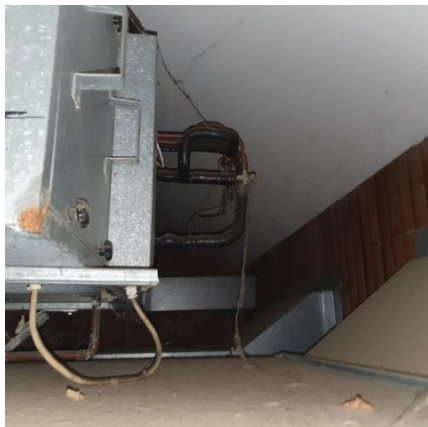
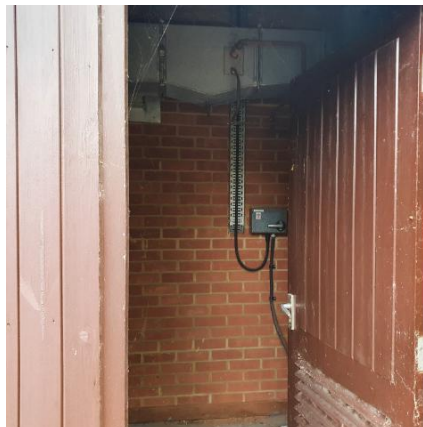
Location: Ground Floor - Treadmill Building - Boiler Room 022

Material Description:	No Suspect Materials Found	
Identification:	N/A	
Approx. quantity:	N/A	
Accessibility	N/A	<i>Assessment Score</i>
Product type:	N/A	N/A
Extent of Damage:	N/A	N/A
Surface Treatment:	N/A	N/A
Asbestos type:	N/A	N/A
Material Assessment Score:		N/A
Risk Assessment Score:		N/A
Action:	N/A	
Comments:	Non asbestos electrics and ductwork

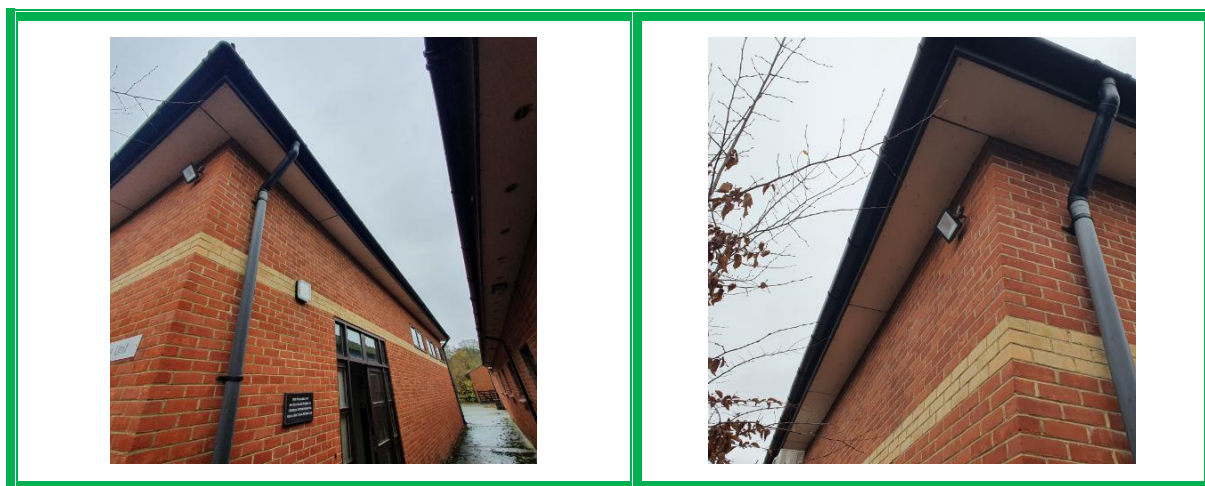
Location: External - Treadmill Building 023

Material Description:	Soffits - Insulating Board	
Identification:	Sampled - No Asbestos Found	
Approx. quantity:	N/A	
Accessibility	N/A	<i>Assessment Score</i>
Product type:	N/A	N/A
Extent of Damage:	N/A	N/A
Surface Treatment:	N/A	N/A
Asbestos type:	N/A	N/A
Material Assessment Score:		N/A
Risk Assessment Score:		N/A
Action:	N/A	
Comments:	Plastic rainwater goods. Built in 1990's.

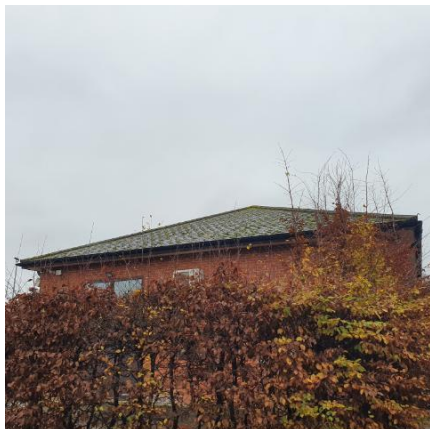
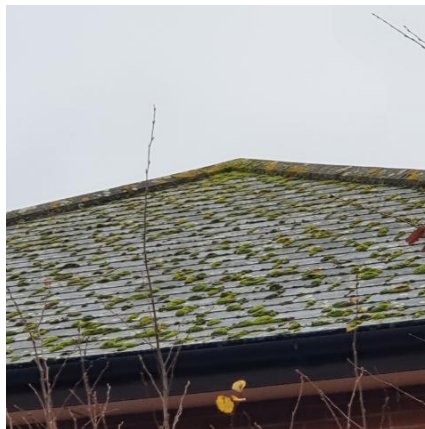
Location: External - Treadmill Building 024

Material Description:	Roof Tiles - Cement Product	
Identification:	Sampled - No Asbestos Found	
Approx. quantity:	N/A	
Accessibility	N/A	<i>Assessment Score</i>
Product type:	N/A	N/A
Extent of Damage:	N/A	N/A
Surface Treatment:	N/A	N/A
Asbestos type:	N/A	N/A
Material Assessment Score:		N/A
Risk Assessment Score:		N/A
Action:	N/A	
Comments:	N/A

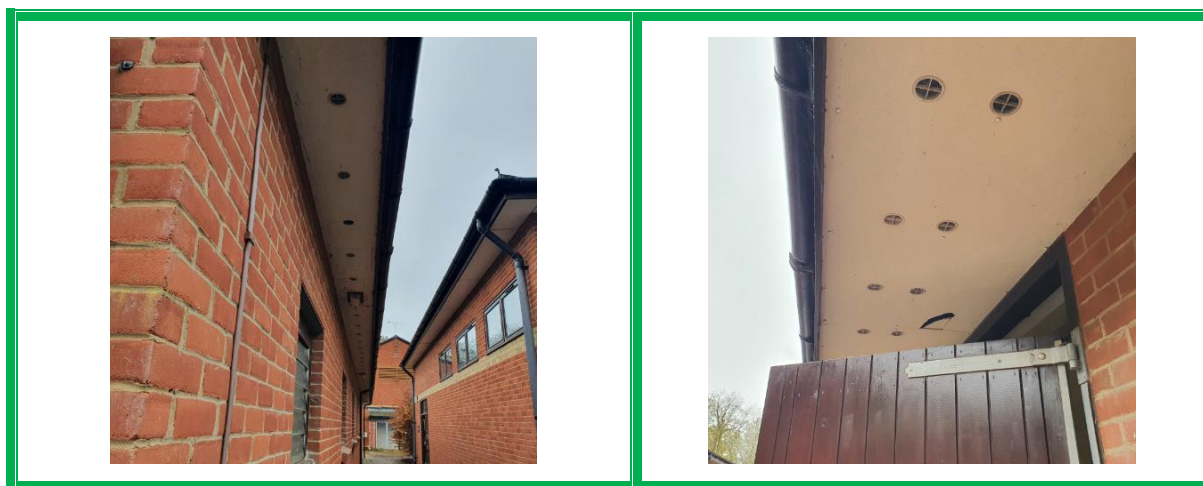
Item No:	25	Sample No:	N/A
Location:	External - Stables 9-15 025

Material Description:	Soffits - Insulating Board	
Identification:	As per sample DK/07 - No Asbestos Found	
Approx. quantity:	N/A	
Accessibility	N/A	<i>Assessment Score</i>
Product type:	N/A	N/A
Extent of Damage:	N/A	N/A
Surface Treatment:	N/A	N/A
Asbestos type:	N/A	N/A
Material Assessment Score:		N/A
Risk Assessment Score:		N/A
Action:	N/A	
Comments:	Plastic rainwater goods. Built in 1990's.

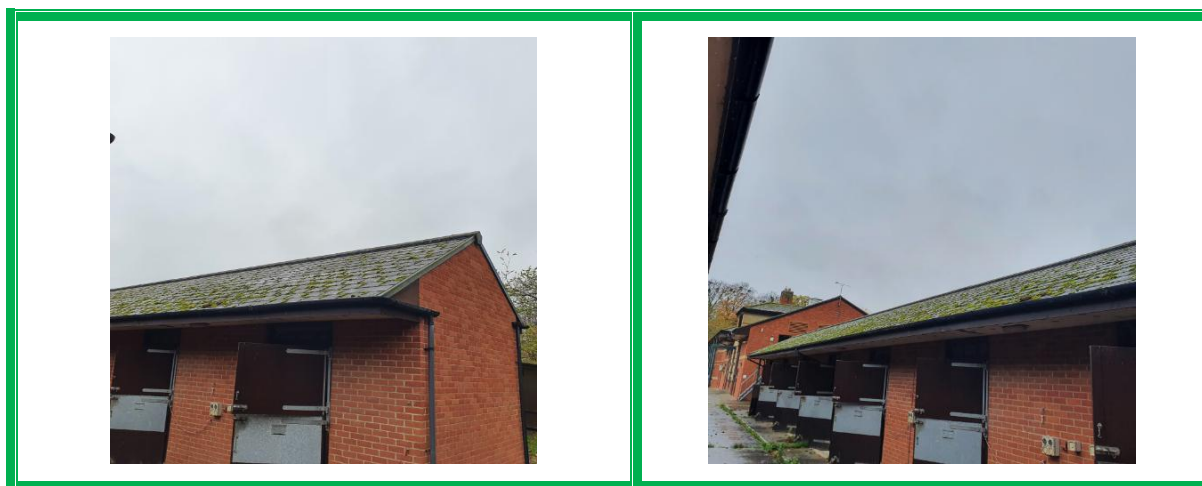
Item No:	26	Sample No:	N/A
Location:	External - Stables 9-15 026

Material Description:	Roof Tiles - Cement Product	
Identification:	As per sample DK/08 - No Asbestos Found	
Approx. quantity:	N/A	
Accessibility	N/A	<i>Assessment Score</i>
Product type:	N/A	N/A
Extent of Damage:	N/A	N/A
Surface Treatment:	N/A	N/A
Asbestos type:	N/A	N/A
Material Assessment Score:		N/A
Risk Assessment Score:		N/A
Action:	N/A	
Comments:	N/A

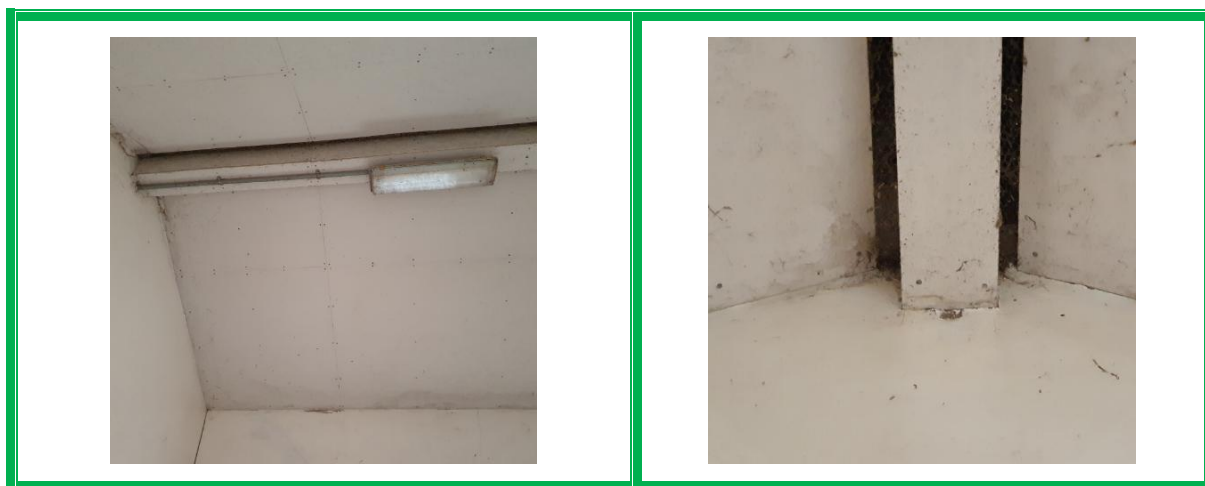
Location: Ground Floor - Stables 9-15 027

Material Description:	Ceiling and Boxing Panels - Insulating Board	
Identification:	Sampled - No Asbestos Found	
Approx. quantity:	N/A	
Accessibility	N/A	<i>Assessment Score</i>
Product type:	N/A	N/A
Extent of Damage:	N/A	N/A
Surface Treatment:	N/A	N/A
Asbestos type:	N/A	N/A
Material Assessment Score:		N/A
Risk Assessment Score:		N/A
Action:	N/A	
Comments:	To all rooms. Solid walls and floors.

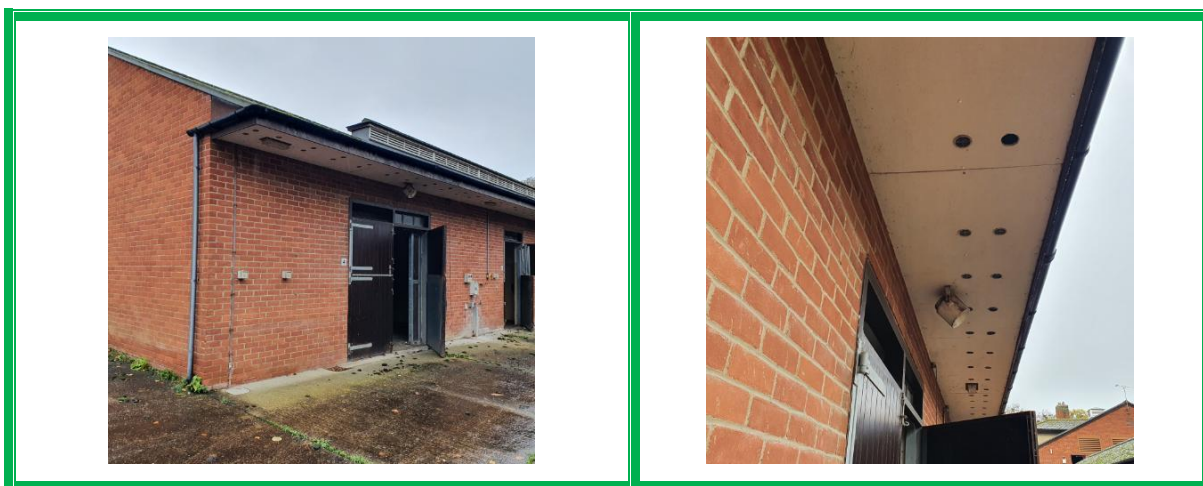
Location: External - Stables 1-8 and Adjoining Rooms 028

Material Description:	Soffits - Insulating Board	
Identification:	As per sample DK/07 - No Asbestos Found	
Approx. quantity:	N/A	
Accessibility	N/A	<i>Assessment Score</i>
Product type:	N/A	N/A
Extent of Damage:	N/A	N/A
Surface Treatment:	N/A	N/A
Asbestos type:	N/A	N/A
Material Assessment Score:		N/A
Risk Assessment Score:		N/A
Action:	N/A	
Comments:	Plastic rainwater goods. Built in 1990's.

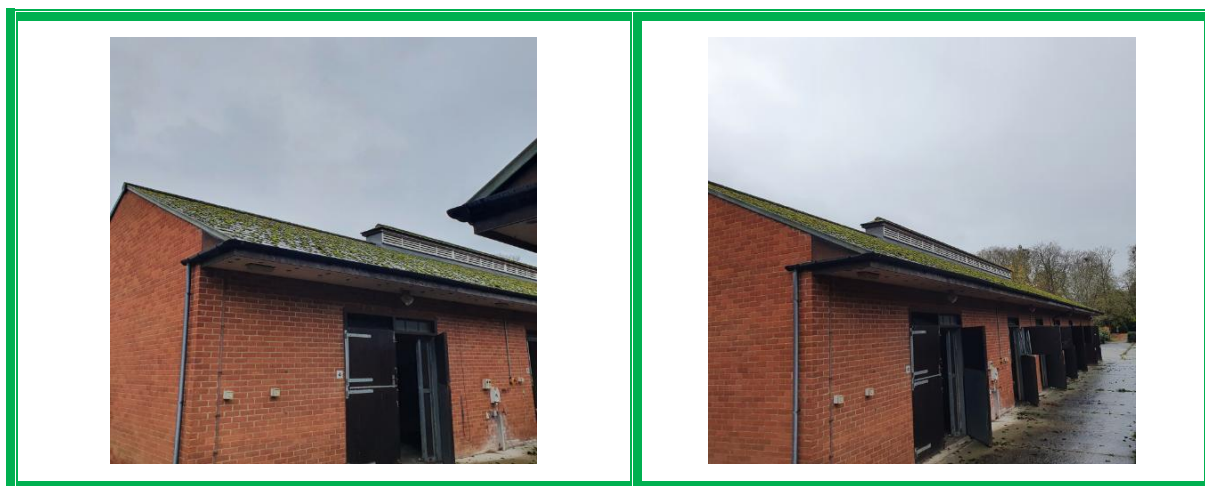
Location: External - Stables 1-8 and Adjoining Rooms 029

Material Description:	Roof Tiles - Cement Product	
Identification:	As per sample DK/08 - No Asbestos Found	
Approx. quantity:	N/A	
Accessibility	N/A	<i>Assessment Score</i>
Product type:	N/A	N/A
Extent of Damage:	N/A	N/A
Surface Treatment:	N/A	N/A
Asbestos type:	N/A	N/A
Material Assessment Score:		N/A
Risk Assessment Score:		N/A
Action:	N/A	
Comments:	N/A

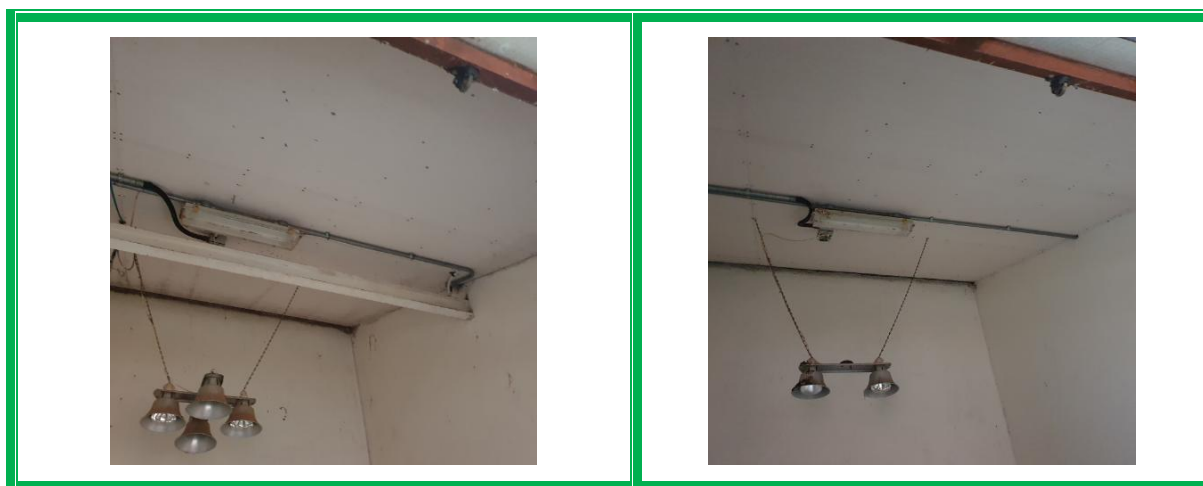
Item No:	30	Sample No:	N/A
Location:	Ground Floor - Stables 1-8 and Adjoining Rooms 030

Material Description:	Ceiling and Boxing Panels - Insulating Board	
Identification:	As per sample DK/09 - No Asbestos Found	
Approx. quantity:	N/A	
Accessibility	N/A	<i>Assessment Score</i>
Product type:	N/A	N/A
Extent of Damage:	N/A	N/A
Surface Treatment:	N/A	N/A
Asbestos type:	N/A	N/A
Material Assessment Score:		N/A
Risk Assessment Score:		N/A
Action:	N/A	
Comments:	To all stables and above plasterboard ceilings. Solid walls and floors.

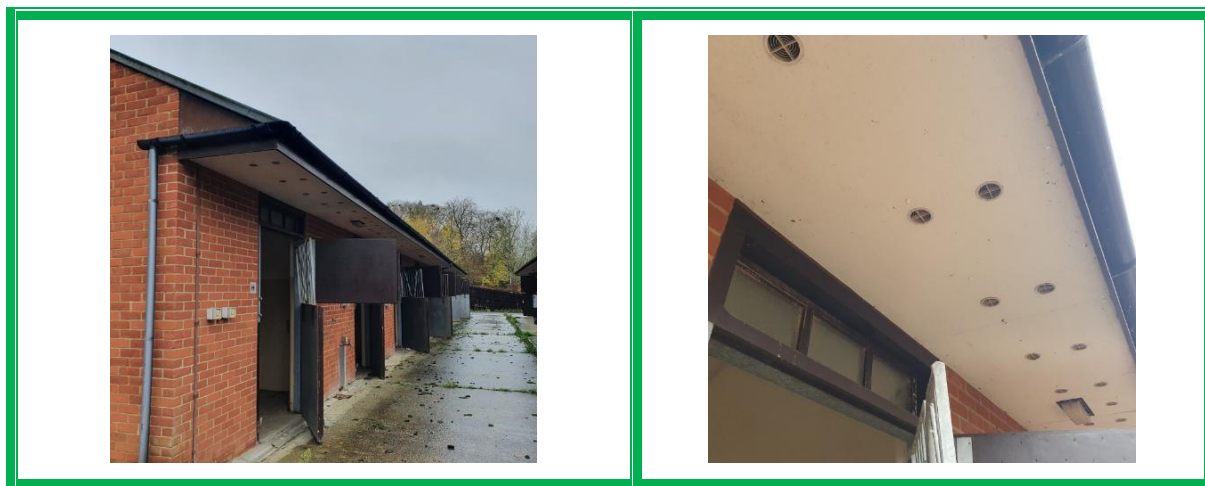
Location: External - Stables A-H 031

Material Description:	Soffits - Insulating Board	
Identification:	As per sample DK/07 - No Asbestos Found	
Approx. quantity:	N/A	
Accessibility	N/A	<i>Assessment Score</i>
Product type:	N/A	N/A
Extent of Damage:	N/A	N/A
Surface Treatment:	N/A	N/A
Asbestos type:	N/A	N/A
Material Assessment Score:		N/A
Risk Assessment Score:		N/A
Action:	N/A	
Comments:	Plastic rainwater goods. Built in 1990's.

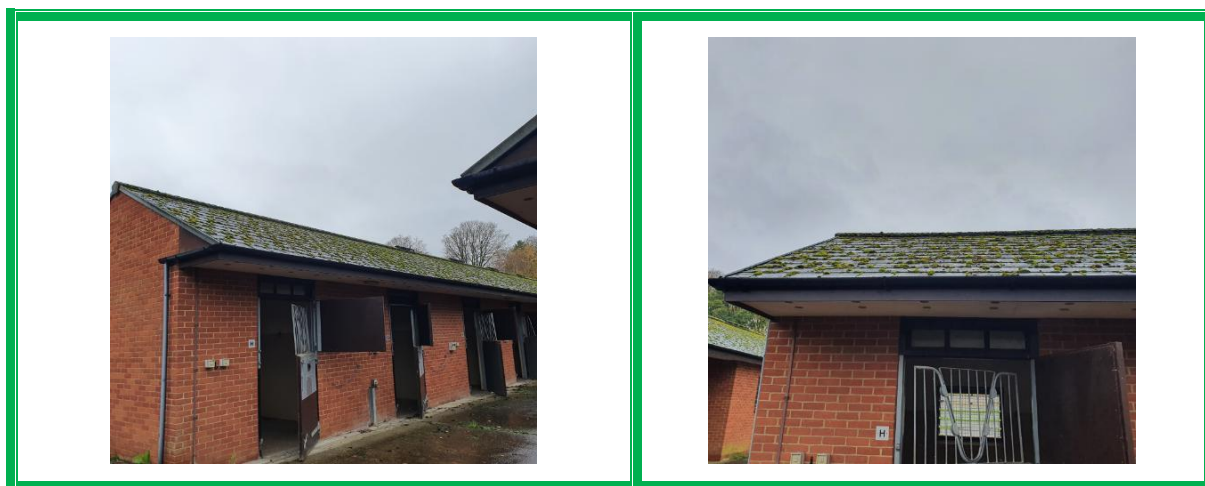
Location: External - Stables A-H 032

Material Description:	Roof Tiles - Cement Product	
Identification:	As per sample DK/08 - No Asbestos Found	
Approx. quantity:	N/A	
Accessibility	N/A	<i>Assessment Score</i>
Product type:	N/A	N/A
Extent of Damage:	N/A	N/A
Surface Treatment:	N/A	N/A
Asbestos type:	N/A	N/A
Material Assessment Score:		N/A
Risk Assessment Score:		N/A
Action:	N/A	
Comments:	N/A

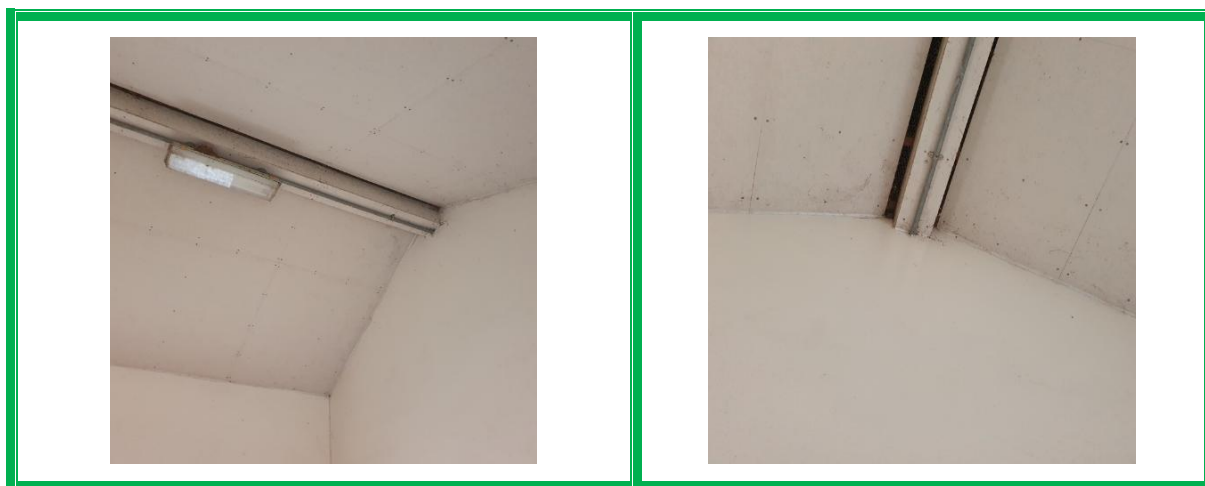
Location: Ground Floor - Stables A-H 033

Material Description:	Ceiling and Boxing Panels - Insulating Board	
Identification:	As per sample DK/09 - No Asbestos Found	
Approx. quantity:	N/A	
Accessibility	N/A	<i>Assessment Score</i>
Product type:	N/A	N/A
Extent of Damage:	N/A	N/A
Surface Treatment:	N/A	N/A
Asbestos type:	N/A	N/A
Material Assessment Score:		N/A
Risk Assessment Score:		N/A
Action:	N/A	
Comments:	To all rooms. Solid walls and floors.

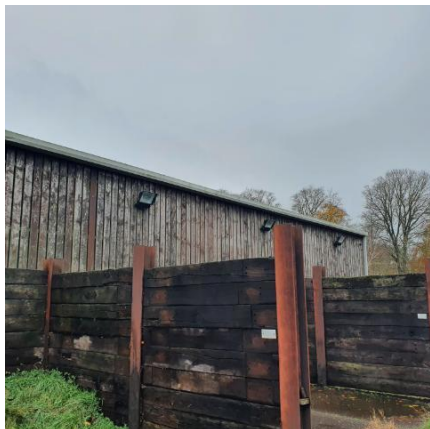
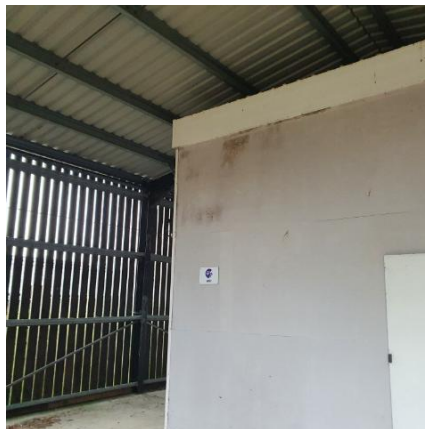
Location: Ground Floor - Barn 034

Material Description:	No Suspect Materials Found	
Identification:	N/A	
Approx. quantity:	N/A	
Accessibility	N/A	<i>Assessment Score</i>
Product type:	N/A	N/A
Extent of Damage:	N/A	N/A
Surface Treatment:	N/A	N/A
Asbestos type:	N/A	N/A
Material Assessment Score:		N/A
Risk Assessment Score:		N/A
Action:	N/A	
Comments:	Timber walls, metal roof, non-asbestos electrics

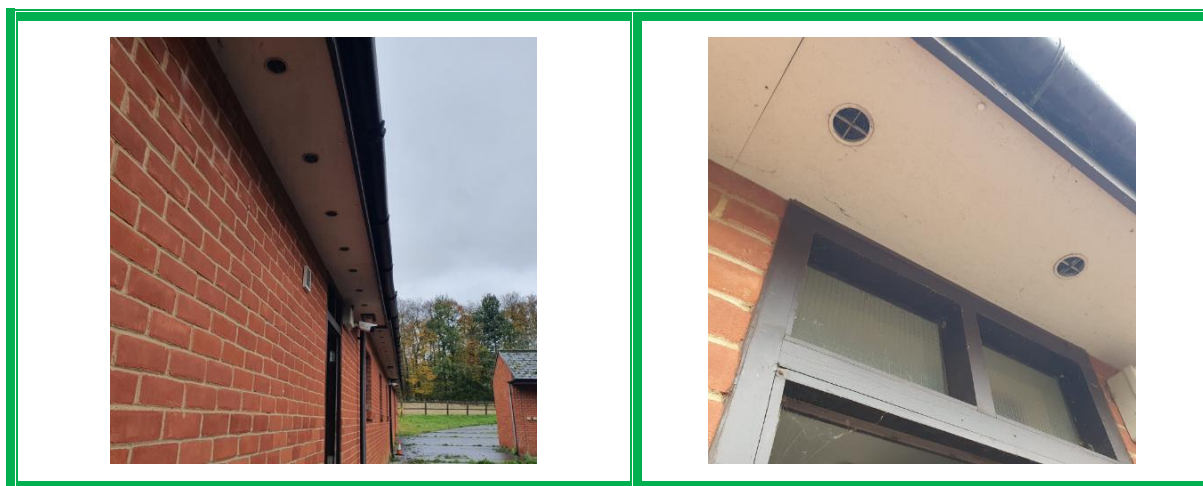
Item No:	35	Sample No:	N/A
Location:	External - Stables 035

Material Description:	Soffits - Insulating Board	
Identification:	As per sample DK/07 - No Asbestos Found	
Approx. quantity:	N/A	
Accessibility	N/A	<i>Assessment Score</i>
Product type:	N/A	N/A
Extent of Damage:	N/A	N/A
Surface Treatment:	N/A	N/A
Asbestos type:	N/A	N/A
Material Assessment Score:		N/A
Risk Assessment Score:		N/A
Action:	N/A	
Comments:	Plastic rainwater goods. Built in 1990's.
