Project Number A-01994

Refurbishment and Demolition
Asbestos Survey Report

**Equine Clinic
Lanwades Park
Newmarket
CB8 7UA**

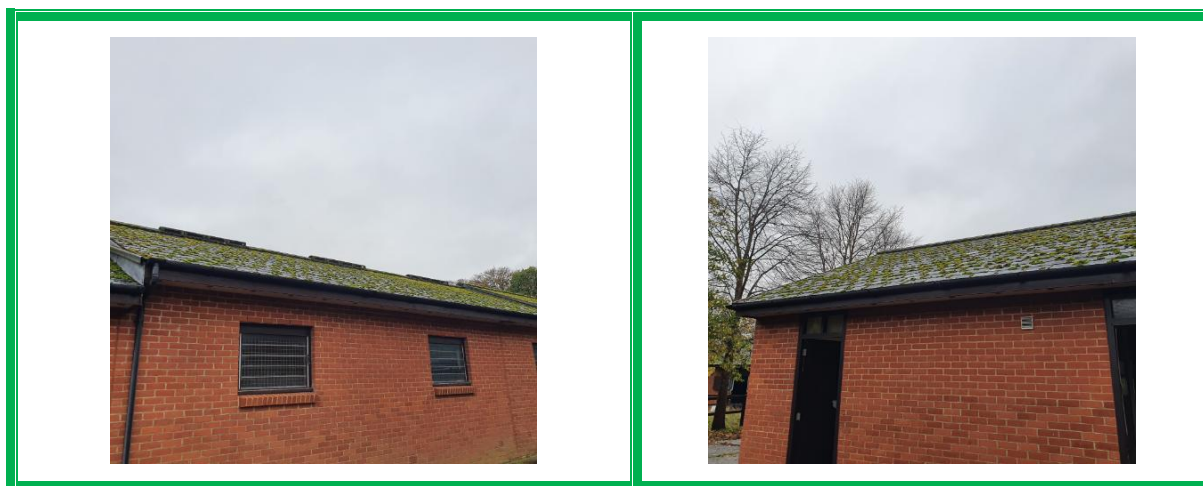
Item No:	36	Sample No:	N/A
Location:	External - Stables 036

Material Description:	Roof Tiles - Cement Product	
Identification:	As per sample DK/08 - No Asbestos Found	
Approx. quantity:	N/A	
Accessibility	N/A	<i>Assessment Score</i>
Product type:	N/A	N/A
Extent of Damage:	N/A	N/A
Surface Treatment:	N/A	N/A
Asbestos type:	N/A	N/A
Material Assessment Score:		N/A
Risk Assessment Score:		N/A
Action:	N/A	
Comments:	N/A

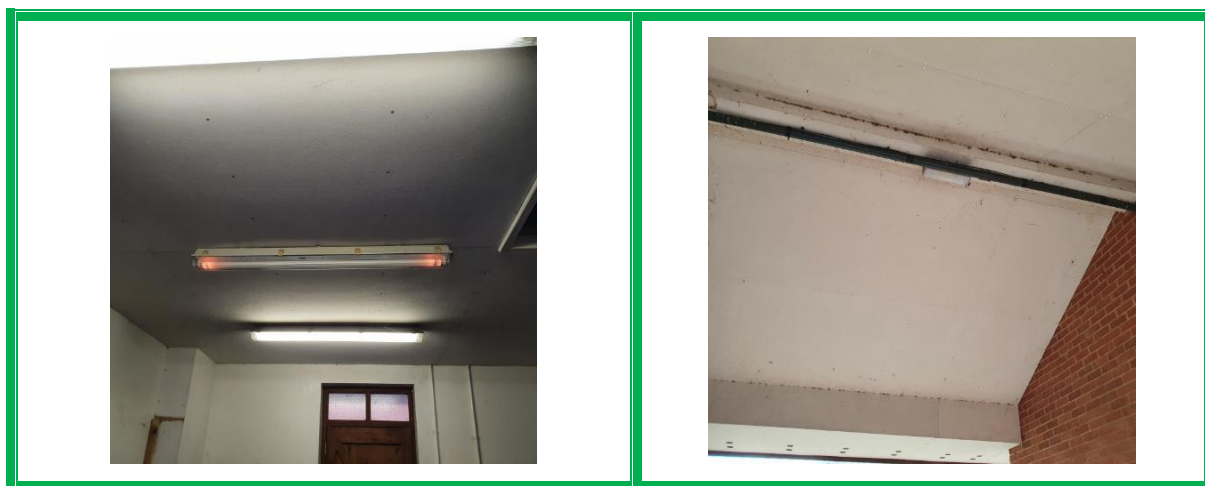
Location: Ground Floor - Stables and Adjoining Rooms 037

Material Description:	Ceiling and Boxing Panels - Insulating Board	
Identification:	As per sample DK/09 - No Asbestos Found	
Approx. quantity:	N/A	
Accessibility	N/A	<i>Assessment Score</i>
Product type:	N/A	N/A
Extent of Damage:	N/A	N/A
Surface Treatment:	N/A	N/A
Asbestos type:	N/A	N/A
Material Assessment Score:		N/A
Risk Assessment Score:		N/A
Action:	N/A	
Comments:	To all rooms. Solid walls and walls.

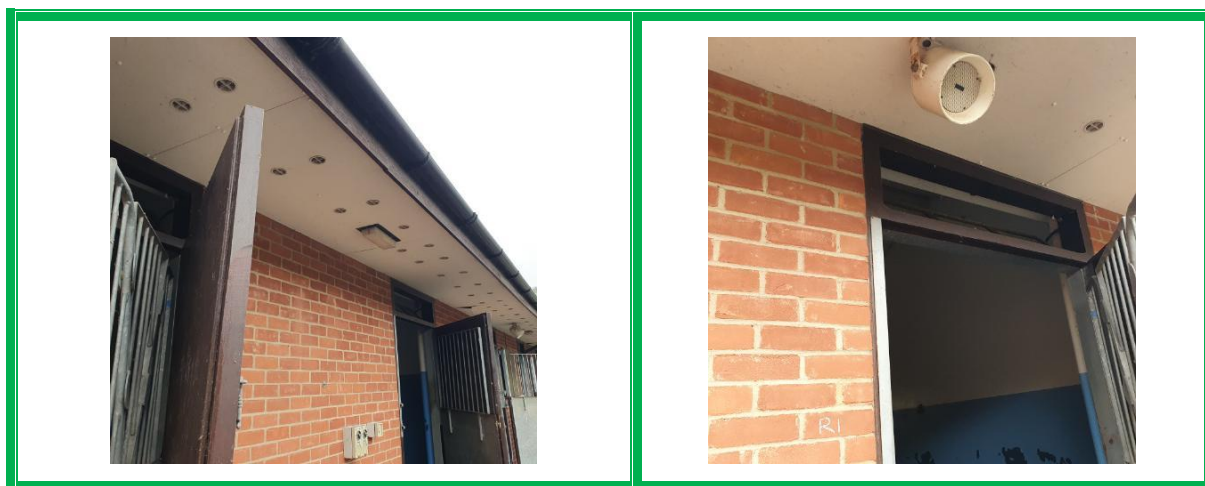
Location: External - Stables R1 to R6 038

Material Description:	Soffits - Insulating Board	
Identification:	As per sample DK/07 - No Asbestos Found	
Approx. quantity:	N/A	
Accessibility	N/A	<i>Assessment Score</i>
Product type:	N/A	N/A
Extent of Damage:	N/A	N/A
Surface Treatment:	N/A	N/A
Asbestos type:	N/A	N/A
Material Assessment Score:		N/A
Risk Assessment Score:		N/A
Action:	N/A	
Comments:	Plastic rainwater goods. Built in 1990's.

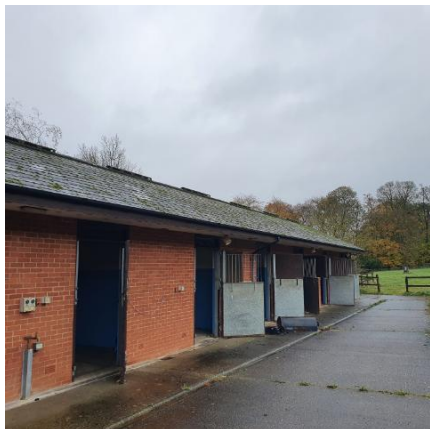
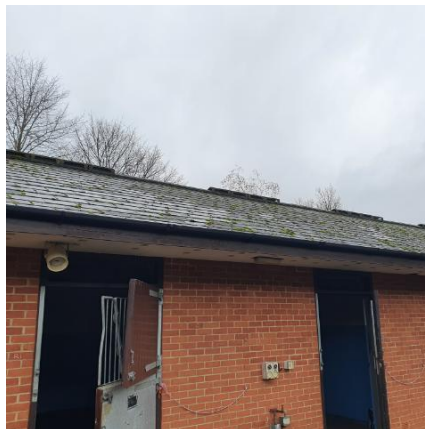
Location: External - Stables R1 to R6 039

Material Description:	Roof Tiles - Cement Product	
Identification:	As per sample DK/08 - No Asbestos Found	
Approx. quantity:	N/A	
Accessibility	N/A	<i>Assessment Score</i>
Product type:	N/A	N/A
Extent of Damage:	N/A	N/A
Surface Treatment:	N/A	N/A
Asbestos type:	N/A	N/A
Material Assessment Score:		N/A
Risk Assessment Score:		N/A
Action:	N/A	
Comments:	N/A

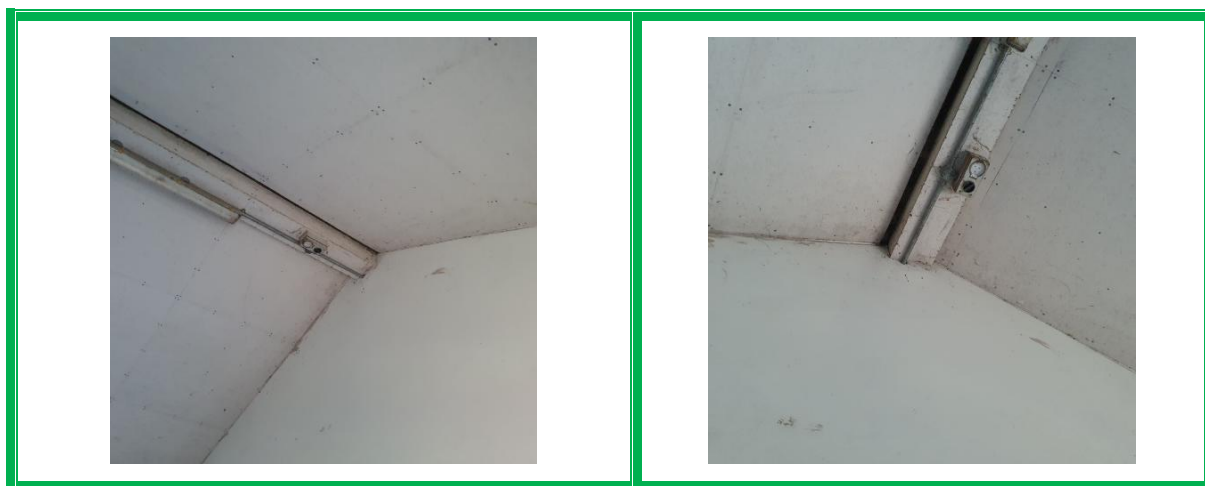
Location: Ground Floor - Stables R1 to R6 040

Material Description:	Ceiling and Boxing Panels - Insulating Board	
Identification:	As per sample DK/09 - No Asbestos Found	
Approx. quantity:	N/A	
Accessibility	N/A	<i>Assessment Score</i>
Product type:	N/A	N/A
Extent of Damage:	N/A	N/A
Surface Treatment:	N/A	N/A
Asbestos type:	N/A	N/A
Material Assessment Score:		N/A
Risk Assessment Score:		N/A
Action:	N/A	
Comments:	To all rooms. Solid walls and walls.

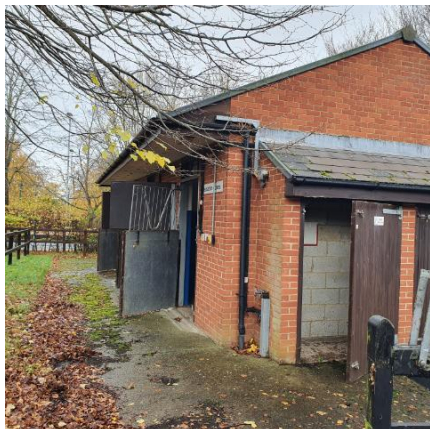
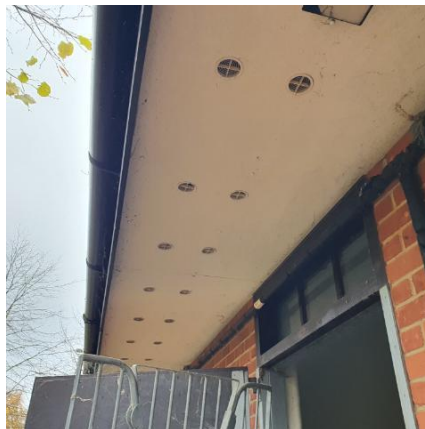
Location: External - Isolation Stables 041

Material Description:	Soffits - Insulating Board	
Identification:	As per sample DK/07 - No Asbestos Found	
Approx. quantity:	N/A	
Accessibility	N/A	<i>Assessment Score</i>
Product type:	N/A	N/A
Extent of Damage:	N/A	N/A
Surface Treatment:	N/A	N/A
Asbestos type:	N/A	N/A
Material Assessment Score:		N/A
Risk Assessment Score:		N/A
Action:	N/A	
Comments:	Plastic rain water goods. Built in 1990's.

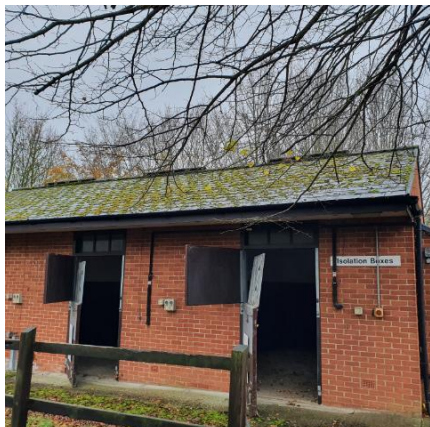
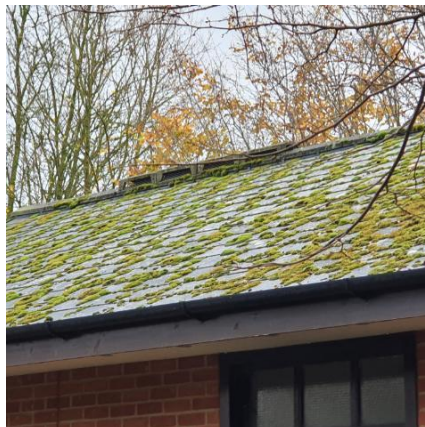
Location: External - Isolation Stables 042

Material Description:	Roof Tiles - Cement Product	
Identification:	As per sample DK/08 - No Asbestos Found	
Approx. quantity:	N/A	
Accessibility	N/A	<i>Assessment Score</i>
Product type:	N/A	N/A
Extent of Damage:	N/A	N/A
Surface Treatment:	N/A	N/A
Asbestos type:	N/A	N/A
Material Assessment Score:		N/A
Risk Assessment Score:		N/A
Action:	N/A	
Comments:	N/A

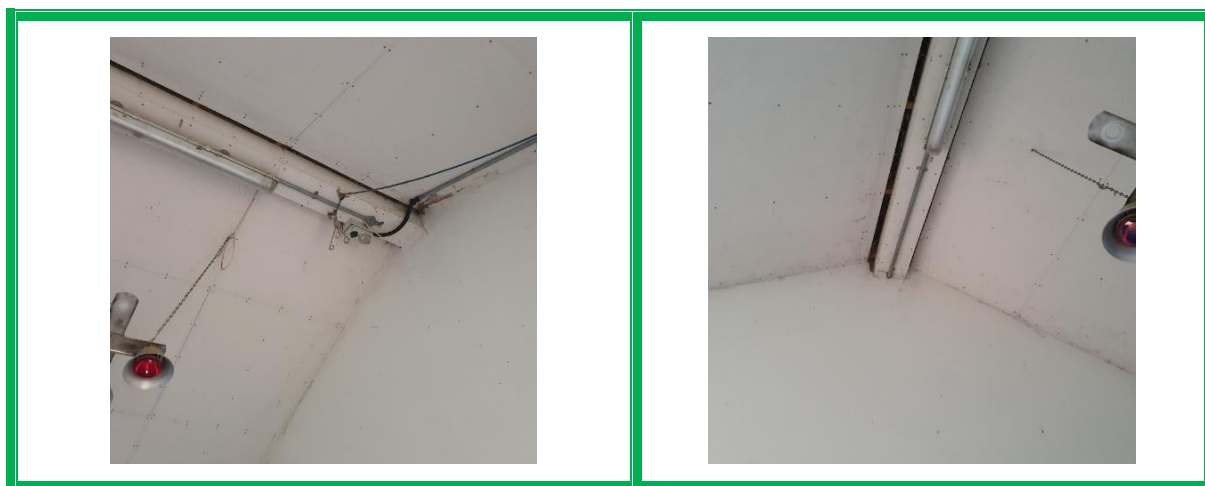
Location: Ground Floor - Isolation Stables 043

Material Description:	Ceiling and Boxing Panels - Insulating Board	
Identification:	As per sample DK/09 - No Asbestos Found	
Approx. quantity:	N/A	
Accessibility	N/A	<i>Assessment Score</i>
Product type:	N/A	N/A
Extent of Damage:	N/A	N/A
Surface Treatment:	N/A	N/A
Asbestos type:	N/A	N/A
Material Assessment Score:		N/A
Risk Assessment Score:		N/A
Action:	N/A	
Comments:	To all rooms. Solid walls and walls.

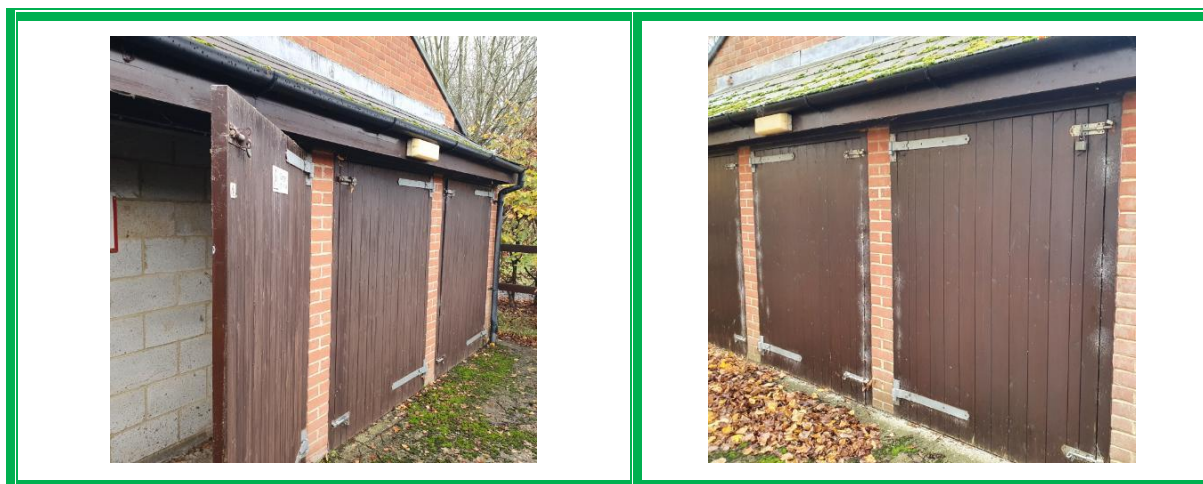
Item No:	44	Sample No:	N/A
Location:	Ground Floor - Isolation Stables - Electrical Rooms x 6 044

Material Description:	No Suspect Materials Found	
Identification:	N/A	
Approx. quantity:	N/A	
Accessibility	N/A	<i>Assessment Score</i>
Product type:	N/A	N/A
Extent of Damage:	N/A	N/A
Surface Treatment:	N/A	N/A
Asbestos type:	N/A	N/A
Material Assessment Score:		N/A
Risk Assessment Score:		N/A
Action:	N/A	
Comments:	Modern electrics

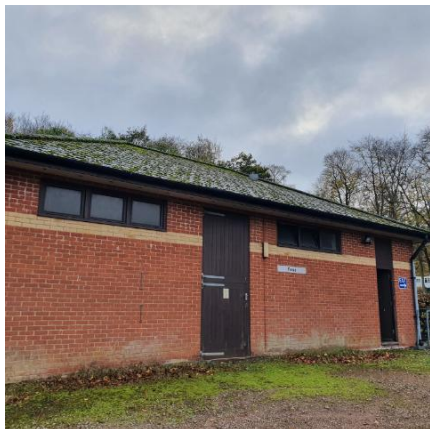
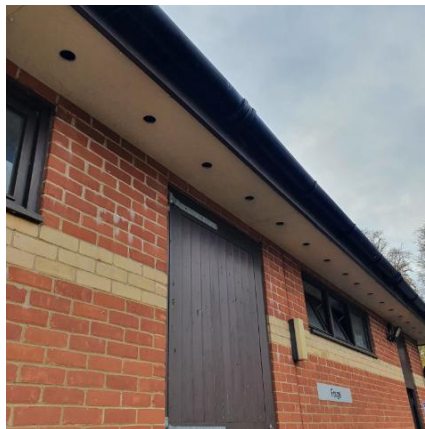
Location: External - Forge 045

Material Description:	Soffits - Insulating Board	
Identification:	As per sample DK/07 - No Asbestos Found	
Approx. quantity:	N/A	
Accessibility	N/A	<i>Assessment Score</i>
Product type:	N/A	N/A
Extent of Damage:	N/A	N/A
Surface Treatment:	N/A	N/A
Asbestos type:	N/A	N/A
Material Assessment Score:		N/A
Risk Assessment Score:		N/A
Action:	N/A	
Comments:	Plastic rainwater goods. Built in 1990's.

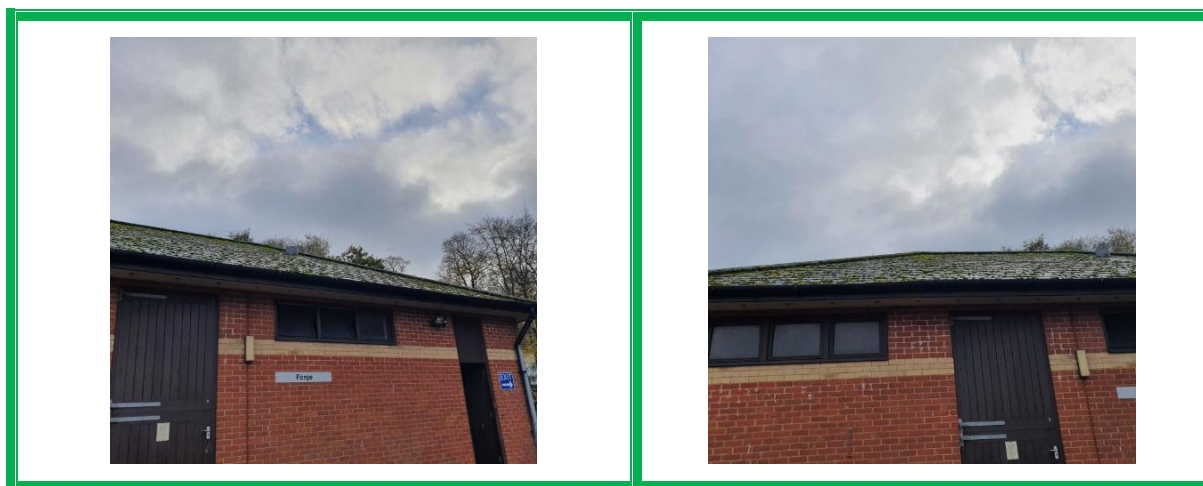
Item No:	46	Sample No:	N/A
Location:	External - Forge 046

Material Description:	Roof Tiles - Cement Product	
Identification:	As per sample DK/08 - No Asbestos Found	
Approx. quantity:	N/A	
Accessibility	N/A	<i>Assessment Score</i>
Product type:	N/A	N/A
Extent of Damage:	N/A	N/A
Surface Treatment:	N/A	N/A
Asbestos type:	N/A	N/A
Material Assessment Score:		N/A
Risk Assessment Score:		N/A
Action:	N/A	
Comments:	Plasterboard ceilings, modern electrics, modern roof felt

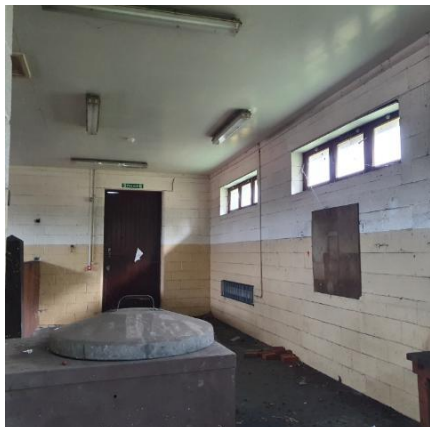
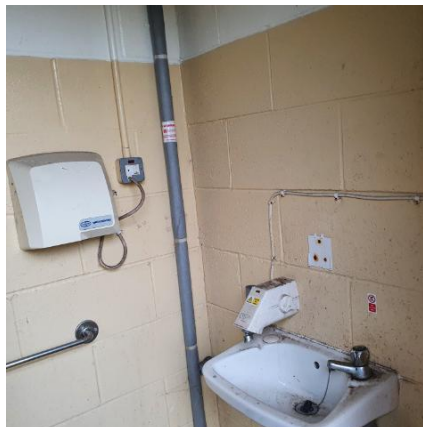
Location: External - Forge, Lobby and WC 047

Material Description:	No Suspect Materials Found	
Identification:	N/A	
Approx. quantity:	N/A	
Accessibility	N/A	<i>Assessment Score</i>
Product type:	N/A	N/A
Extent of Damage:	N/A	N/A
Surface Treatment:	N/A	N/A
Asbestos type:	N/A	N/A
Material Assessment Score:		N/A
Risk Assessment Score:		N/A
Action:	N/A	
Comments:	Modern electrics, plasterboard ceilings, non asbestos boarding above windows
