Project Number A-02001 (6724)

**Refurbishment and Demolition
Asbestos Survey Report**

**MRI Unit
Lanwades Park
Newmarket
CBU 7UA**

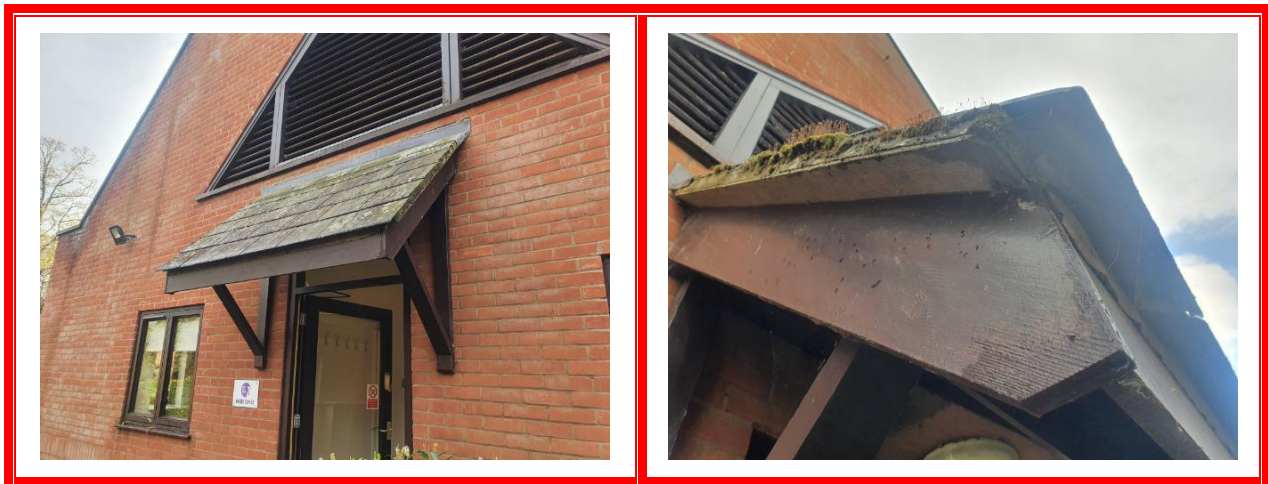
Item No:	1	Sample No:	JH/01
Location:	External - Porch 001

Material Description:	Cement Undercloaking - Cement Product	
Identification:	Sampled - Asbestos Detected	
Approx. quantity:	3 LM	
Accessibility	Medium	Assessment Score
Product type:	Cement	1
Extent of Damage:	Slight / minor damage	1
Surface Treatment:	Unsealed Cement	1
Asbestos type:	Chrysotile	1
Material Assessment Score:		4
Risk Assessment Score:		Negligible
Action:	Remove if likely to be disturbed by works	
Comments:	Slate roof tiles, samples undercloaking, timber frame, brick walls Undercloaking to the porch roof

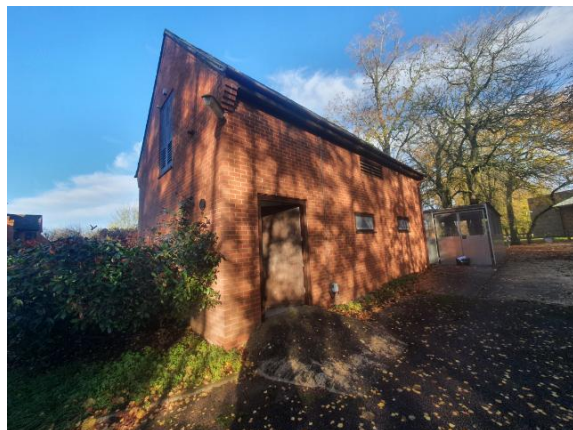
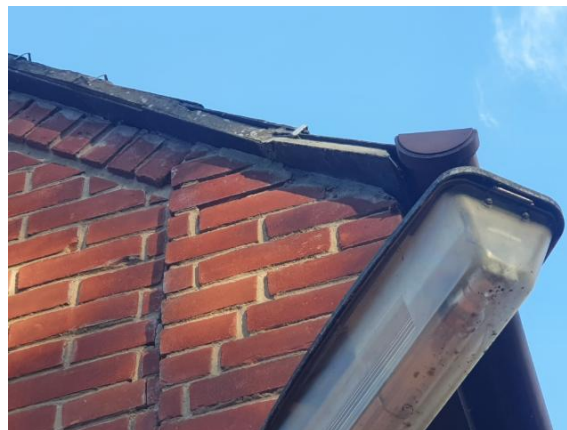
Item No: 13

Material Description:	Cement Undercloaking - Cement Product	
Identification:	Sampled - Asbestos Detected	
Approx. quantity:	20 LM	
Accessibility	Medium	Assessment Score
Product type:	Cement	1
Extent of Damage:	Slight / minor damage	1
Surface Treatment:	Unsealed Cement	1
Asbestos type:	Chrysotile	1
Material Assessment Score:		4
Risk Assessment Score:		Negligible
Action:	Remove if likely to be disturbed by works	
Comments:	Slate roof tiles, sampled undercloaking, brick walls, timber soffits, timber doors and frames, plastic gutters, and downpipes Undercloaking to the pitched roof

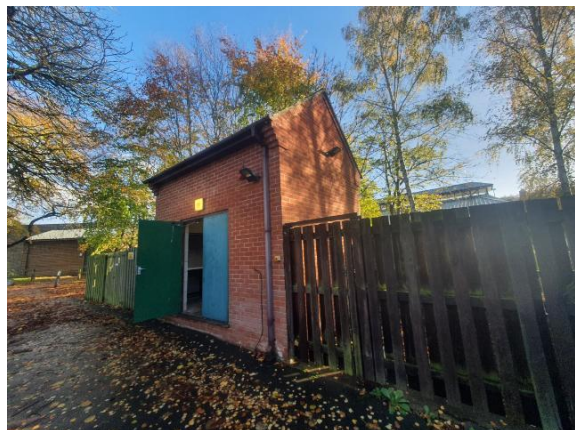
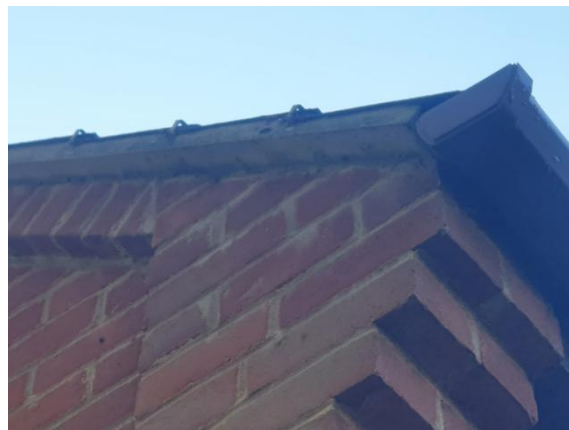
Item No: 16

Material Description:	Cement Undercloaking - Cement Product	
Identification:	Sampled - Asbestos Detected	
Approx. quantity:	12 LM	
Accessibility	Medium	Assessment Score
Product type:	Cement	1
Extent of Damage:	Slight / minor damage	1
Surface Treatment:	Unsealed Cement	1
Asbestos type:	Chrysotile	1
Material Assessment Score:		4
Risk Assessment Score:		Negligible
Action:	Remove if likely to be disturbed by works	
Comments:	Slate roof tiles, sampled undercloaking, brick walls, timber soffits, timber doors and frames, plastic gutters, and downpipes Undercloaking to the pitched roof

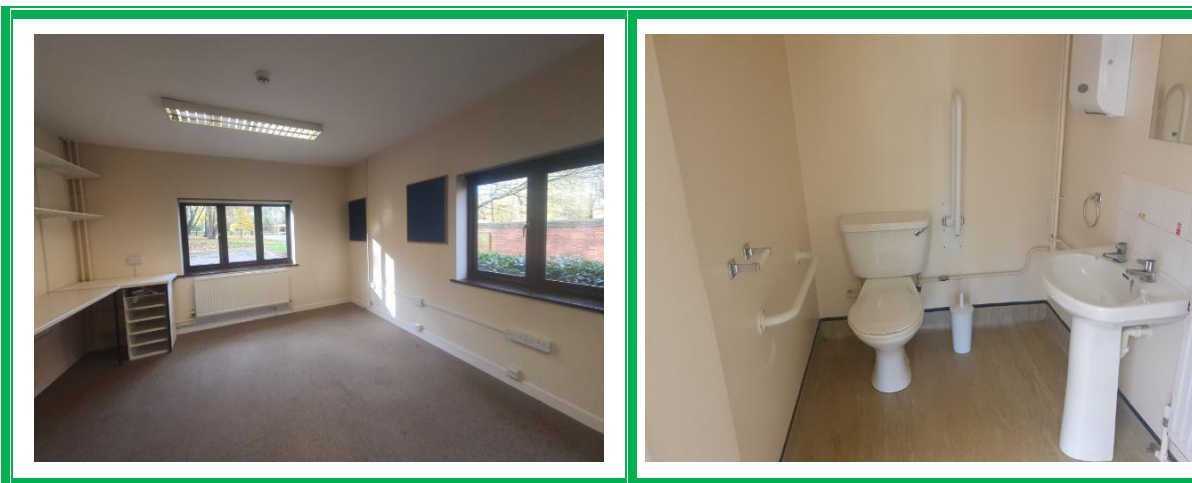
Item No:	2	Sample No:	N/A
Location:	Ground Floor - Office x 2 & Toilet 002

Material Description:	No Suspect Materials Found	
Identification:	N/A	
Approx. quantity:	N/A	
Accessibility	N/A	<i>Assessment Score</i>
Product type:	N/A	N/A
Extent of Damage:	N/A	N/A
Surface Treatment:	N/A	N/A
Asbestos type:	N/A	N/A
Material Assessment Score:		N/A
Risk Assessment Score:		N/A
Action:	N/A	
Comments:	plasterboard ceiling, brick and plaster walls, timber window frames and sill, modern heaters, timber door and frame, timber cabinets and shelving, modern facilities, plastic and metal pipework, tiled wall areas, carpet and lino floor to concrete

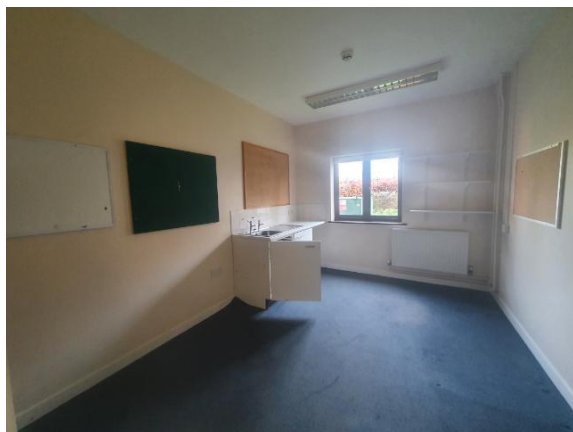
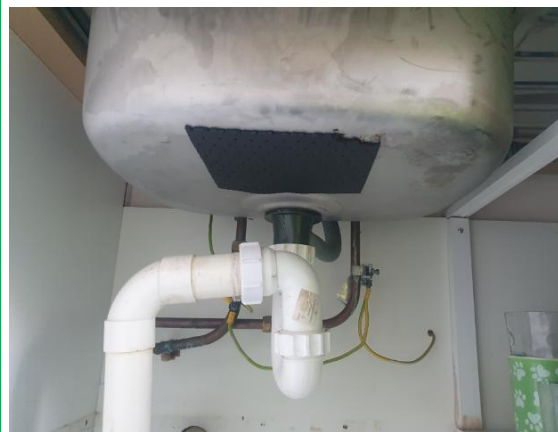
Item No: 3

Material Description:	Sink Pad - Bituminous Product	
Identification:	Sampled - No Asbestos Found	
Approx. quantity:	N/A	
Accessibility	N/A	<i>Assessment Score</i>
Product type:	N/A	N/A
Extent of Damage:	N/A	N/A
Surface Treatment:	N/A	N/A
Asbestos type:	N/A	N/A
Material Assessment Score:		N/A
Risk Assessment Score:		N/A
Action:	N/A	
Comments:	Plasterboard ceiling, plaster and brick walls, timber window frame and sill, timber door and frame, modern heater, timber cabinets and shelves, metal and plastic pipes, carpet floor to concrete Sink Pad to metal sink

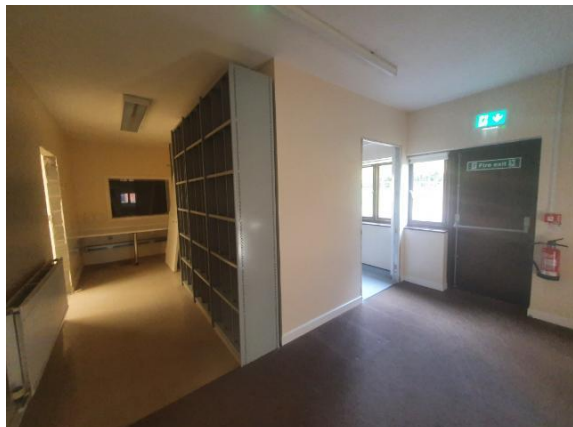
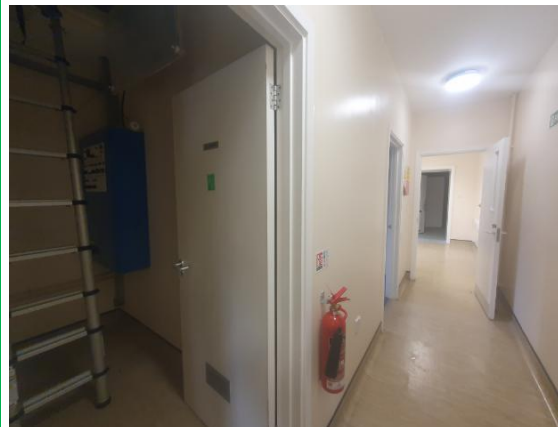
Item No: 4

Material Description:	No Suspect Materials Found	
Identification:	N/A	
Approx. quantity:	N/A	
Accessibility	N/A	<i>Assessment Score</i>
Product type:	N/A	N/A
Extent of Damage:	N/A	N/A
Surface Treatment:	N/A	N/A
Asbestos type:	N/A	N/A
Material Assessment Score:		N/A
Risk Assessment Score:		N/A
Action:	N/A	
Comments:	Plasterboard ceiling, plaster and brick walls, plasterboard partition, timber door and frame, timber window frame and sill, modern heater, ceramic sink, modern electrical unit, caper and lino floor to concrete

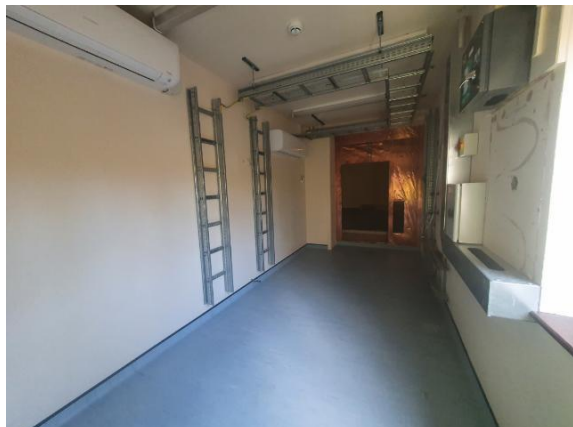
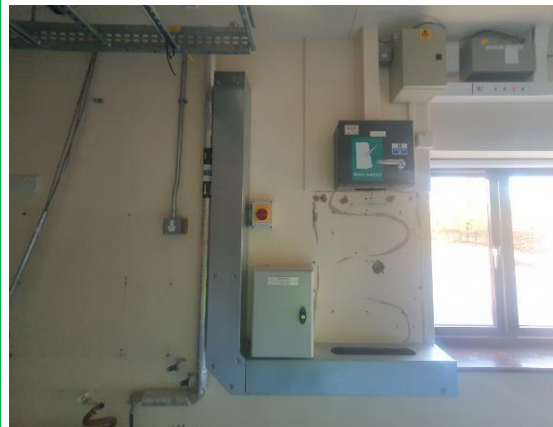
Item No: 5

Material Description:	No Suspect Materials Found	
Identification:	N/A	
Approx. quantity:	N/A	
Accessibility	N/A	<i>Assessment Score</i>
Product type:	N/A	N/A
Extent of Damage:	N/A	N/A
Surface Treatment:	N/A	N/A
Asbestos type:	N/A	N/A
Material Assessment Score:		N/A
Risk Assessment Score:		N/A
Action:	N/A	
Comments:	Plasterboard ceiling, plaster and brick walls, plasterboard partition, timber door and frame, copper lined wall, timber window frame and sill, modern electrical units, metal cable tracking, lino floor to concrete

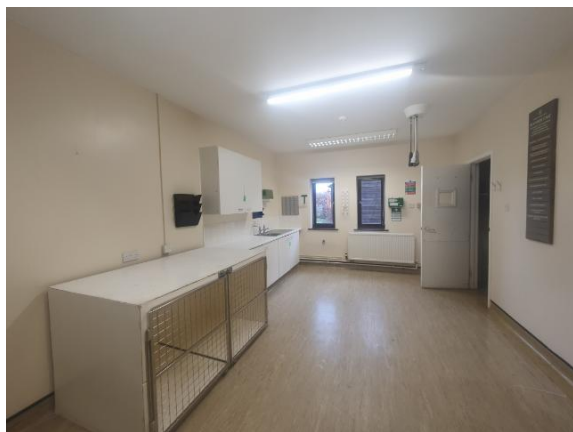
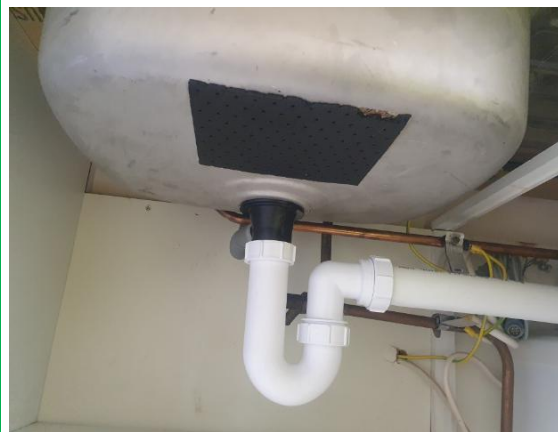
Item No: 6

Material Description:	Sink Pad - Bituminous Product	
Identification:	As per sample JH/02 - No Asbestos Found	
Approx. quantity:	N/A	
Accessibility	N/A	<i>Assessment Score</i>
Product type:	N/A	N/A
Extent of Damage:	N/A	N/A
Surface Treatment:	N/A	N/A
Asbestos type:	N/A	N/A
Material Assessment Score:		N/A
Risk Assessment Score:		N/A
Action:	N/A	
Comments:	<p>Plasterboard ceiling, plaster and brick walls, timber window frame and sill, timber door and frame, modern heater, timber cabinets and shelves, plastic cable boxing, metal, and plastic pipes, lino floor to concrete</p> <p>Sink Pad to metal sink, Cross referenced with sample number 2 due to being visually similar</p>

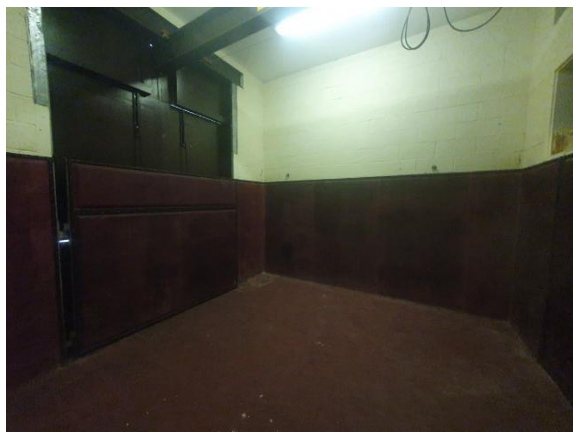
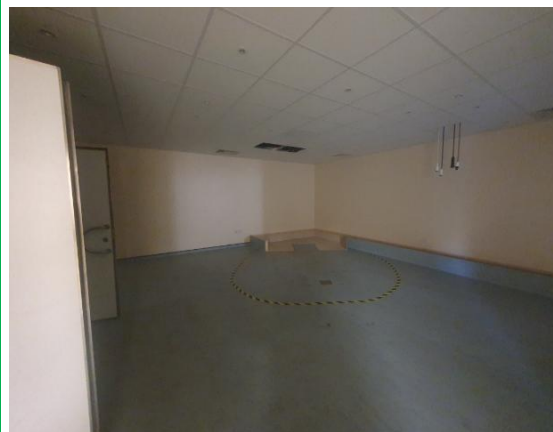
Item No: 7

Material Description:	No Suspect Materials Found	
Identification:	N/A	
Approx. quantity:	N/A	
Accessibility	N/A	<i>Assessment Score</i>
Product type:	N/A	N/A
Extent of Damage:	N/A	N/A
Surface Treatment:	N/A	N/A
Asbestos type:	N/A	N/A
Material Assessment Score:		N/A
Risk Assessment Score:		N/A
Action:	N/A	
Comments:	Non-ACM ceiling tiles to void with modern insulation, plasterboard ceiling, padded walls and ceiling, brick and plaster walls, timber door and frame, metal door and frame, timber boxing, lino floor to concrete

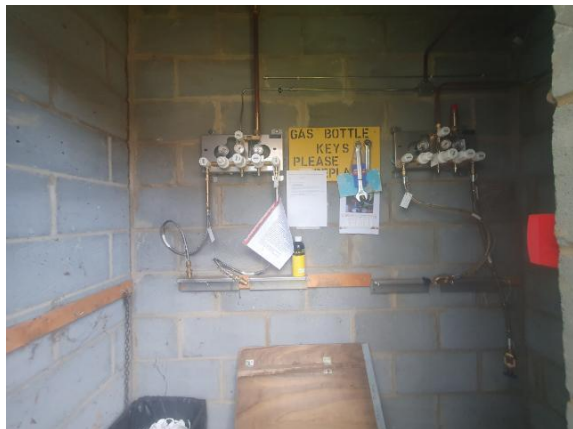
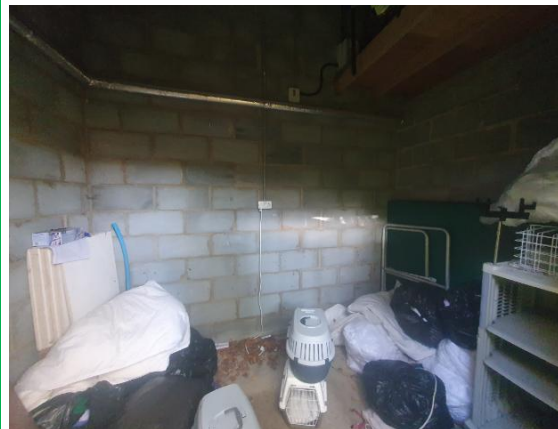
Item No: 8

Material Description:	No Suspect Materials Found	
Identification:	N/A	
Approx. quantity:	N/A	
Accessibility	N/A	<i>Assessment Score</i>
Product type:	N/A	N/A
Extent of Damage:	N/A	N/A
Surface Treatment:	N/A	N/A
Asbestos type:	N/A	N/A
Material Assessment Score:		N/A
Risk Assessment Score:		N/A
Action:	N/A	
Comments:	Timber ceiling, block walls, metal pipework, timber door and frame, concrete floor

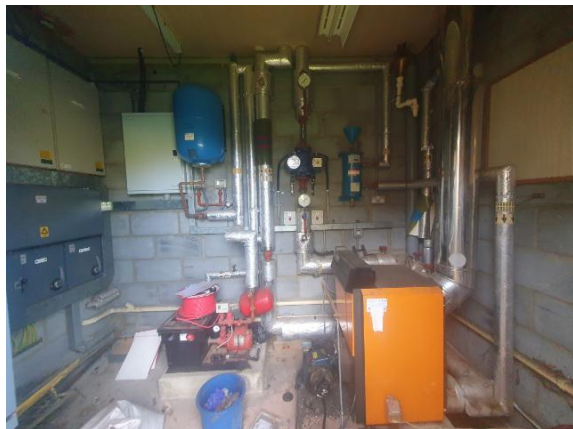
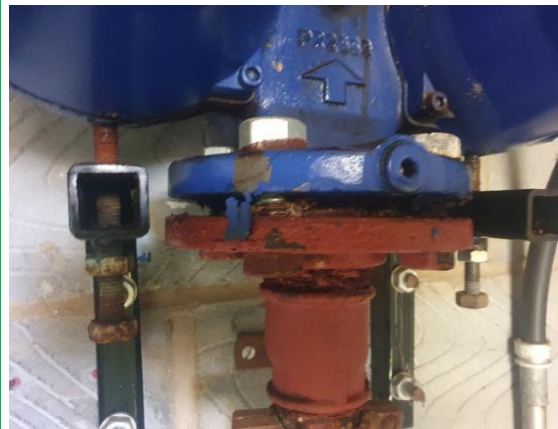
Item No: 9

Material Description:	Gaskets - Gaskets (compressed)	
Identification:	Sampled - No Asbestos Found	
Approx. quantity:	N/A	
Accessibility	N/A	<i>Assessment Score</i>
Product type:	N/A	N/A
Extent of Damage:	N/A	N/A
Surface Treatment:	N/A	N/A
Asbestos type:	N/A	N/A
Material Assessment Score:		N/A
Risk Assessment Score:		N/A
Action:	N/A	
Comments:	Plasterboard ceiling, block walls, metal pipework, modern pipe insulation, modern electrical units, metal cable boxing, plastic pipes, metal ducting, timber door and frame, concrete floor Gaskets to pipe work flanges within the plant room

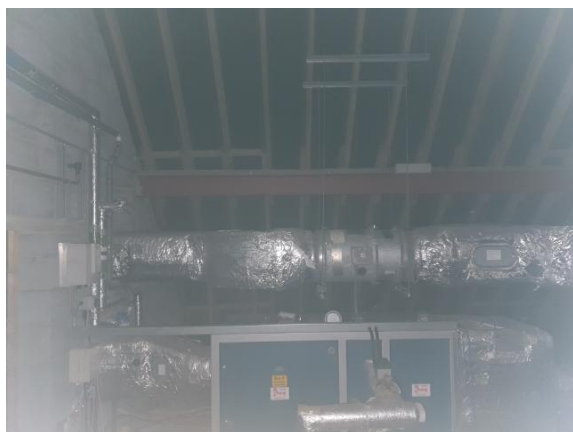
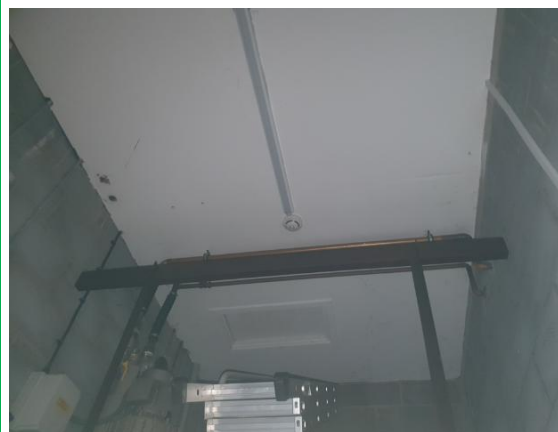
Item No: 10

Material Description:	No Suspect Materials Found	
Identification:	N/A	
Approx. quantity:	N/A	
Accessibility	N/A	<i>Assessment Score</i>
Product type:	N/A	N/A
Extent of Damage:	N/A	N/A
Surface Treatment:	N/A	N/A
Asbestos type:	N/A	N/A
Material Assessment Score:		N/A
Risk Assessment Score:		N/A
Action:	N/A	
Comments:	modern roof felt, timber batons, block walls, metal ducting, modern insulation, modern AHU, timber boarding, metal pipework, timber floor panels

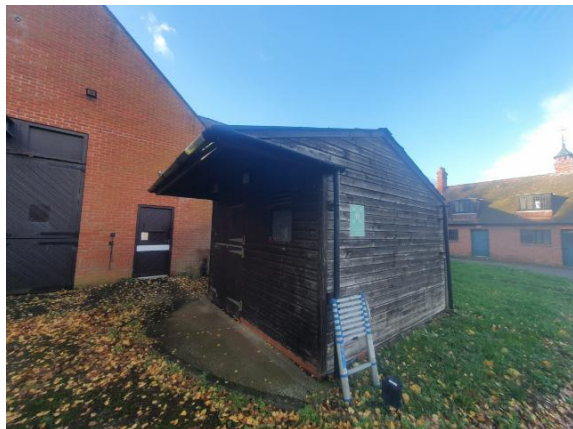
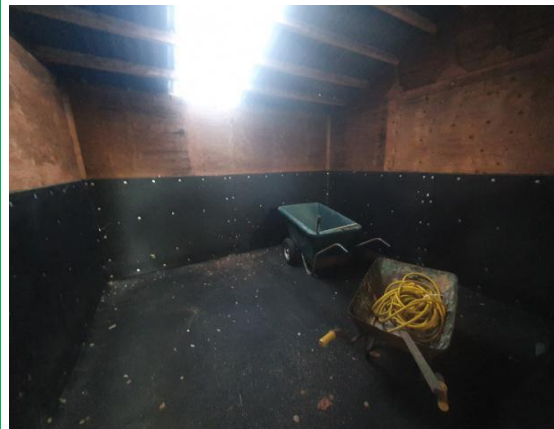
Item No: 11

Material Description:	No Suspect Materials Found	
Identification:	N/A	
Approx. quantity:	N/A	
Accessibility	N/A	<i>Assessment Score</i>
Product type:	N/A	N/A
Extent of Damage:	N/A	N/A
Surface Treatment:	N/A	N/A
Asbestos type:	N/A	N/A
Material Assessment Score:		N/A
Risk Assessment Score:		N/A
Action:	N/A	
Comments:	Timber construction shed, non-asbestos roof panels, rubber fascia to walls, plastic gutters and downpipes, rubber floor to timber and concrete

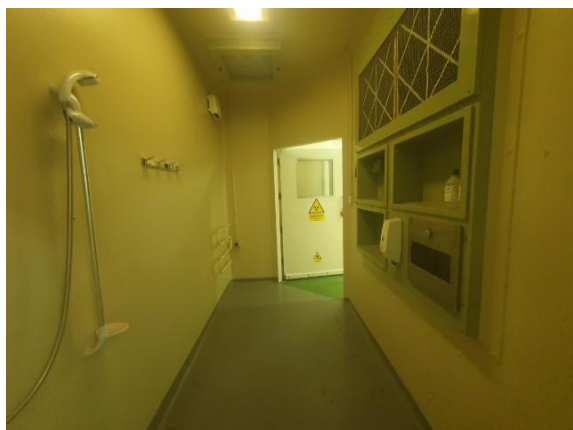
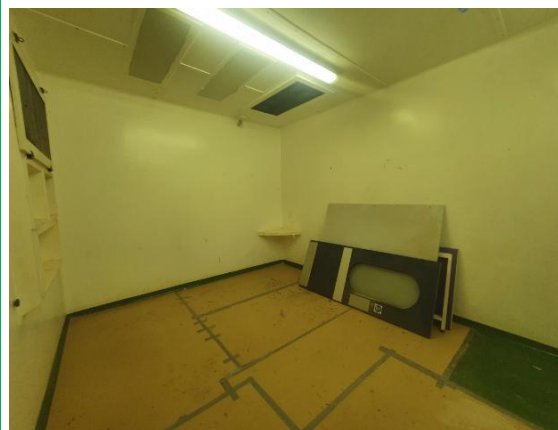
Item No: 12

Material Description:	No Suspect Materials Found	
Identification:	N/A	
Approx. quantity:	N/A	
Accessibility	N/A	<i>Assessment Score</i>
Product type:	N/A	N/A
Extent of Damage:	N/A	N/A
Surface Treatment:	N/A	N/A
Asbestos type:	N/A	N/A
Material Assessment Score:		N/A
Risk Assessment Score:		N/A
Action:	N/A	
Comments:	Timber panel ceiling, solid walls, metal door and frames, timber door and frames, timber fascia to walls, metal fascia to walls, modern electrical panels, timber boxing, lino floor to concrete

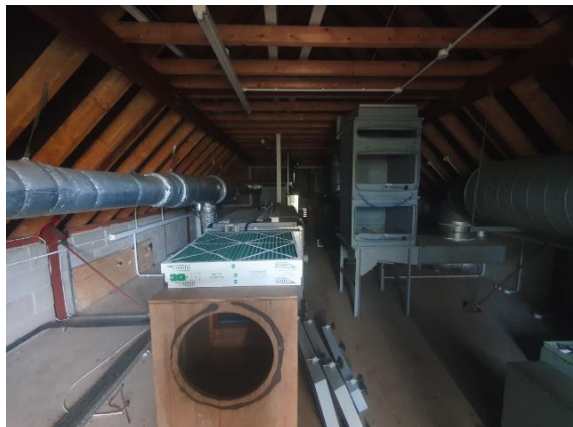
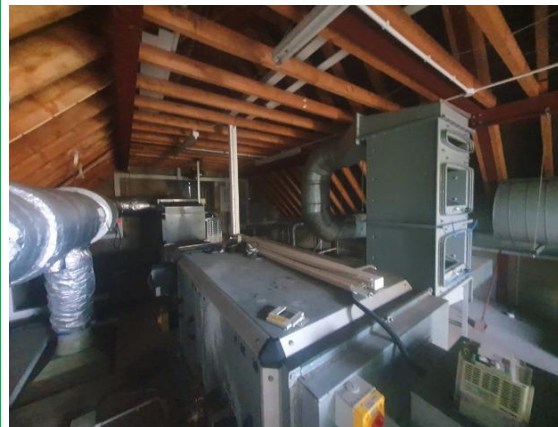
Item No: 14

Material Description:	No Suspect Materials Found	
Identification:	N/A	
Approx. quantity:	N/A	
Accessibility	N/A	<i>Assessment Score</i>
Product type:	N/A	N/A
Extent of Damage:	N/A	N/A
Surface Treatment:	N/A	N/A
Asbestos type:	N/A	N/A
Material Assessment Score:		N/A
Risk Assessment Score:		N/A
Action:	N/A	
Comments:	Timber framed roof, modern felt, metal ductwork, modern insulation, modern AHU, timber door and frame, block walls, timber panel floor

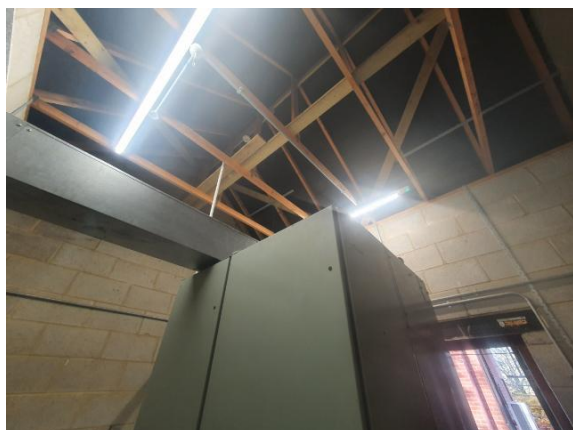
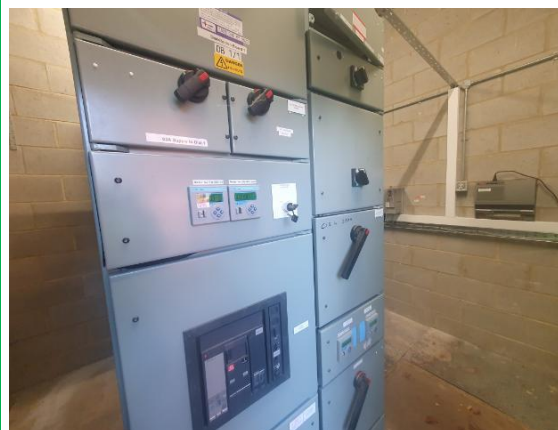
Item No: 15

Material Description:	No Suspect Materials Found	
Identification:	N/A	
Approx. quantity:	N/A	
Accessibility	N/A	<i>Assessment Score</i>
Product type:	N/A	N/A
Extent of Damage:	N/A	N/A
Surface Treatment:	N/A	N/A
Asbestos type:	N/A	N/A
Material Assessment Score:		N/A
Risk Assessment Score:		N/A
Action:	N/A	
Comments:	Pitched timber frame roof, modern roof felt, block walls, timber door and frame, timber shelving, modern distribution board, plastic cable boxing, timber floor to concrete

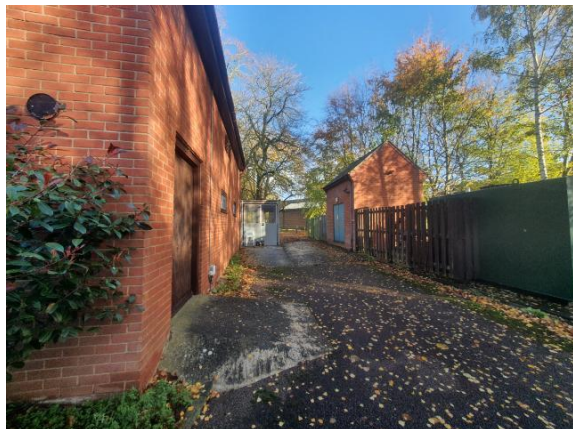
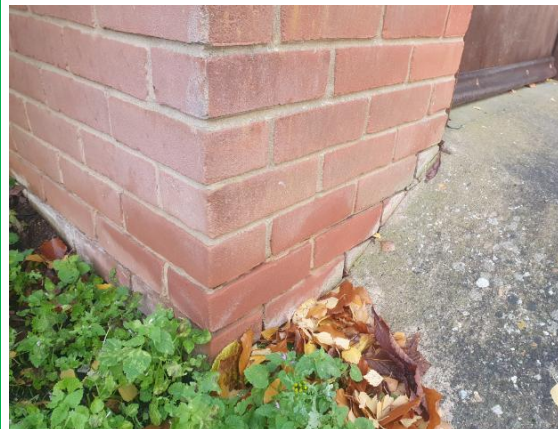
Item No: 17

Material Description:	DPC - Bituminous Product	
Identification:	Sampled - No Asbestos Found	
Approx. quantity:	N/A	
Accessibility	N/A	<i>Assessment Score</i>
Product type:	N/A	N/A
Extent of Damage:	N/A	N/A
Surface Treatment:	N/A	N/A
Asbestos type:	N/A	N/A
Material Assessment Score:		N/A
Risk Assessment Score:		N/A
Action:	N/A	
Comments:	Damp proof course to the external of all brick buildings within the complex

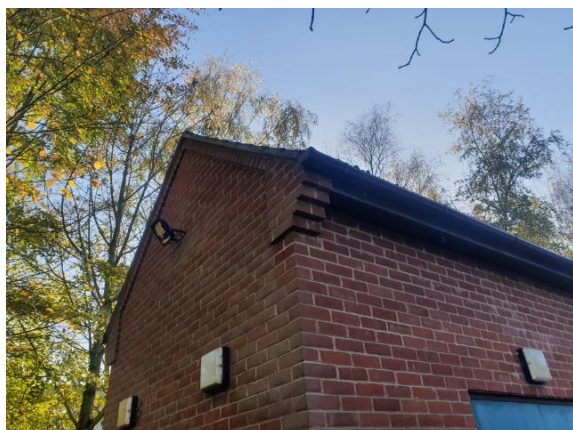
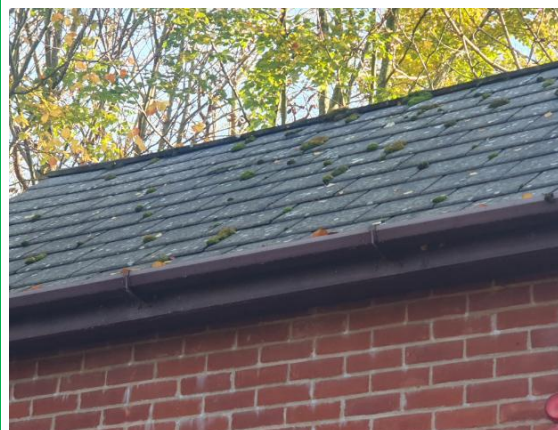
Item No: 18

Material Description:	Roof Tile - Cement Product	
Identification:	Sampled - No Asbestos Found	
Approx. quantity:	N/A	
Accessibility	N/A	<i>Assessment Score</i>
Product type:	N/A	N/A
Extent of Damage:	N/A	N/A
Surface Treatment:	N/A	N/A
Asbestos type:	N/A	N/A
Material Assessment Score:		N/A
Risk Assessment Score:		N/A
Action:	N/A	
Comments:	Composite roof tiles to the pitched roof
