Project Number A-02003 (6724)

**Refurbishment and Demolition
Asbestos Survey Report**

**Vaccine Centre
Lanwades Park
Newmarket
CB8 7UA**

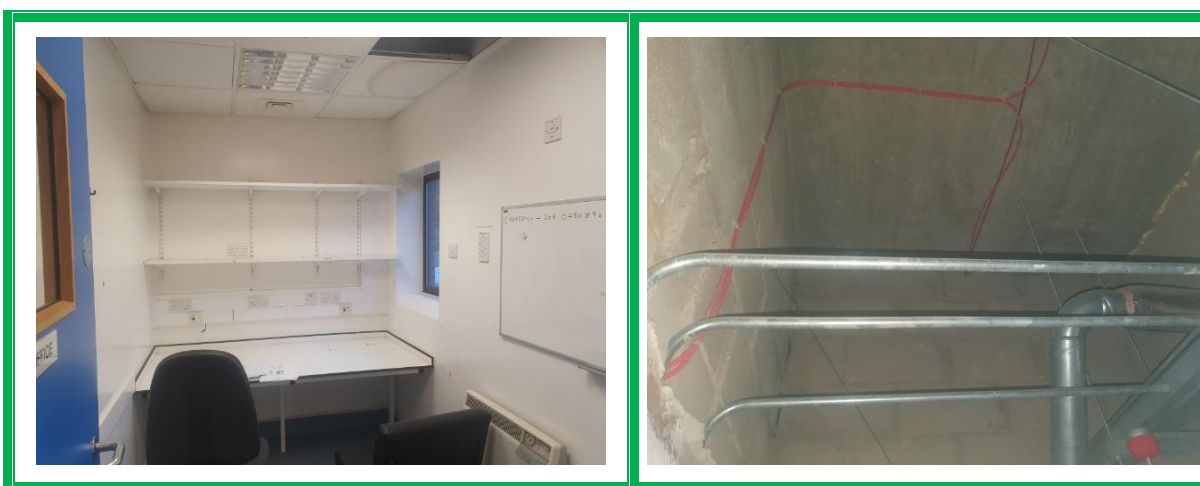
Item No:	1	Sample No:	N/A
Location:	Ground Floor - Offices, Toilets & Changing Rooms 001

Material Description:	No Suspect Materials Found	
Identification:	N/A	
Approx. quantity:	N/A	
Accessibility	N/A	<i>Assessment Score</i>
Product type:	N/A	N/A
Extent of Damage:	N/A	N/A
Surface Treatment:	N/A	N/A
Asbestos type:	N/A	N/A
Material Assessment Score:		N/A
Risk Assessment Score:		N/A
Action:	N/A	
Comments:	Non asbestos ceiling to tiles to large void with block walls and concrete ceiling, timber ceiling, plasterboard ceilings, block riser with metal ducting, timber doors and frames, metal doors and frames, block walls, non asbestos heaters, metal window frames, modern facilities, metal and plastic pipework, solid floor

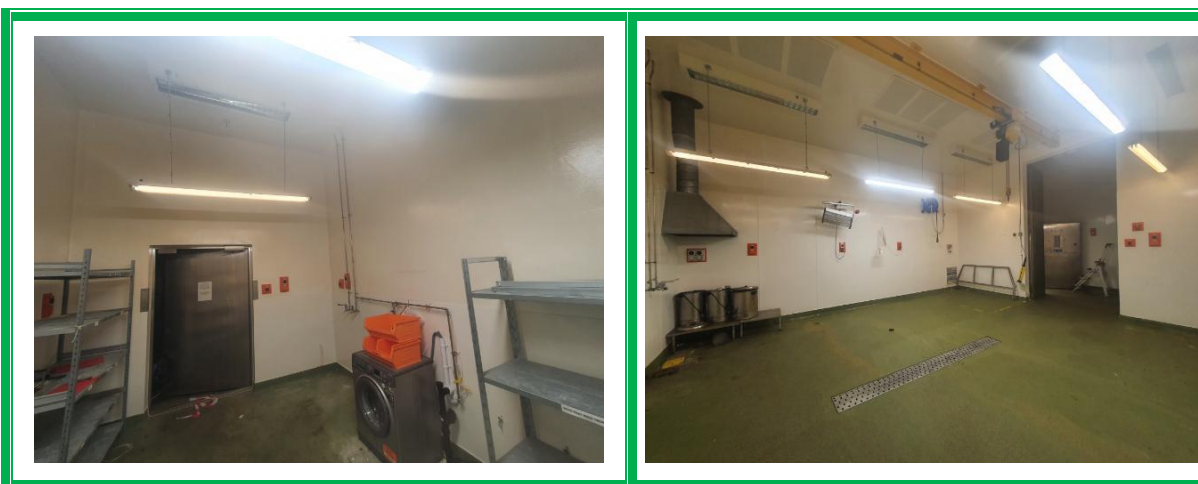
Item No:	2	Sample No:	N/A
Location:	Ground Floor - Post Mortem, Cold Stores & Air Locks 002

Material Description:	No Suspect Materials Found	
Identification:	N/A	
Approx. quantity:	N/A	
Accessibility	N/A	<i>Assessment Score</i>
Product type:	N/A	N/A
Extent of Damage:	N/A	N/A
Surface Treatment:	N/A	N/A
Asbestos type:	N/A	N/A
Material Assessment Score:		N/A
Risk Assessment Score:		N/A
Action:	N/A	
Comments:	Solid ceiling, solid walls, plastic fascia and panels to walls, timber and metal doors, solid floor

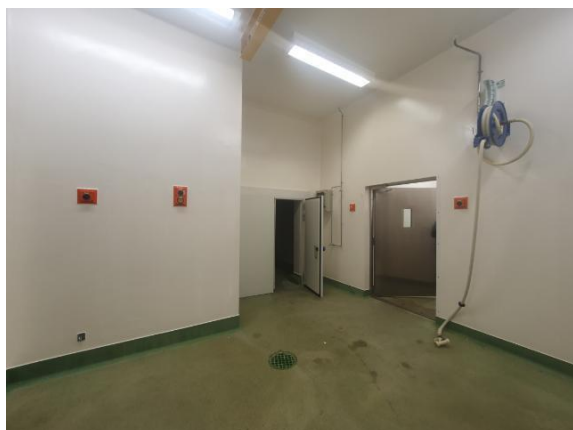
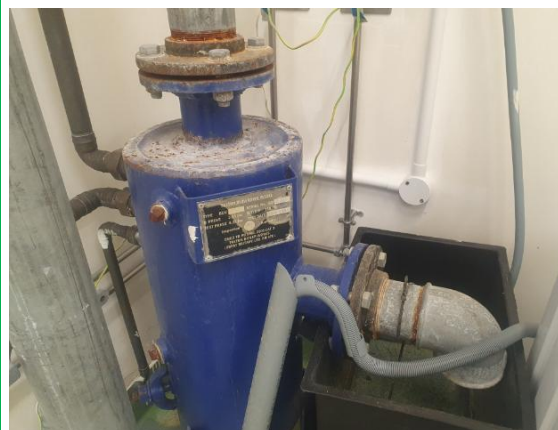
Location: Ground Floor - Stores x2 & Machinery Room 003

Material Description:	Gasket - Gaskets (compressed)	
Identification:	Sampled - No Asbestos Found	
Approx. quantity:	N/A	
Accessibility	N/A	<i>Assessment Score</i>
Product type:	N/A	N/A
Extent of Damage:	N/A	N/A
Surface Treatment:	N/A	N/A
Asbestos type:	N/A	N/A
Material Assessment Score:		N/A
Risk Assessment Score:		N/A
Action:	N/A	
Comments:	Solid ceiling, solid walls, plastic fascia and panels to walls, metal pipe work, large machinery, timber and metal doors, solid floor Gasket to flanges within corner

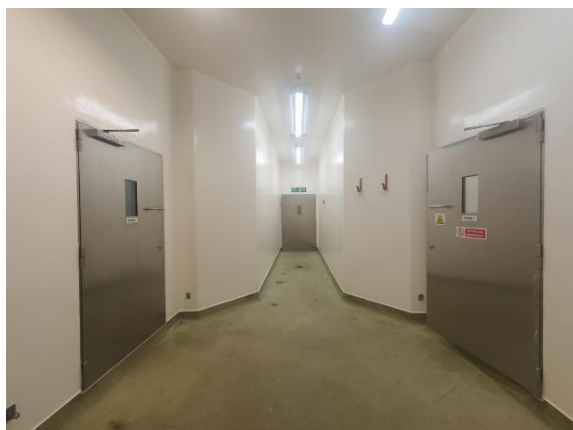
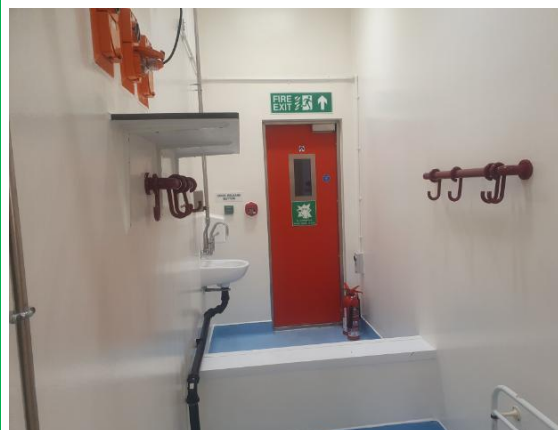
Location: Ground Floor - Corridor & Washroom 004

Material Description:	No Suspect Materials Found	
Identification:	N/A	
Approx. quantity:	N/A	
Accessibility	N/A	<i>Assessment Score</i>
Product type:	N/A	N/A
Extent of Damage:	N/A	N/A
Surface Treatment:	N/A	N/A
Asbestos type:	N/A	N/A
Material Assessment Score:		N/A
Risk Assessment Score:		N/A
Action:	N/A	
Comments:	Solid ceiling, solid walls, plastic fascia and panels to walls, timber and metal doors, solid floor

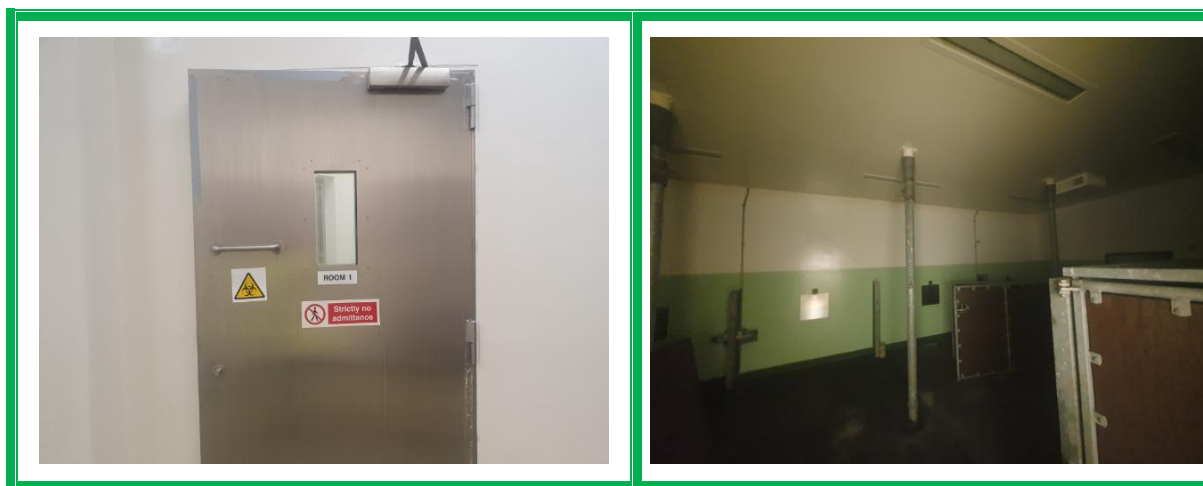
Item No:	5	Sample No:	N/A
Location:	Ground Floor - Animal Room 1 005

Material Description:	No Suspect Materials Found	
Identification:	N/A	
Approx. quantity:	N/A	
Accessibility	N/A	<i>Assessment Score</i>
Product type:	N/A	N/A
Extent of Damage:	N/A	N/A
Surface Treatment:	N/A	N/A
Asbestos type:	N/A	N/A
Material Assessment Score:		N/A
Risk Assessment Score:		N/A
Action:	N/A	
Comments:	Solid ceiling, solid walls, plastic fascia and panels to walls, timber and metal doors, solid floor

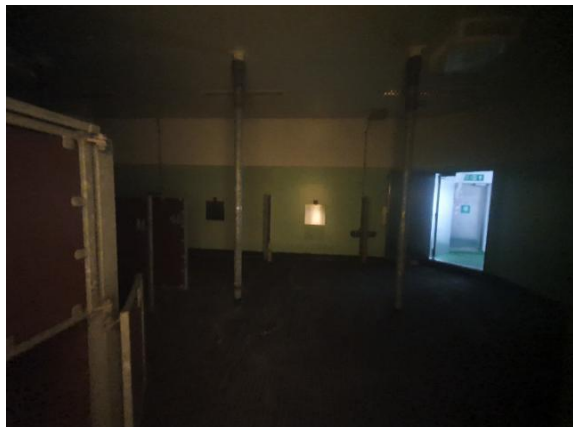
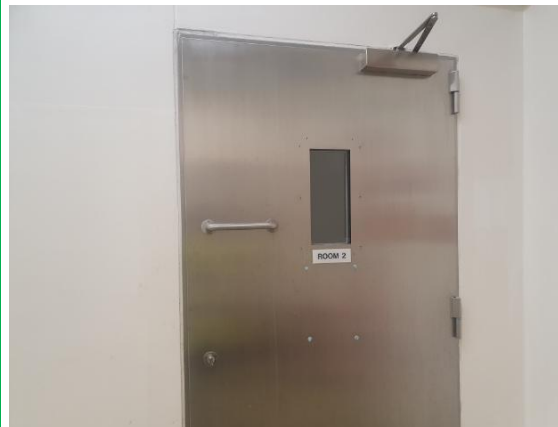
Location: Ground Floor - Animal Room 2 006

Material Description:	No Suspect Materials Found	
Identification:	N/A	
Approx. quantity:	N/A	
Accessibility	N/A	<i>Assessment Score</i>
Product type:	N/A	N/A
Extent of Damage:	N/A	N/A
Surface Treatment:	N/A	N/A
Asbestos type:	N/A	N/A
Material Assessment Score:		N/A
Risk Assessment Score:		N/A
Action:	N/A	
Comments:	Solid ceiling, solid walls, plastic fascia and panels to walls, timber and metal doors, solid floor

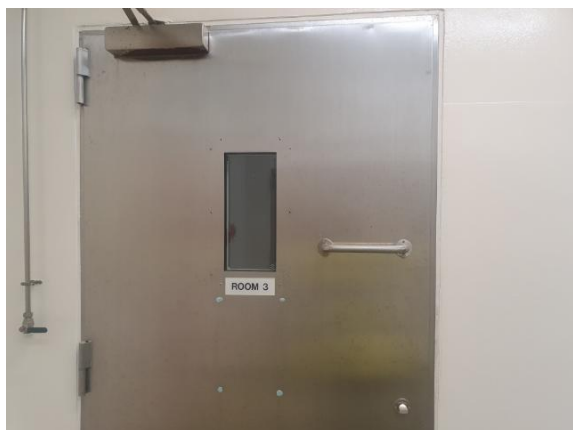
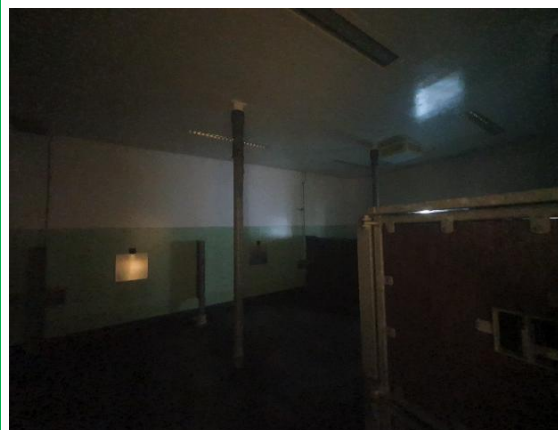
Location: Ground Floor - Animal Room 3 007

Material Description:	No Suspect Materials Found	
Identification:	N/A	
Approx. quantity:	N/A	
Accessibility	N/A	<i>Assessment Score</i>
Product type:	N/A	N/A
Extent of Damage:	N/A	N/A
Surface Treatment:	N/A	N/A
Asbestos type:	N/A	N/A
Material Assessment Score:		N/A
Risk Assessment Score:		N/A
Action:	N/A	
Comments:	Solid ceiling, solid walls, plastic fascia and panels to walls, timber and metal doors, solid floor

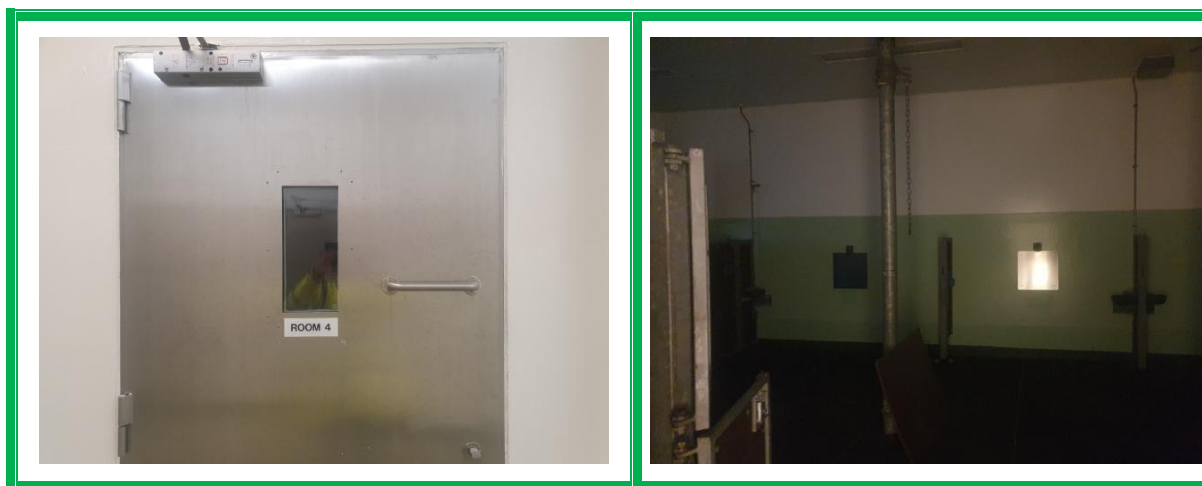
Item No:	8	Sample No:	N/A
Location:	Ground Floor - Animal Room 4 008

Material Description:	No Suspect Materials Found	
Identification:	N/A	
Approx. quantity:	N/A	
Accessibility	N/A	<i>Assessment Score</i>
Product type:	N/A	N/A
Extent of Damage:	N/A	N/A
Surface Treatment:	N/A	N/A
Asbestos type:	N/A	N/A
Material Assessment Score:		N/A
Risk Assessment Score:		N/A
Action:	N/A	
Comments:	Solid ceiling, solid walls, plastic fascia and panels to walls, timber and metal doors, solid floor

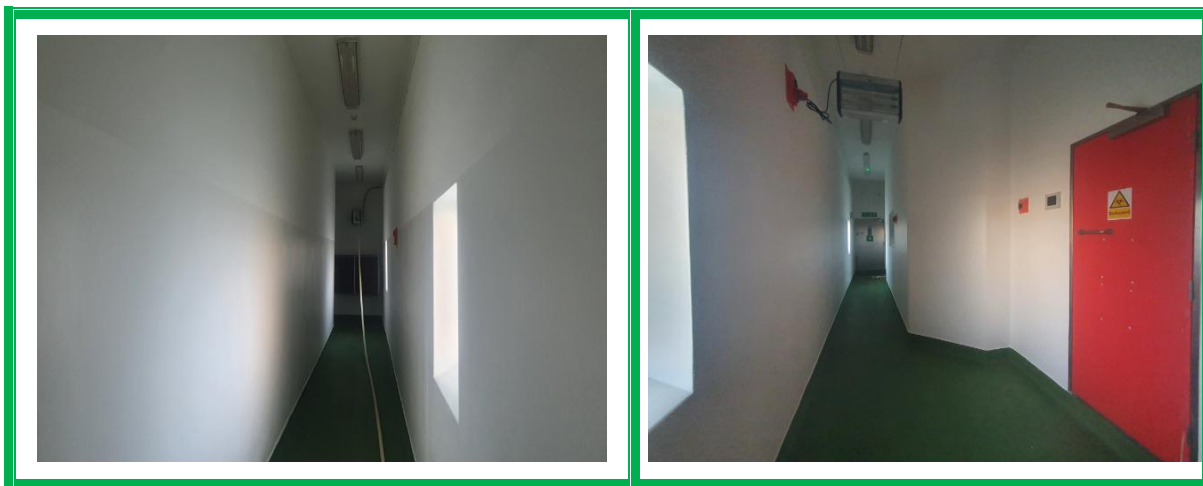
Location: Ground Floor - Corridor 009

Material Description:	No Suspect Materials Found	
Identification:	N/A	
Approx. quantity:	N/A	
Accessibility	N/A	<i>Assessment Score</i>
Product type:	N/A	N/A
Extent of Damage:	N/A	N/A
Surface Treatment:	N/A	N/A
Asbestos type:	N/A	N/A
Material Assessment Score:		N/A
Risk Assessment Score:		N/A
Action:	N/A	
Comments:	Solid ceiling, solid walls, plastic fascia and panels to walls, timber and metal doors, solid floor

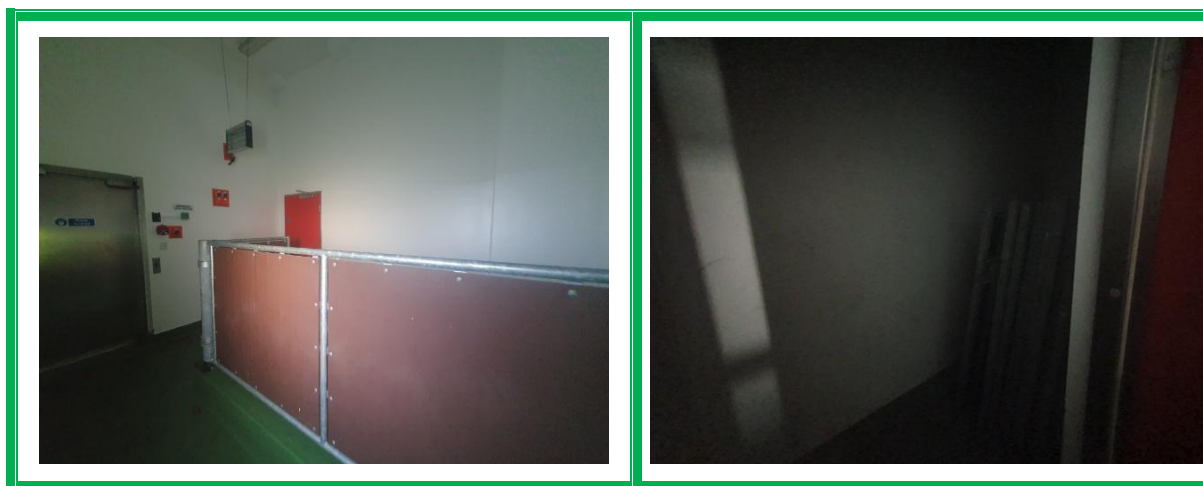
Item No:	10	Sample No:	N/A
Location:	Ground Floor - Stores x2 010

Material Description:	No Suspect Materials Found	
Identification:	N/A	
Approx. quantity:	N/A	
Accessibility	N/A	<i>Assessment Score</i>
Product type:	N/A	N/A
Extent of Damage:	N/A	N/A
Surface Treatment:	N/A	N/A
Asbestos type:	N/A	N/A
Material Assessment Score:		N/A
Risk Assessment Score:		N/A
Action:	N/A	
Comments:	Solid ceiling, solid walls, plastic fascia and panels to walls, timber and metal doors, solid floor

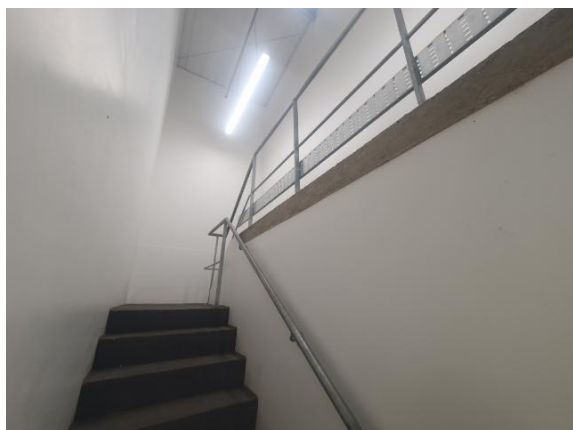
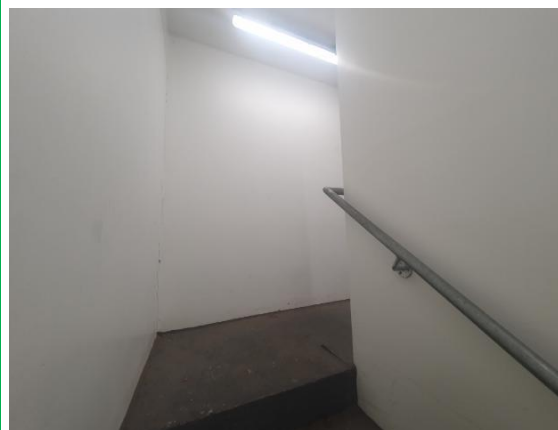
Location: First Floor - Stairwell 011

Material Description:	No Suspect Materials Found	
Identification:	N/A	
Approx. quantity:	N/A	
Accessibility	N/A	<i>Assessment Score</i>
Product type:	N/A	N/A
Extent of Damage:	N/A	N/A
Surface Treatment:	N/A	N/A
Asbestos type:	N/A	N/A
Material Assessment Score:		N/A
Risk Assessment Score:		N/A
Action:	N/A	
Comments:	Metal roof, solid walls, concrete staircase, concrete floor, timber and metal doors

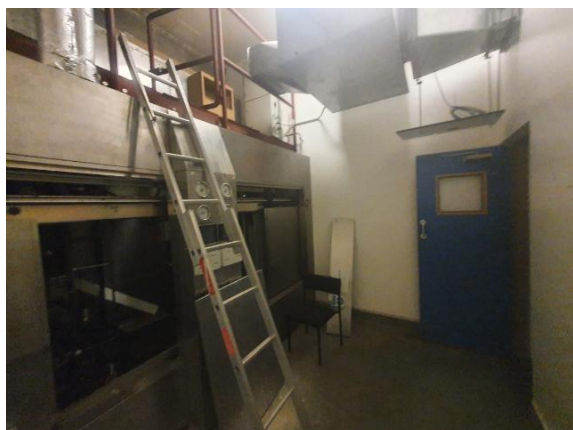
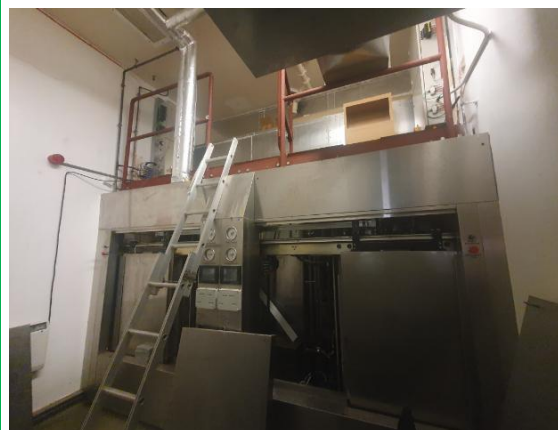
Location: Ground Floor - Machinery Room 012

Material Description:	No Suspect Materials Found	
Identification:	N/A	
Approx. quantity:	N/A	
Accessibility	N/A	<i>Assessment Score</i>
Product type:	N/A	N/A
Extent of Damage:	N/A	N/A
Surface Treatment:	N/A	N/A
Asbestos type:	N/A	N/A
Material Assessment Score:		N/A
Risk Assessment Score:		N/A
Action:	N/A	
Comments:	solid walls and ceiling, large modern machinery, timber door and frame, solid floor

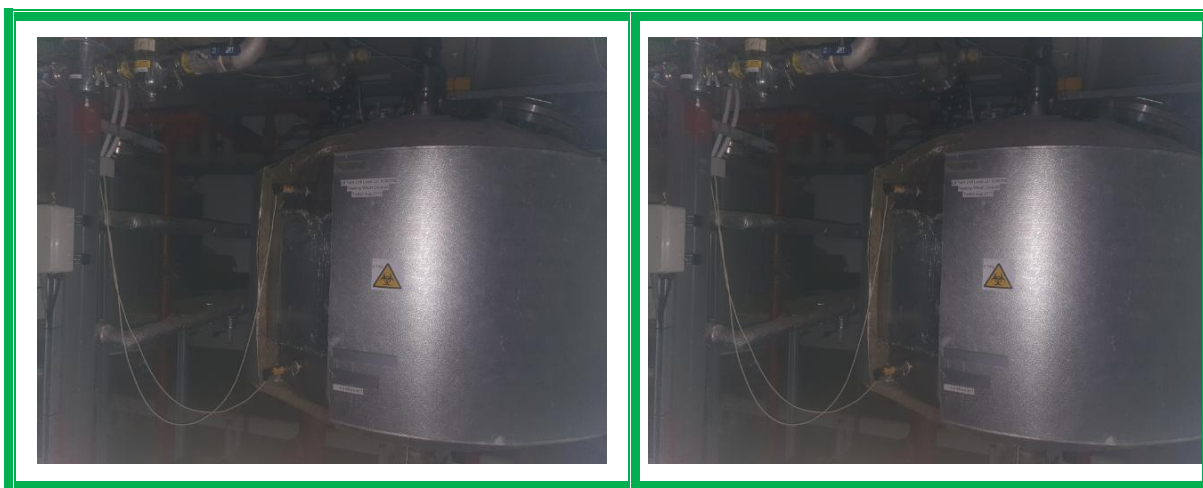
Location: Basement - Basement Machinery & Corridor 013

Material Description:	No Suspect Materials Found	
Identification:	N/A	
Approx. quantity:	N/A	
Accessibility	N/A	<i>Assessment Score</i>
Product type:	N/A	N/A
Extent of Damage:	N/A	N/A
Surface Treatment:	N/A	N/A
Asbestos type:	N/A	N/A
Material Assessment Score:		N/A
Risk Assessment Score:		N/A
Action:	N/A	
Comments:	plasterboard ceiling solid ceiling, metal pipework, modern insulation, rubber gaskets to flanges, timber and metal doors, plastic fascia's to walls, solid floor

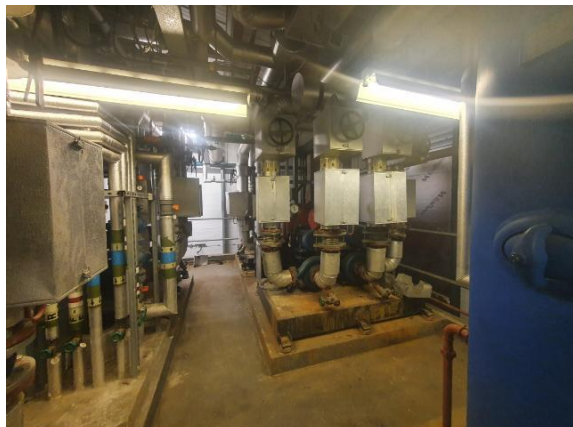
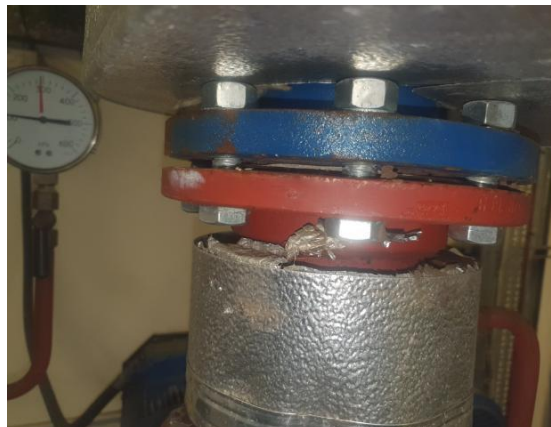
Location: First Floor - Boiler Room 014

Material Description:	Gasket - Gaskets (compressed)	
Identification:	Sampled - No Asbestos Found	
Approx. quantity:	N/A	
Accessibility	N/A	<i>Assessment Score</i>
Product type:	N/A	N/A
Extent of Damage:	N/A	N/A
Surface Treatment:	N/A	N/A
Asbestos type:	N/A	N/A
Material Assessment Score:		N/A
Risk Assessment Score:		N/A
Action:	N/A	
Comments:	<p>Metal ceiling, solid walls, timber door and frame, modern equipment and boiler, metal pipe work, modern pipe insulation, metal structural beams, solid floor</p> <p>Gaskets to pipework flanges within the boiler room</p>

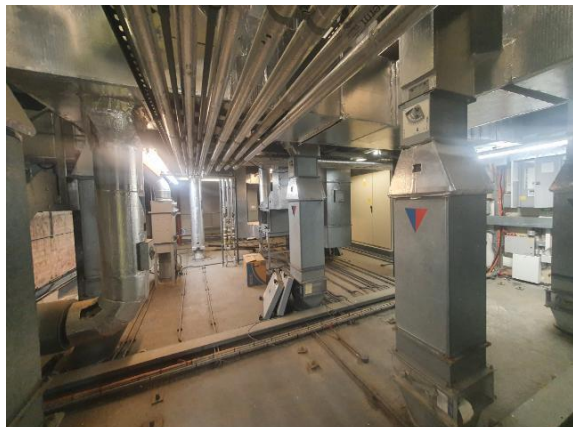
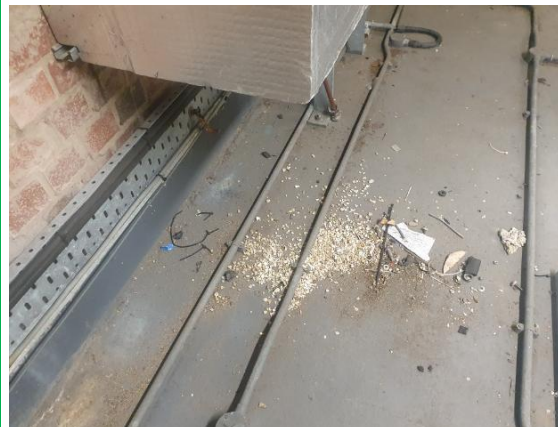
Location: First Floor - Plant Room & Mezzanine Floor 015

Material Description:	Vermiculite - Insulation	
Identification:	Sampled - No Asbestos Found	
Approx. quantity:	N/A	
Accessibility	N/A	Assessment Score
Product type:	N/A	N/A
Extent of Damage:	N/A	N/A
Surface Treatment:	N/A	N/A
Asbestos type:	N/A	N/A
Material Assessment Score:		N/A
Risk Assessment Score:		N/A
Action:	N/A	
Comments:	<p>Metal roof, solid walls, metal ducting, metal pipework with sampled gaskets, modern machinery, modern pipe insulation, modern electrical units, metal mezzanine floor, timber panels, plasterboard partition, timber and metal doors, metal staircase, solid floor</p> <p>Loose vermiculite to floor within plant room</p>

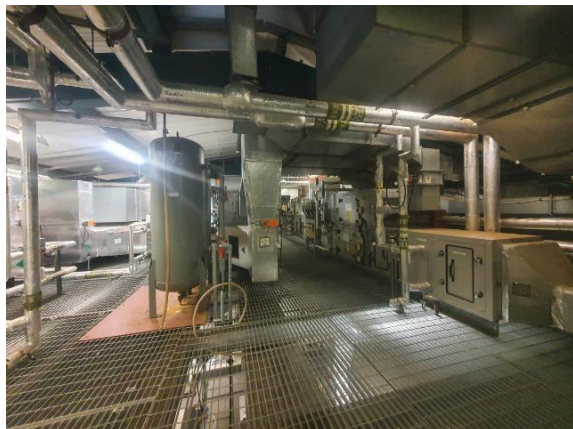
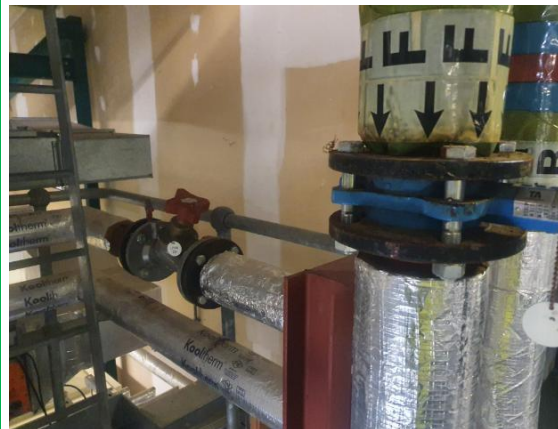
Location: First Floor - Plant Room & Mezzanine Floor 016

Material Description:	Gasket - Gaskets (compressed)	
Identification:	Sampled - No Asbestos Found	
Approx. quantity:	N/A	
Accessibility	N/A	Assessment Score
Product type:	N/A	N/A
Extent of Damage:	N/A	N/A
Surface Treatment:	N/A	N/A
Asbestos type:	N/A	N/A
Material Assessment Score:		N/A
Risk Assessment Score:		N/A
Action:	N/A	
Comments:	<p>Metal roof, solid walls, metal ducting, metal pipework with sampled gaskets, modern machinery, modern pipe insulation, modern electrical units, metal mezzanine floor, timber panels, plasterboard partition, timber and metal doors, metal staircase, solid floor</p> <p>Gaskets to flanges within metal pipework</p>

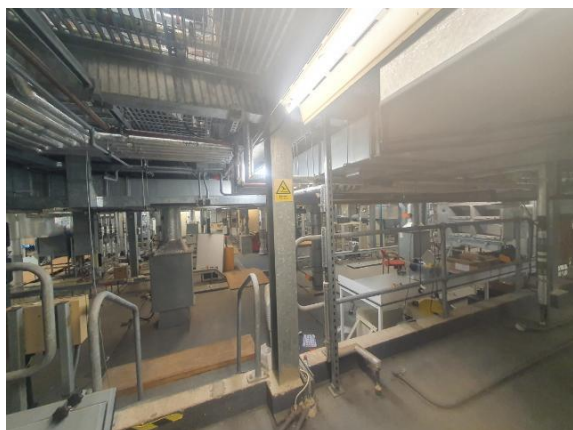
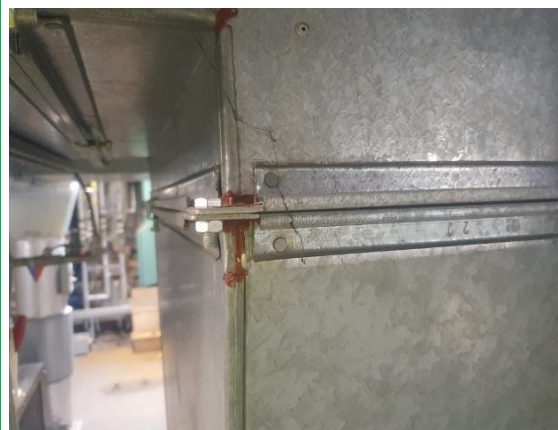
Location: First Floor - Plant Room & Mezzanine Floor 017

Material Description:	Putty - Vinyl Products	
Identification:	Sampled - No Asbestos Found	
Approx. quantity:	N/A	
Accessibility	N/A	<i>Assessment Score</i>
Product type:	N/A	N/A
Extent of Damage:	N/A	N/A
Surface Treatment:	N/A	N/A
Asbestos type:	N/A	N/A
Material Assessment Score:		N/A
Risk Assessment Score:		N/A
Action:	N/A	
Comments:	<p>Metal roof, solid walls, metal ducting, metal pipework with sampled gaskets, modern machinery, modern pipe insulation, modern electrical units, metal mezzanine floor, timber panels, plasterboard partition, timber and metal doors, metal staircase, solid floor</p> <p>Putty to metal duct work within plant room</p>
