Project Number A-01988 (6947)

**Refurbishment and Demolition
Asbestos Survey Report**

**Laboratory Buildings
Lanwades Park
Newmarket
CB8 7UA**

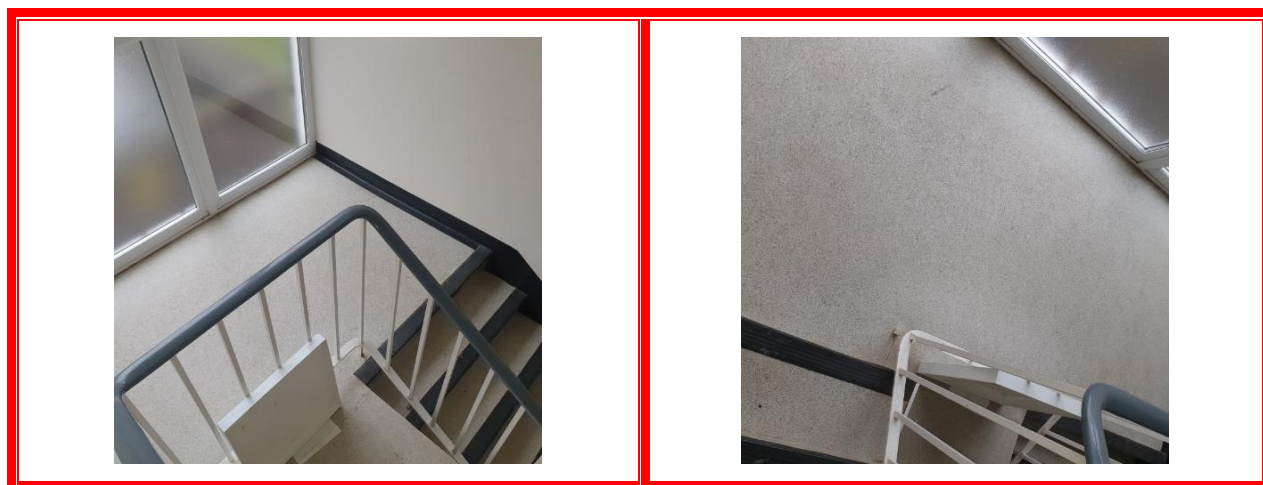
Item No:	3	Sample No:	DK/02
Location:	Laboratory Buildings, First Floor - Stairwell 003

Material Description:	Floor Tiles - Vinyl Products	
Identification:	Sampled - Asbestos Detected	
Approx. quantity:	10 m ²	
Accessibility	Difficult	Assessment Score
Product type:	Vinyl	1
Extent of Damage:	Slight / minor damage	1
Surface Treatment:	Non-friable	0
Asbestos type:	Chrysotile	1
Material Assessment Score:		3
Risk Assessment Score:		Negligible
Action:	Remove	
Comments:	Under lino to stairs

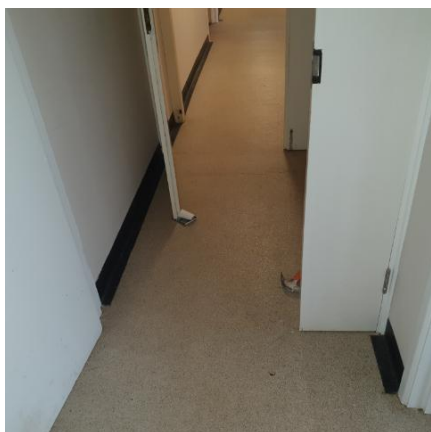
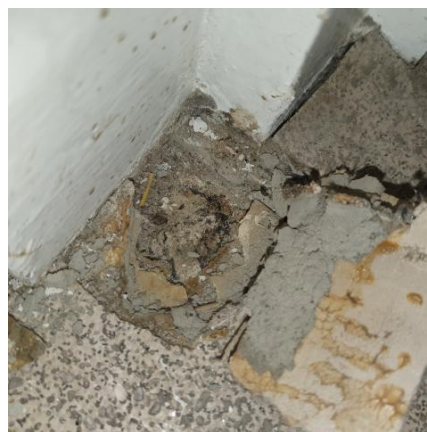
Item No: 4

Material Description:	Floor Tiles and Adhesive - Vinyl Products	
Identification:	Sampled - Asbestos Detected	
Approx. quantity:	26 m ²	
Accessibility	Difficult	Assessment Score
Product type:	Vinyl	1
Extent of Damage:	Slight / minor damage	1
Surface Treatment:	Non-friable	0
Asbestos type:	Chrysotile	1
Material Assessment Score:		3
Risk Assessment Score:		Negligible
Action:	Remove	
Comments:	Under lino and screed. Limited access under lino flooring as limited damage was possible - May be found under screed throughout. Limited access in and around ductwork above timber ceilings in corridor - Apply caution

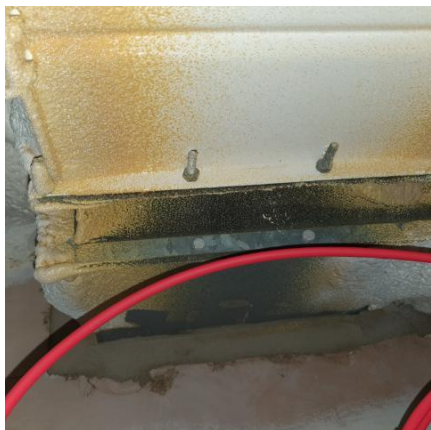
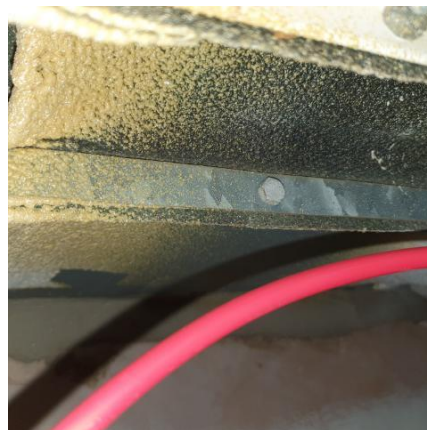
Item No: 12

Material Description:	Gater to Ductwork - Woven Product	
Identification:	Sampled - Asbestos Detected	
Approx. quantity:	Throughout ductwork	
Accessibility	Difficult	Assessment Score
Product type:	Rope	2
Extent of Damage:	Slight / minor damage	1
Surface Treatment:	Woven Material	1
Asbestos type:	Chrysotile	1
Material Assessment Score:		5
Risk Assessment Score:		Low
Action:	Remove	
Comments:	To ductwork throughout ceiling voids

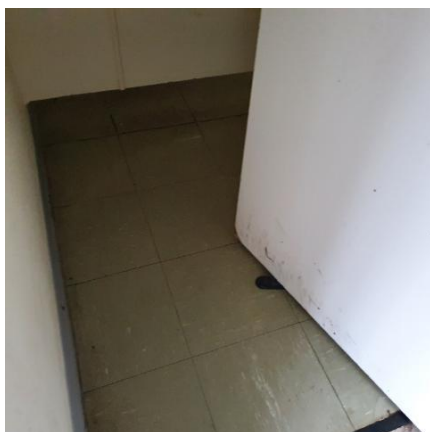
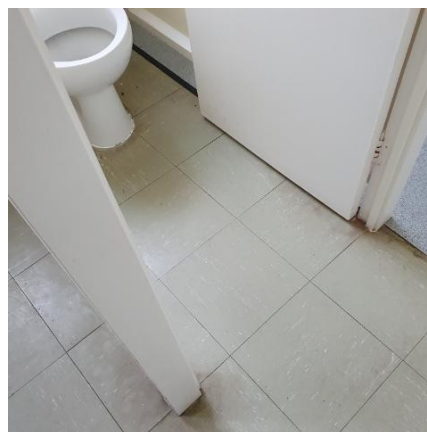
Item No: 17 **Sample No:** DK/09

Material Description:	Floor Tiles - Vinyl Products	
Identification:	Sampled - Asbestos Detected	
Approx. quantity:	36 m ²	
Accessibility	Easy	<i>Assessment Score</i>
Product type:	Vinyl	1
Extent of Damage:	Slight / minor damage	1
Surface Treatment:	Non-friable	0
Asbestos type:	Chrysotile	1
Material Assessment Score:		3
Risk Assessment Score:		Negligible
Action:	Remove	
Comments:	Concrete ceiling, solid and timber walls, modern electrics

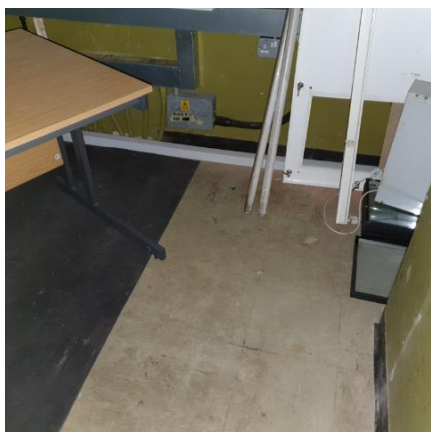
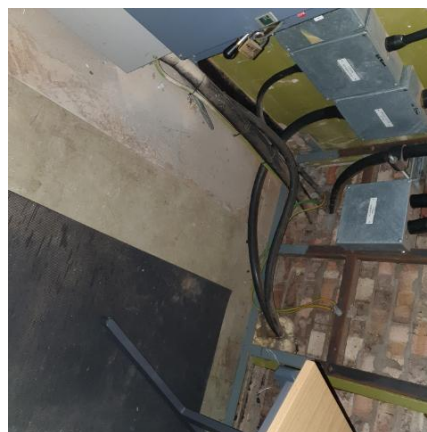
Item No: 18

Material Description:	Floor Tiles - Vinyl Products	
Identification:	As per sample DK/09 - Asbestos Detected	
Approx. quantity:	6 m ²	
Accessibility	Easy	Assessment Score
Product type:	Vinyl	1
Extent of Damage:	Slight / minor damage	1
Surface Treatment:	Non-friable	0
Asbestos type:	Chrysotile	1
Material Assessment Score:		3
Risk Assessment Score:		Negligible
Action:	Remove	
Comments:	Non asbestos electrics

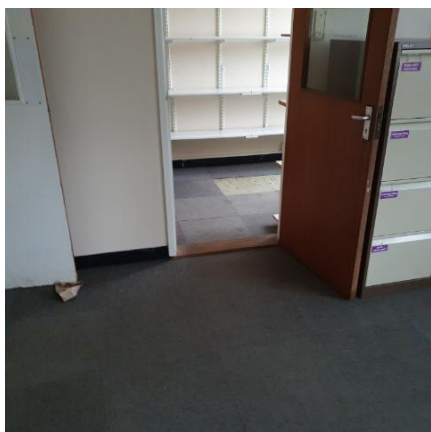
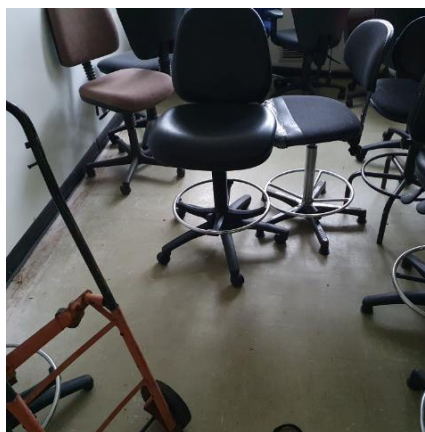
Item No: 20

Material Description:	Floor Tiles - Vinyl Products	
Identification:	As per sample DK/09 - Asbestos Detected	
Approx. quantity:	45 m ²	
Accessibility	Easy	Assessment Score
Product type:	Vinyl	1
Extent of Damage:	Slight / minor damage	1
Surface Treatment:	Non-friable	0
Asbestos type:	Chrysotile	1
Material Assessment Score:		3
Risk Assessment Score:		Negligible
Action:	Remove	
Comments:	N/A

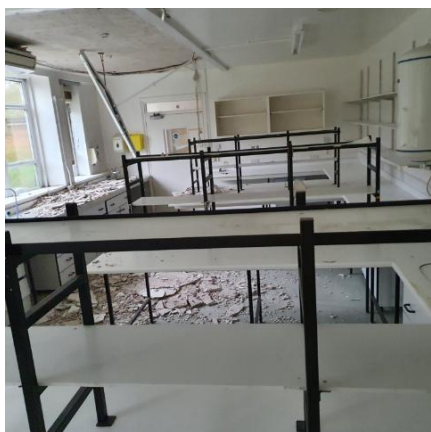
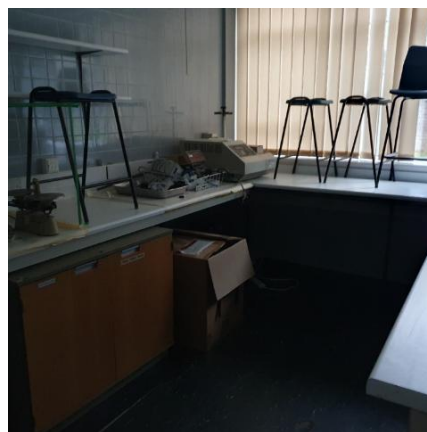
Item No: 22

Material Description:	Floor Tiles - Vinyl Products	
Identification:	As per sample DK/09 - Asbestos Detected	
Approx. quantity:	72 m ²	
Accessibility	Difficult	Assessment Score
Product type:	Vinyl	1
Extent of Damage:	Slight / minor damage	1
Surface Treatment:	Non-friable	0
Asbestos type:	Chrysotile	1
Material Assessment Score:		3
Risk Assessment Score:		Negligible
Action:	Remove	
Comments:	Under modern lino

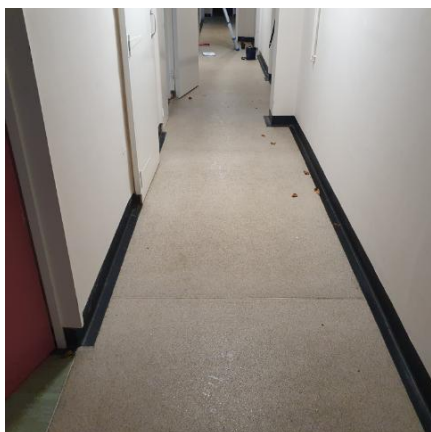
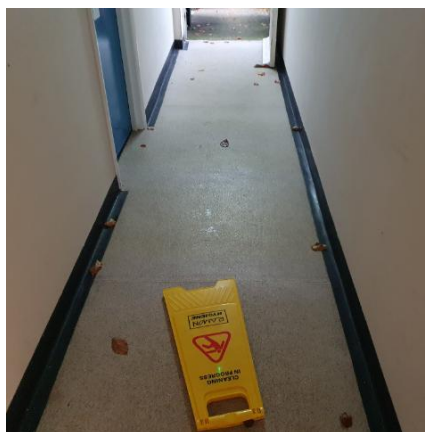
Item No: 24

Material Description:	Floor Tiles - Vinyl Products	
Identification:	Sampled - Asbestos Detected	
Approx. quantity:	30 m ²	
Accessibility	Difficult	<i>Assessment Score</i>
Product type:	Vinyl	1
Extent of Damage:	Slight / minor damage	1
Surface Treatment:	Non-friable	0
Asbestos type:	Chrysotile	1
Material Assessment Score:		3
Risk Assessment Score:		Negligible
Action:	Remove	
Comments:	Under modern lino

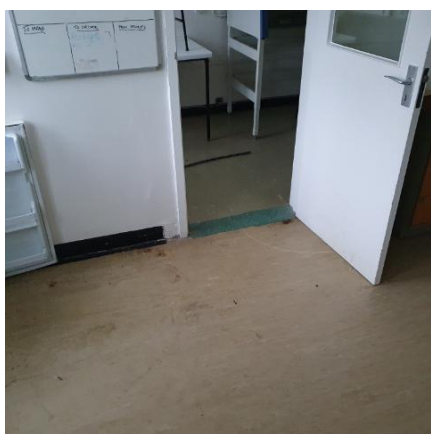
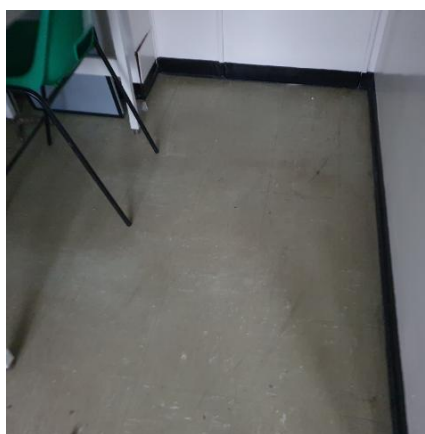
Item No: 26

Material Description:	Floor Tiles - Vinyl Products	
Identification:	Sampled - Asbestos Detected	
Approx. quantity:	24 m ²	
Accessibility	Difficult	Assessment Score
Product type:	Vinyl	1
Extent of Damage:	Slight / minor damage	1
Surface Treatment:	Non-friable	0
Asbestos type:	Chrysotile	1
Material Assessment Score:		3
Risk Assessment Score:		Negligible
Action:	Remove	
Comments:	Under modern lino

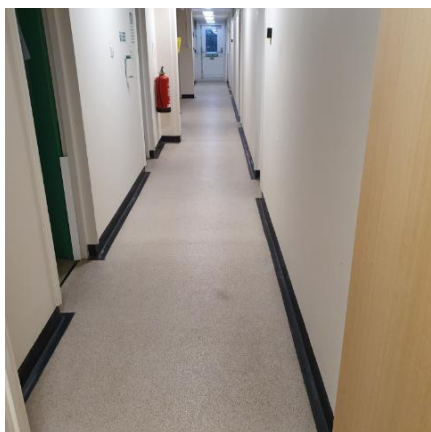
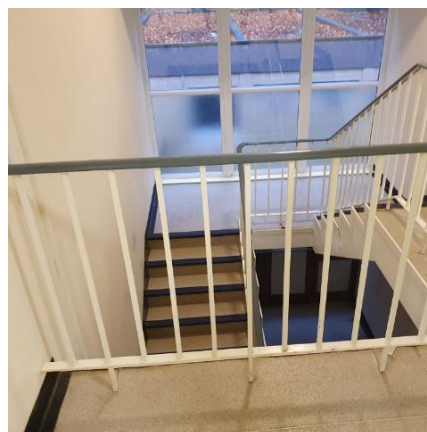
Item No: 28 **Sample No:** N/A

Material Description:	Floor Tiles - Vinyl Products	
Identification:	As per sample DK/13 - Asbestos Detected	
Approx. quantity:	42 m ²	
Accessibility	Difficult	Assessment Score
Product type:	Vinyl	1
Extent of Damage:	Slight / minor damage	1
Surface Treatment:	Non-friable	0
Asbestos type:	Chrysotile	1
Material Assessment Score:		3
Risk Assessment Score:		Negligible
Action:	Remove	
Comments:	Under modern lino. Modern electrics. Plasterboard, solid and timber walls, timber ceiling with concrete above

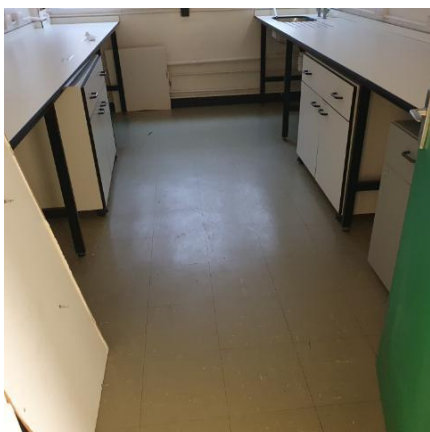
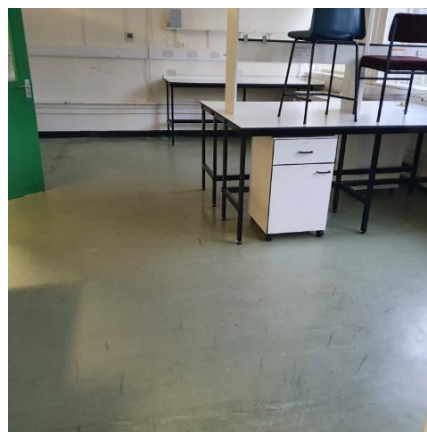
Item No: 29

Material Description:	Floor Tiles - Vinyl Products	
Identification:	As per sample DK/13 - Asbestos Detected	
Approx. quantity:	124 m ²	
Accessibility	Difficult	Assessment Score
Product type:	Vinyl	1
Extent of Damage:	Slight / minor damage	1
Surface Treatment:	Non-friable	0
Asbestos type:	Chrysotile	1
Material Assessment Score:		3
Risk Assessment Score:		Negligible
Action:	Remove	
Comments:	Under modern lino in 12/13.

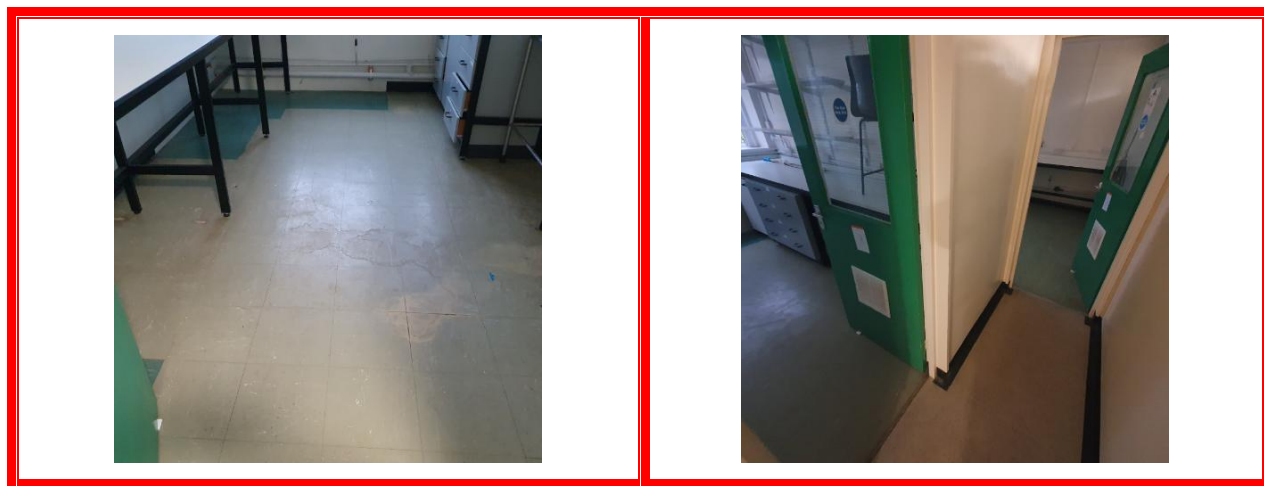
Item No:	31	Sample No:	N/A
Location:	Laboratory Buildings, Ground Floor - Block A - Rooms 5,6,7,8, 14 and 15 031

Material Description:	Floor Tiles - Vinyl Products	
Identification:	As per sample DK/13 - Asbestos Detected	
Approx. quantity:	62 m ²	
Accessibility	Easy	Assessment Score
Product type:	Vinyl	1
Extent of Damage:	Slight / minor damage	1
Surface Treatment:	Non-friable	0
Asbestos type:	Chrysotile	1
Material Assessment Score:		3
Risk Assessment Score:		Negligible
Action:	Remove	
Comments:	N/A

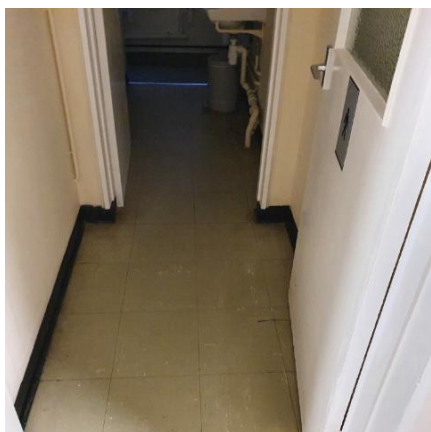
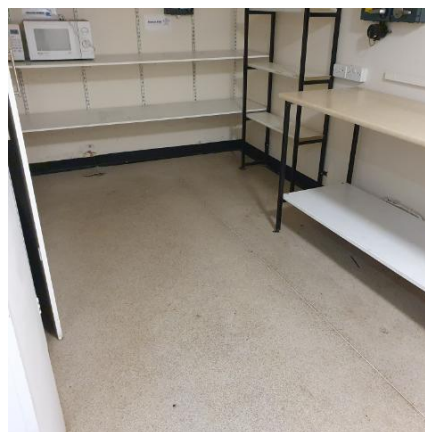
Item No: 32

Material Description:	Floor Tiles - Vinyl Products	
Identification:	As per sample DK/13 - Asbestos Detected	
Approx. quantity:	m ²	
Accessibility	Easy	Assessment Score
Product type:	Vinyl	1
Extent of Damage:	Slight / minor damage	1
Surface Treatment:	Non-friable	0
Asbestos type:	Chrysotile	1
Material Assessment Score:		3
Risk Assessment Score:		Negligible
Action:	Remove	
Comments:	Under lino and exposed. Non asbestos electrics

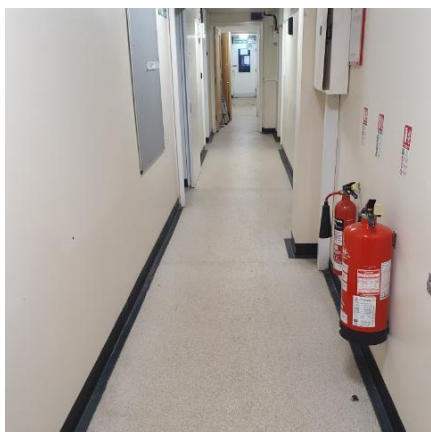
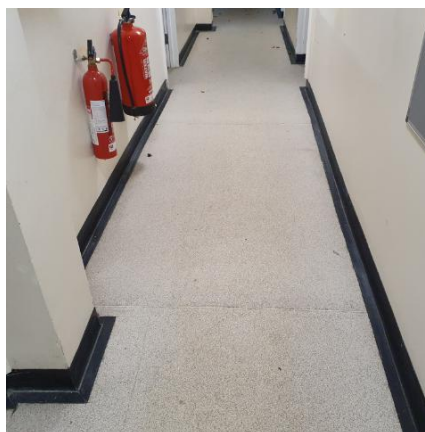
Item No: 33

Material Description:	Floor Tiles - Vinyl Products	
Identification:	As per sample DK/13 - Asbestos Detected	
Approx. quantity:	42 m ²	
Accessibility	Easy	Assessment Score
Product type:	Vinyl	1
Extent of Damage:	Slight / minor damage	1
Surface Treatment:	Non-friable	0
Asbestos type:	Chrysotile	1
Material Assessment Score:		3
Risk Assessment Score:		Negligible
Action:	Remove	
Comments:	Under lino. Plasterboard and solid walls.

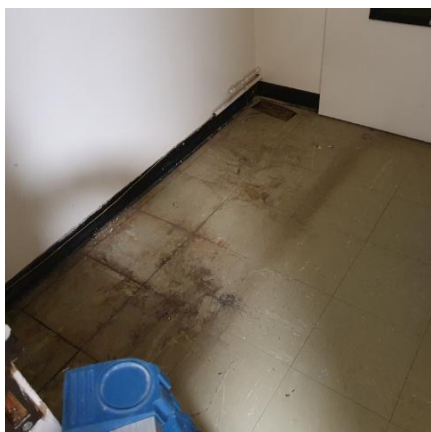
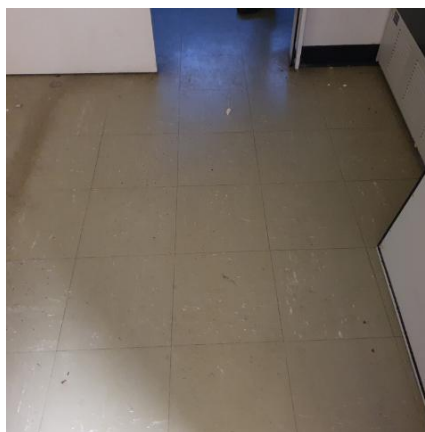
Item No: 34

Material Description:	Floor Tiles - Vinyl Products	
Identification:	As per sample DK/13 - Asbestos Detected	
Approx. quantity:	10 m ²	
Accessibility	Easy	Assessment Score
Product type:	Vinyl	1
Extent of Damage:	Slight / minor damage	1
Surface Treatment:	Non-friable	0
Asbestos type:	Chrysotile	1
Material Assessment Score:		3
Risk Assessment Score:		Negligible
Action:	Remove	
Comments:	N/A

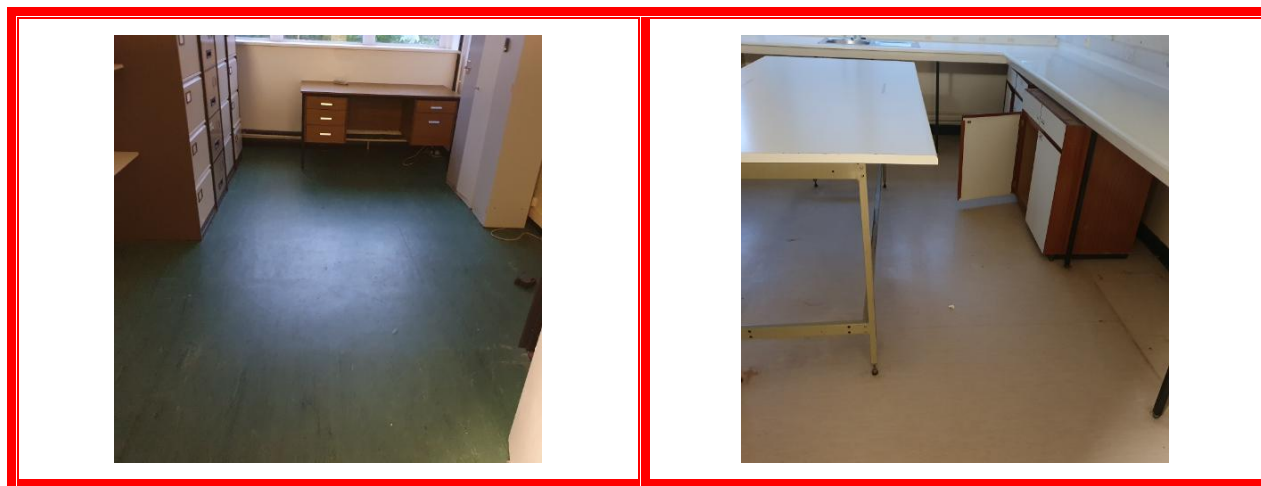
Item No:	35	Sample No:	N/A
Location:	Laboratory Buildings, Ground Floor - Block A - Rooms 28 and 29 035

Material Description:	Floor Tiles - Vinyl Products	
Identification:	As per sample DK/13 - Asbestos Detected	
Approx. quantity:	35 m ²	
Accessibility	Difficult	Assessment Score
Product type:	Vinyl	1
Extent of Damage:	Slight / minor damage	1
Surface Treatment:	Non-friable	0
Asbestos type:	Chrysotile	1
Material Assessment Score:		3
Risk Assessment Score:		Negligible
Action:	Remove	
Comments:	Under modern lino

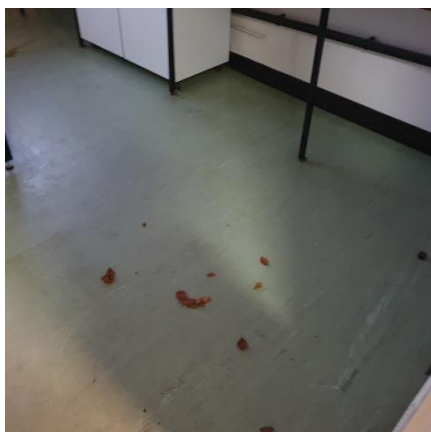
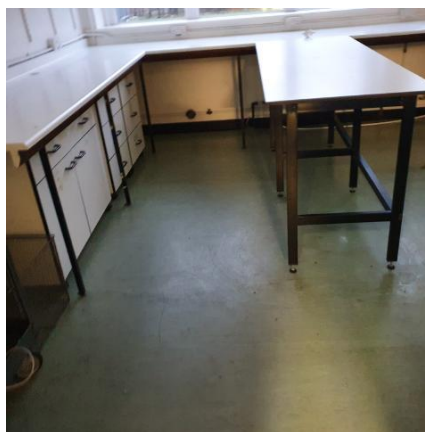
Item No: 37

Material Description:	Floor Tiles - Vinyl Products	
Identification:	As per sample DK/13 - Asbestos Detected	
Approx. quantity:	20 m ²	
Accessibility	Difficult	Assessment Score
Product type:	Vinyl	1
Extent of Damage:	Slight / minor damage	1
Surface Treatment:	Non-friable	0
Asbestos type:	Chrysotile	1
Material Assessment Score:		3
Risk Assessment Score:		Negligible
Action:	Remove	
Comments:	Under modern lino

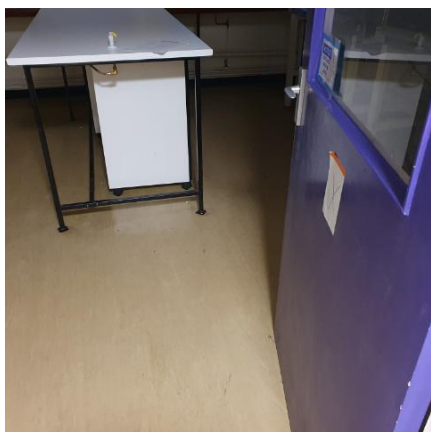
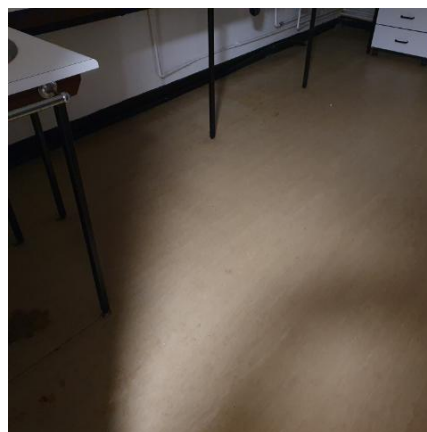
Item No: 38

Material Description:	Floor Tiles - Vinyl Products	
Identification:	As per sample DK/13 - Asbestos Detected	
Approx. quantity:	20 m ²	
Accessibility	Difficult	Assessment Score
Product type:	Vinyl	1
Extent of Damage:	Slight / minor damage	1
Surface Treatment:	Non-friable	0
Asbestos type:	Chrysotile	1
Material Assessment Score:		3
Risk Assessment Score:		Negligible
Action:	Remove	
Comments:	Under modern lino

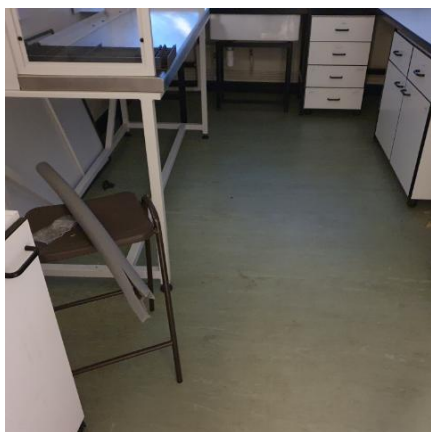
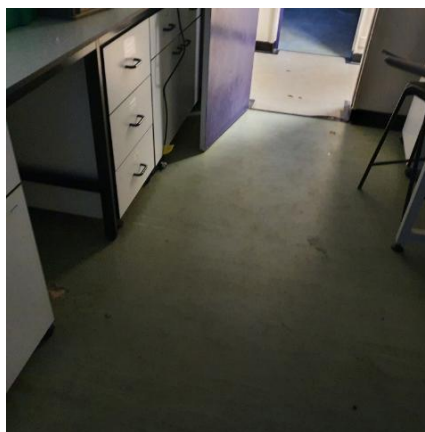
Item No: 40

Material Description:	Floor Tiles - Vinyl Products	
Identification:	As per sample DK/13 - Asbestos Detected	
Approx. quantity:	12 m ²	
Accessibility	Difficult	Assessment Score
Product type:	Vinyl	1
Extent of Damage:	Slight / minor damage	1
Surface Treatment:	Non-friable	0
Asbestos type:	Chrysotile	1
Material Assessment Score:		3
Risk Assessment Score:		Negligible
Action:	Remove	
Comments:	Under modern lino

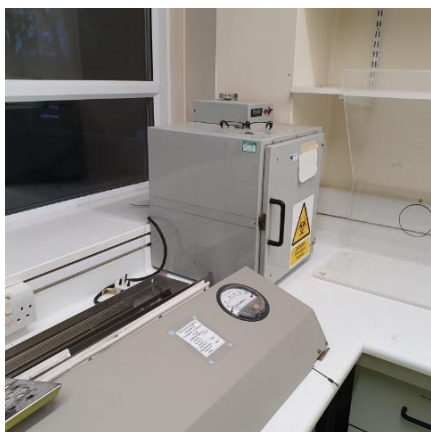
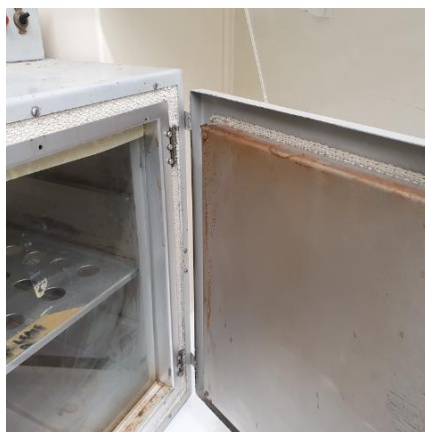
Item No: 41

Material Description:	Rope Seal to Equipment - Gaskets (rope/woven)	
Identification:	Sampled - Asbestos Detected	
Approx. quantity:	1 no	
Accessibility	Difficult	Assessment Score
Product type:	Rope	2
Extent of Damage:	Slight / minor damage	1
Surface Treatment:	Woven Material	1
Asbestos type:	Chrysotile	1
Material Assessment Score:		5
Risk Assessment Score:		Low
Action:	Remove	
Comments:	Concrete under lino

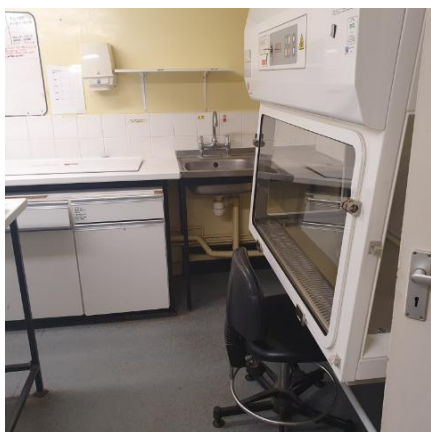
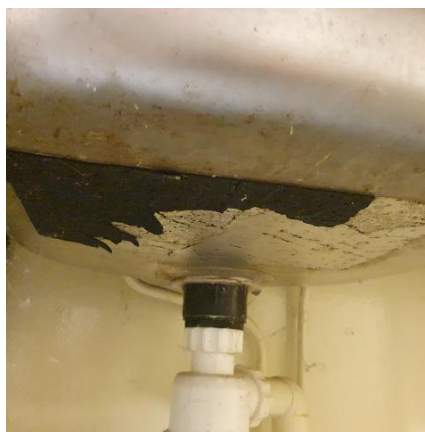
Item No: 51

Material Description:	Sink Pad - Bituminous Product	
Identification:	Sampled - Asbestos Detected	
Approx. quantity:	1 no	
Accessibility	Medium	Assessment Score
Product type:	Bitumen	1
Extent of Damage:	Moderate damage	2
Surface Treatment:	Non-friable	0
Asbestos type:	Chrysotile	1
Material Assessment Score:		4
Risk Assessment Score:		Negligible
Action:	Remove	
Comments:	Plasterboard ceiling
