Project Number A-02002 (6724)

**Refurbishment and Demolition
Asbestos Survey Report**

**Visitor Centre
Lanwades Park
Newmarket
CN8 7UA**

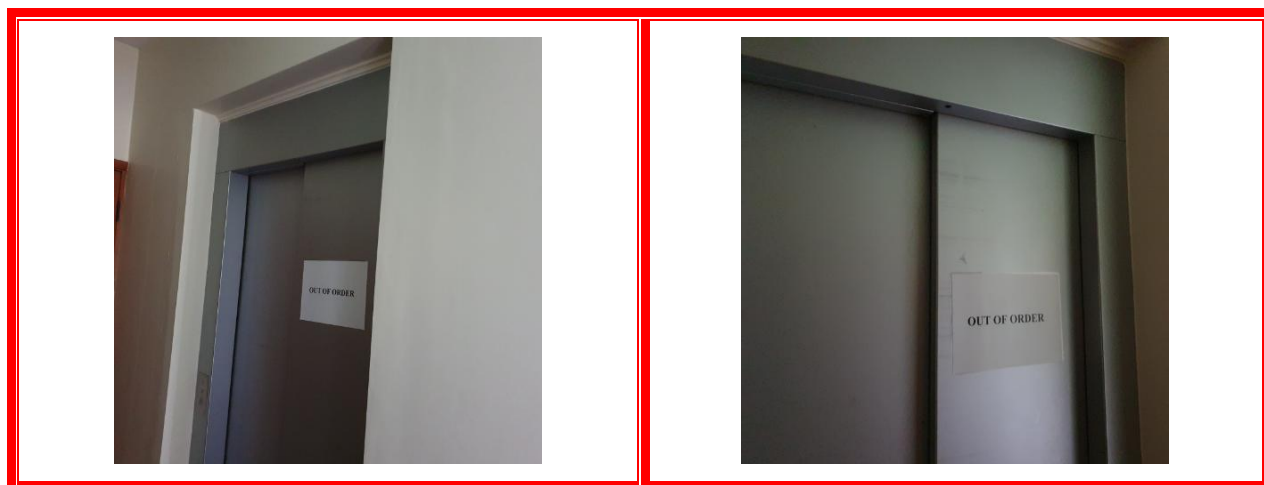
Item No:	14	Sample No:	N/A
Location:	First Floor - Lift Shaft 014

Material Description:	All - No Access Gained	
Identification:	Presumed to Contain Asbestos	
Approx. quantity:	1 no	
Accessibility	Difficult	Assessment Score
Product type:	Presumed	3
Extent of Damage:	Major damage	3
Surface Treatment:	Unsealed Insulation	3
Asbestos type:	Amosite, Chrysotile, Crocidolite	3
Material Assessment Score:		12
Risk Assessment Score:		High
Action:	Further Investigation Needed	
Comments:	No access within lift shaft as no lift engineer on site.

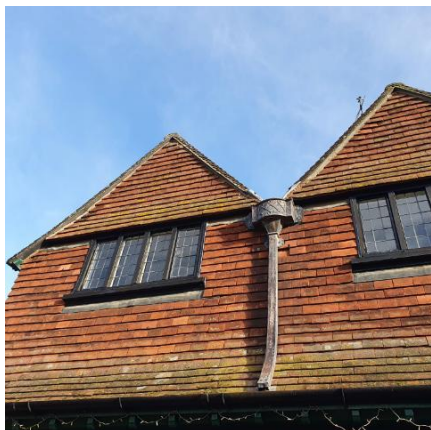
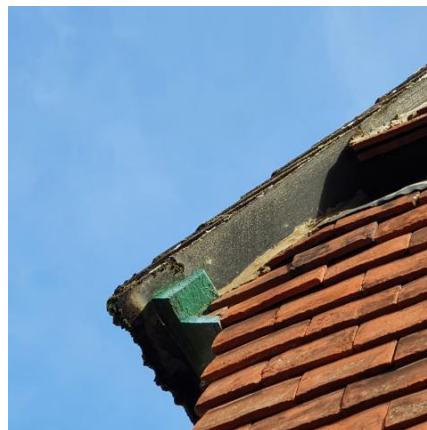
Item No: 29

Material Description:	Undercloaking - Cement Product	
Identification:	Sampled - Asbestos Detected	
Approx. quantity:	38 LM	
Accessibility	Difficult	Assessment Score
Product type:	Cement	1
Extent of Damage:	Slight / minor damage	1
Surface Treatment:	Non-friable	0
Asbestos type:	Chrysotile	1
Material Assessment Score:		3
Risk Assessment Score:		Negligible
Action:	Remove	
Comments:	Non-asbestos roof tiles

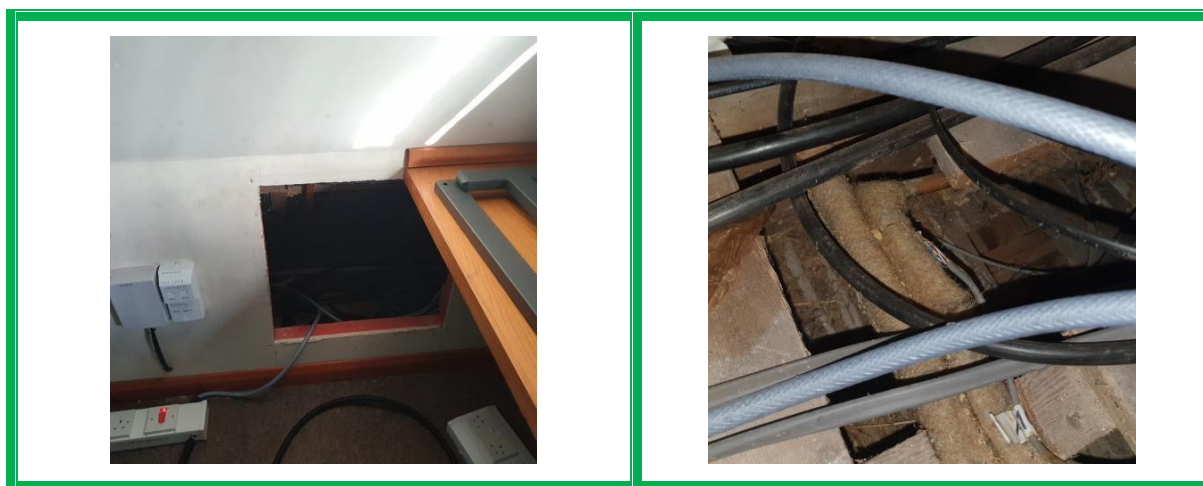
Item No:	1	Sample No:	DK/01
Location:	First Floor - Workshop 001

Material Description:	Hessian Pipework Insulation - Woven Product	
Identification:	Sampled - No Asbestos Found	
Approx. quantity:	N/A	
Accessibility	N/A	<i>Assessment Score</i>
Product type:	N/A	N/A
Extent of Damage:	N/A	N/A
Surface Treatment:	N/A	N/A
Asbestos type:	N/A	N/A
Material Assessment Score:		N/A
Risk Assessment Score:		N/A
Action:	N/A	
Comments:	Located to pipework within eaves and likely found throughout building

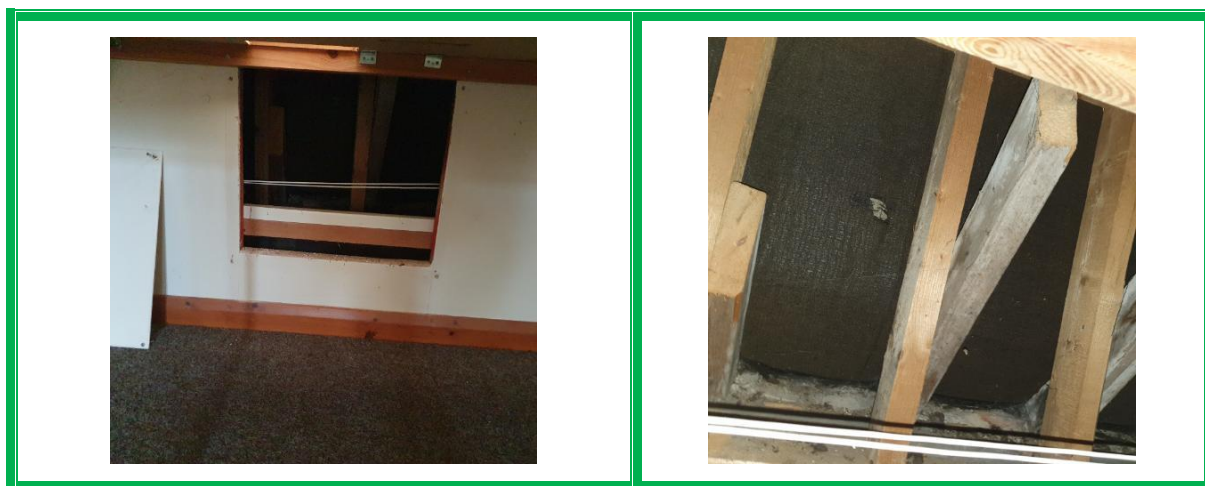
Item No: 2

Material Description:	Felt to Underside of Roof - Bituminous Product	
Identification:	Sampled - No Asbestos Found	
Approx. quantity:	N/A	
Accessibility	N/A	<i>Assessment Score</i>
Product type:	N/A	N/A
Extent of Damage:	N/A	N/A
Surface Treatment:	N/A	N/A
Asbestos type:	N/A	N/A
Material Assessment Score:		N/A
Risk Assessment Score:		N/A
Action:	N/A	
Comments:	Visible within plasterboard eave boxing. Plasterboard walls/ceilings. Rubber stair nosing

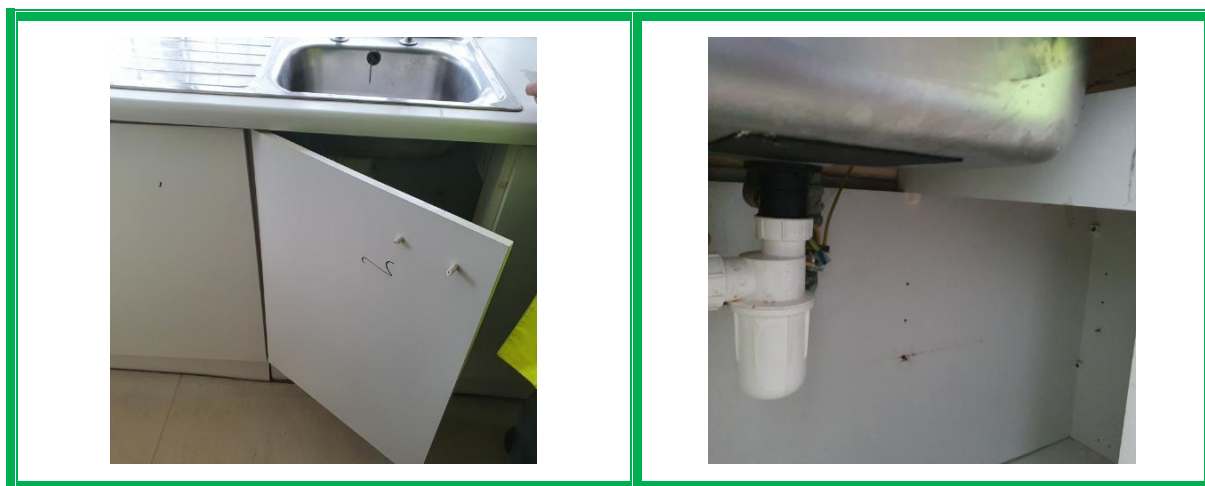
Item No: 3

Material Description:	Sink Pad - Bituminous Product	
Identification:	Sampled - No Asbestos Found	
Approx. quantity:	N/A	
Accessibility	N/A	<i>Assessment Score</i>
Product type:	N/A	N/A
Extent of Damage:	N/A	N/A
Surface Treatment:	N/A	N/A
Asbestos type:	N/A	N/A
Material Assessment Score:		N/A
Risk Assessment Score:		N/A
Action:	N/A	
Comments:	Plasterboard and solid walls, modern lino flooring, plasterboard ceiling

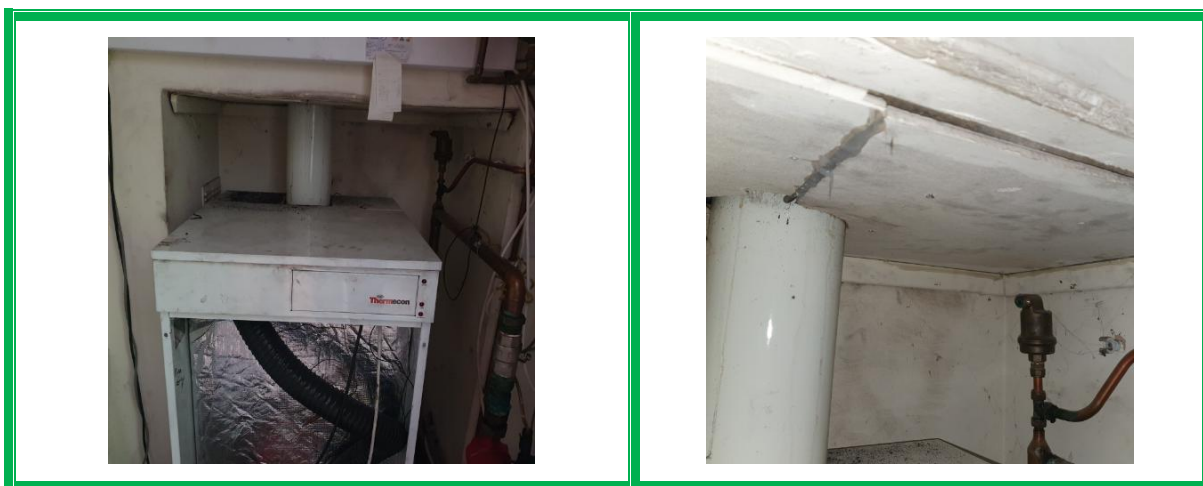
Item No: 4

Material Description:	Panel above Boiler - Insulating Board	
Identification:	Sampled - No Asbestos Found	
Approx. quantity:	N/A	
Accessibility	N/A	<i>Assessment Score</i>
Product type:	N/A	N/A
Extent of Damage:	N/A	N/A
Surface Treatment:	N/A	N/A
Asbestos type:	N/A	N/A
Material Assessment Score:		N/A
Risk Assessment Score:		N/A
Action:	N/A	
Comments:	Plasterboard walls and ceiling. Non-asbestos Thermocon boiler

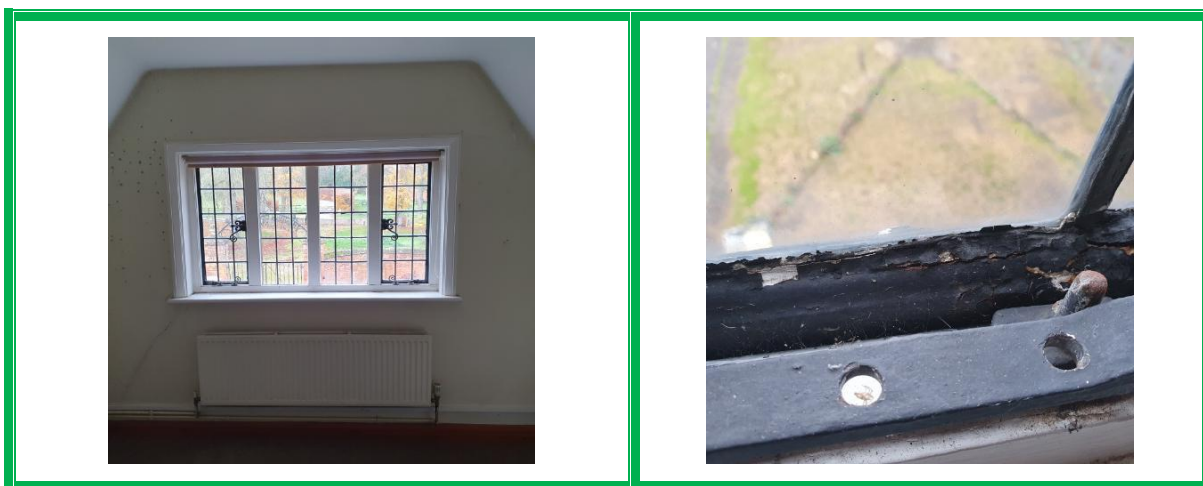
Item No: 5

Material Description:	Putty to Windows - PVC / Reinforced Plastics	
Identification:	Sampled - No Asbestos Found	
Approx. quantity:	N/A	
Accessibility	N/A	<i>Assessment Score</i>
Product type:	N/A	N/A
Extent of Damage:	N/A	N/A
Surface Treatment:	N/A	N/A
Asbestos type:	N/A	N/A
Material Assessment Score:		N/A
Risk Assessment Score:		N/A
Action:	N/A	
Comments:	Treat as uniform to windows throughout building. Solid panel to fireplace. Plasterboard and solid walls.

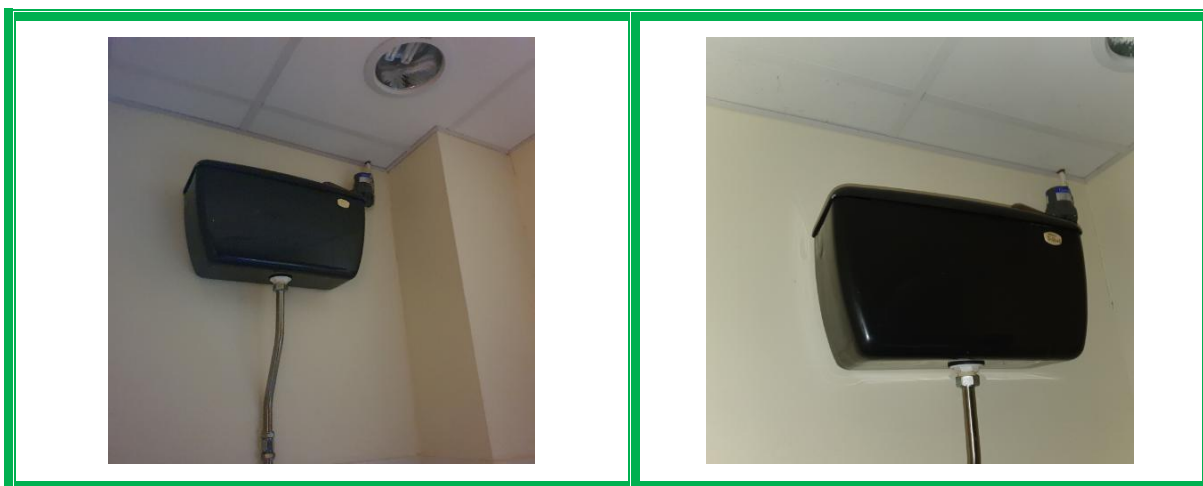
Item No: 19

Material Description:	Cistern - PVC / Reinforced Plastics	
Identification:	Sampled - No Asbestos Found	
Approx. quantity:	N/A	
Accessibility	N/A	<i>Assessment Score</i>
Product type:	N/A	N/A
Extent of Damage:	N/A	N/A
Surface Treatment:	N/A	N/A
Asbestos type:	N/A	N/A
Material Assessment Score:		N/A
Risk Assessment Score:		N/A
Action:	N/A	
Comments:	Plasterboard walls and ceilings. Modern lino flooring

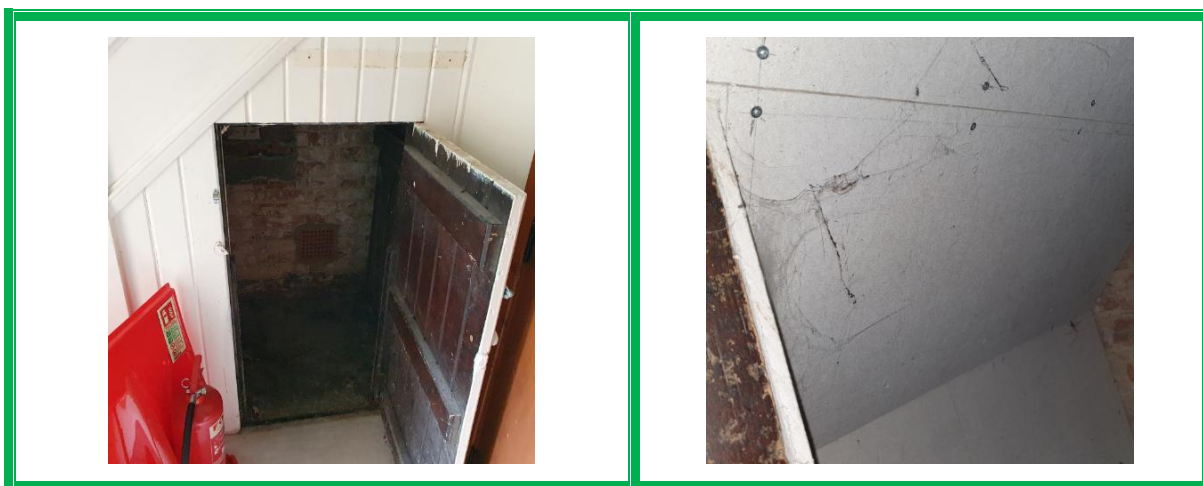
Item No: 22

Material Description:	Ceiling and Wall - Insulating Board	
Identification:	Sampled - No Asbestos Found	
Approx. quantity:	N/A	
Accessibility	N/A	<i>Assessment Score</i>
Product type:	N/A	N/A
Extent of Damage:	N/A	N/A
Surface Treatment:	N/A	N/A
Asbestos type:	N/A	N/A
Material Assessment Score:		N/A
Risk Assessment Score:		N/A
Action:	N/A	
Comments:	N/A

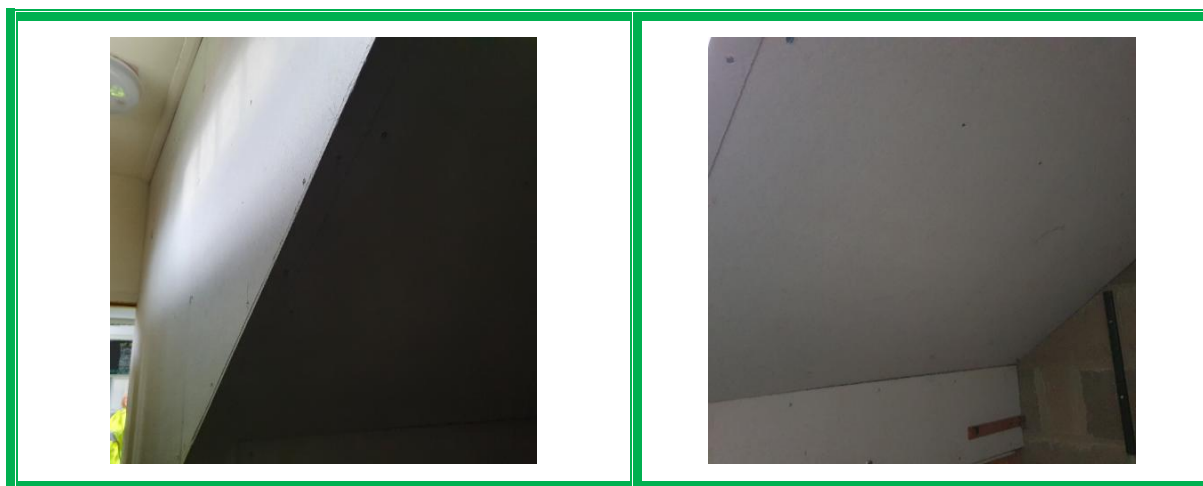
Item No:	26	Sample No:	DK/08
Location:	Ground Floor - Lift Motor Room 026

Material Description:	Ceiling - Insulating Board	
Identification:	Sampled - No Asbestos Found	
Approx. quantity:	N/A	
Accessibility	N/A	<i>Assessment Score</i>
Product type:	N/A	N/A
Extent of Damage:	N/A	N/A
Surface Treatment:	N/A	N/A
Asbestos type:	N/A	N/A
Material Assessment Score:		N/A
Risk Assessment Score:		N/A
Action:	N/A	
Comments:	Modern electrics and lift motor

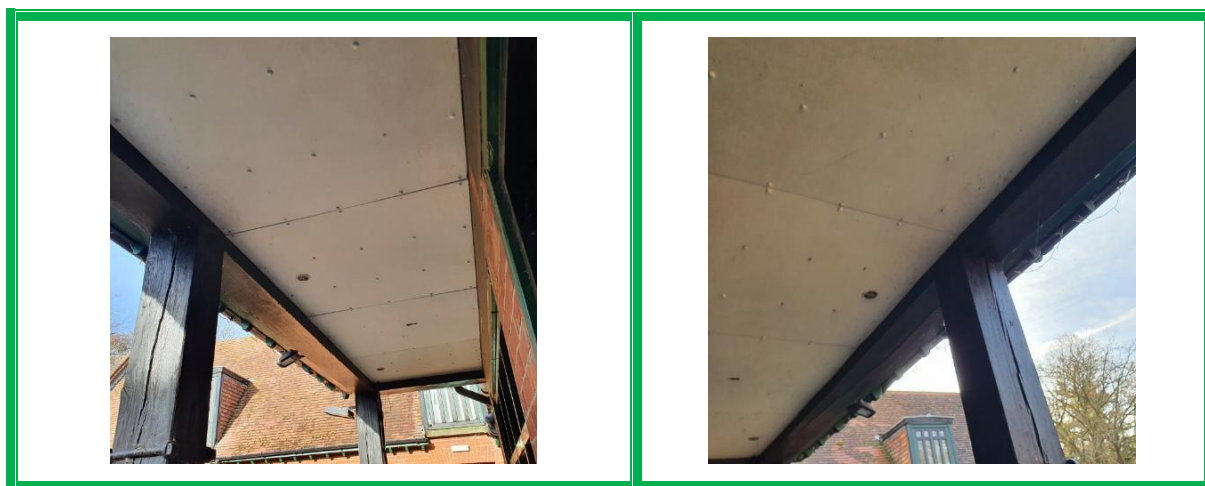
Item No: 28

Material Description:	Soffit - Insulating Board	
Identification:	Sampled - No Asbestos Found	
Approx. quantity:	N/A	
Accessibility	N/A	<i>Assessment Score</i>
Product type:	N/A	N/A
Extent of Damage:	N/A	N/A
Surface Treatment:	N/A	N/A
Asbestos type:	N/A	N/A
Material Assessment Score:		N/A
Risk Assessment Score:		N/A
Action:	N/A	
Comments:	Timber high level soffits
