Ground Conditions - Technical Note

Lanwades Park

Kentford, Newmarket

May 2025

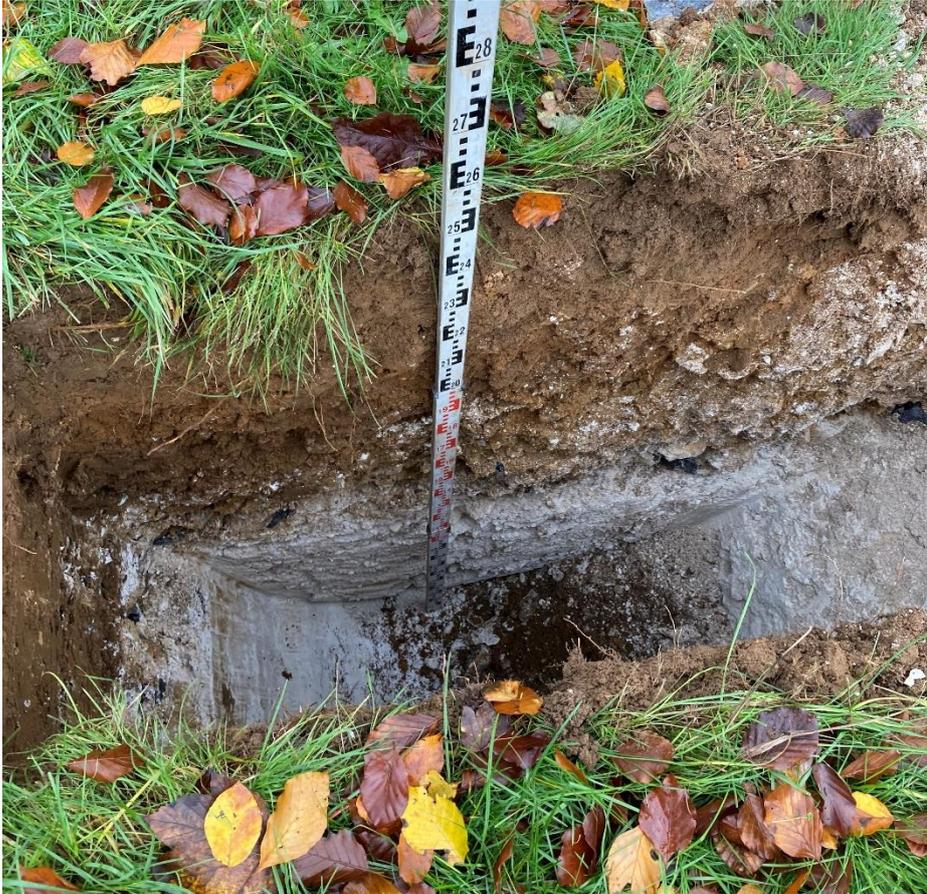
Figure 6-1: Topsoil within TP15

- 6.2.1 □ Topsoil was encountered in all exploratory holes, with the exception of HP02, HP03 and TP04. The base of the unit varied between 0.1m and 1.0m thick. The Topsoil comprises dark brown, gravelly, sandy clay with gravel consisting of flint.
- 6.2.2 □ A typical photograph of topsoil deposits encountered is presented below.

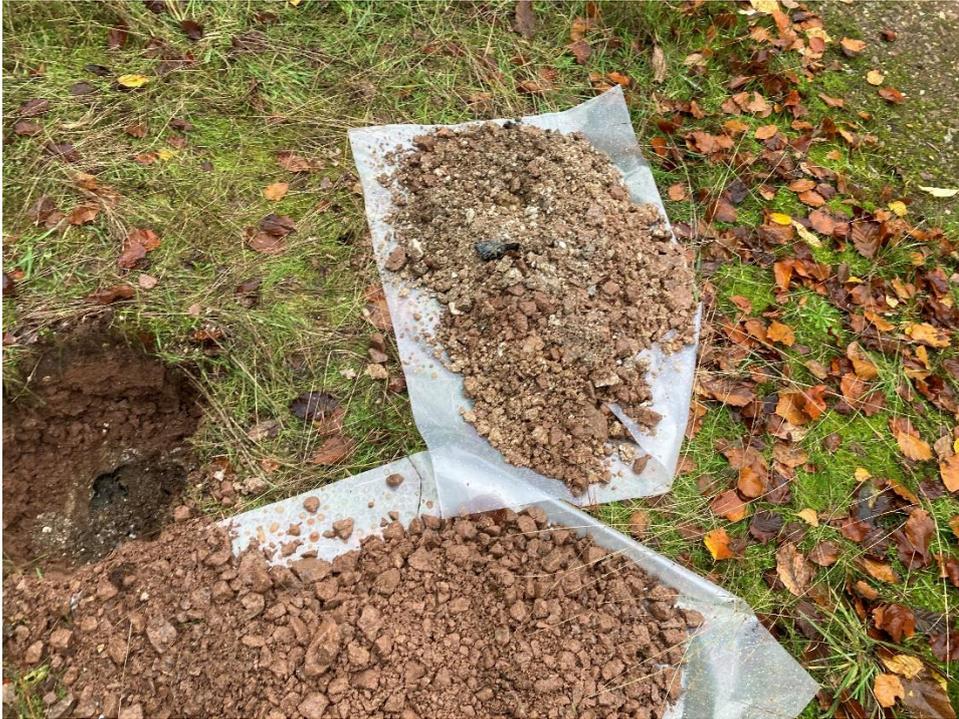
Figure 6-2: Made Ground in HP03

- 6.3.2□ Made Ground is variable but generally comprises grey and light brown, slightly sandy to sandy, clayey gravel or gravelly, slightly clayey sand and light brown and light grey, slightly sandy, slightly gravelly clay. Gravels consist of chalk, flint, brick, clinker, concrete and sandstone. Occasional wood and fabric are present in the cohesive deposits in TP04 to the north of the incinerator building. Staining and a strong hydrocarbon odour were also noted between 0.6m and 1.20m in this area.

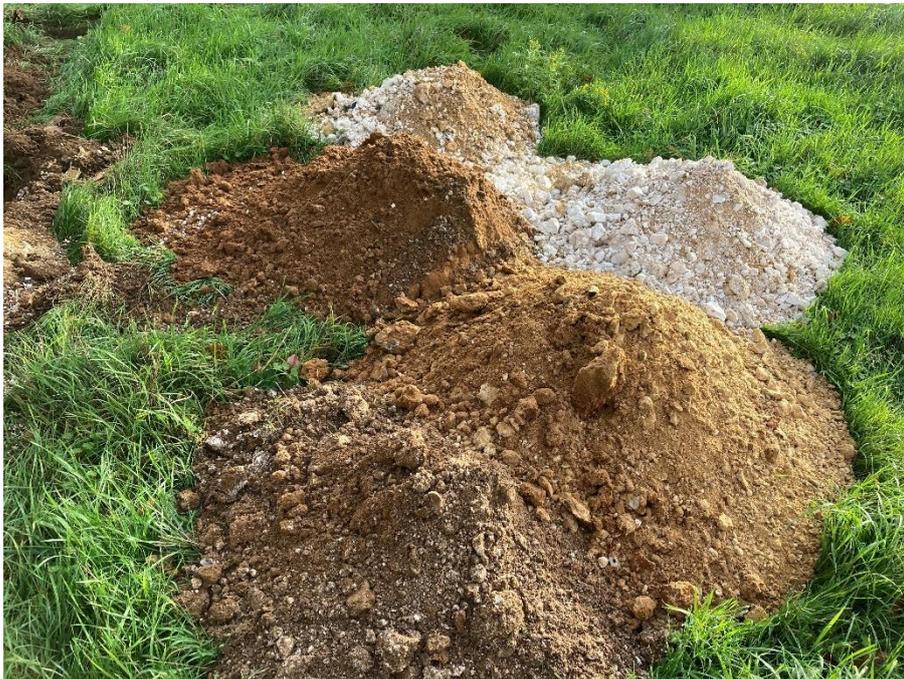
Figure 6-5 Quaternary Deposits taken from TP14.

- 6.4.3 □ Such deposits are likely to be part of the Lowestoft Formation, though the variability and locally low strength provides some doubt, with such deposits also reminiscent of alluvial and/or Head deposits and as such have been given the more generic term of Quaternary Deposits.

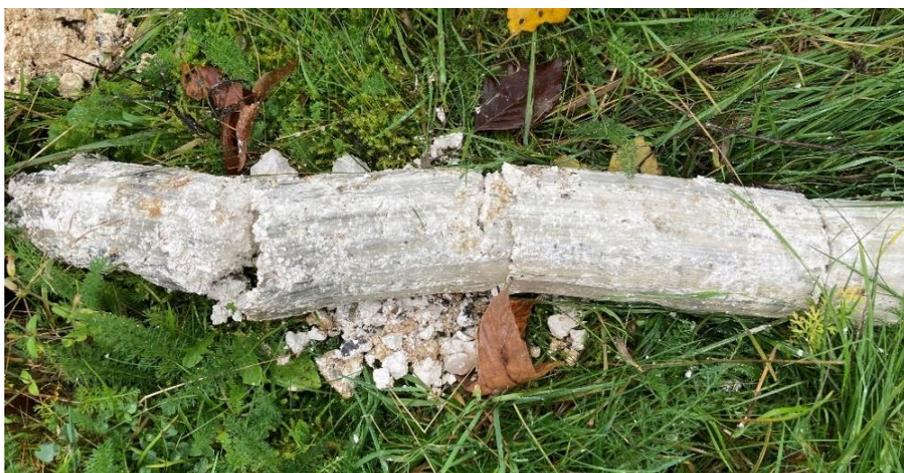
Figure 6-6: Chalk – Grade Dm from WS03

6.5.2 □ Generally, the Chalk Formation comprised structureless chalk composed of sandy gravel with varying concentrations of clay (Grade Dc). Gravels were weak to moderately weak, low to medium density and varied in colour from light brown to white. Occasional to frequent flint gravels were also present. In two boreholes, the Chalk comprised a gravelly sandy clay (Grade Dm). However, SPTs refused at the base of the boreholes suggesting more competent Grade Dc soils below.

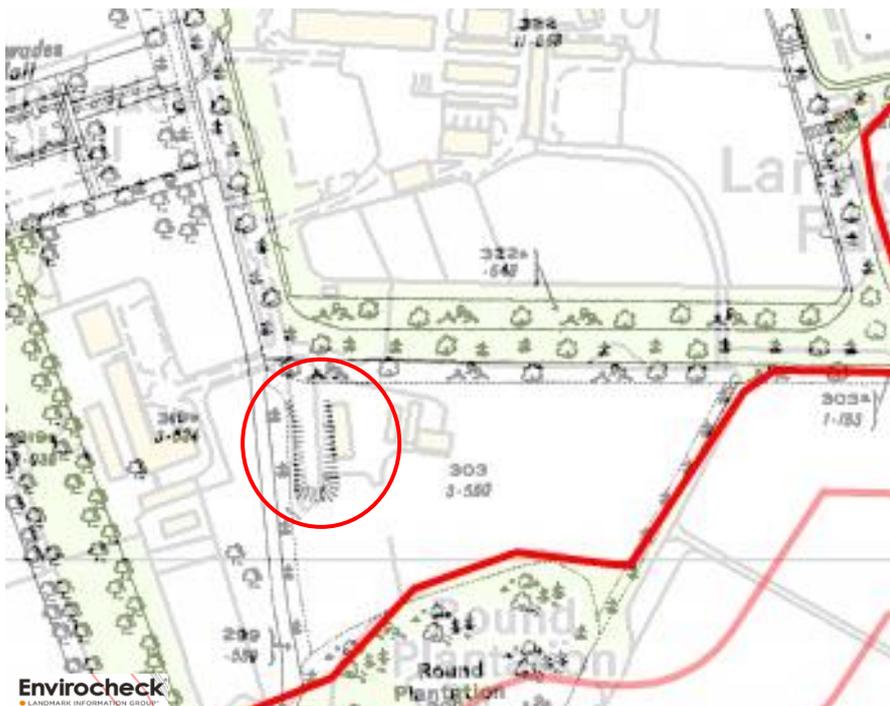
Figure 7-1: Mapping overlays from 1926 and 2006 showing existing layout and location of former quarry

- 7.4.2□ Based on historical maps, a backfilled quarry is likely to be present on site as indicated by the red circle on Figure 7-1. This area lies below an existing building and access way and investigations have not been undertaken in this location at this time. This is likely to be an area of deep Made Ground and may require further investigation depending on development proposals. Again, a piled foundation solution may be required in this area should buildings be proposed over the former quarry.

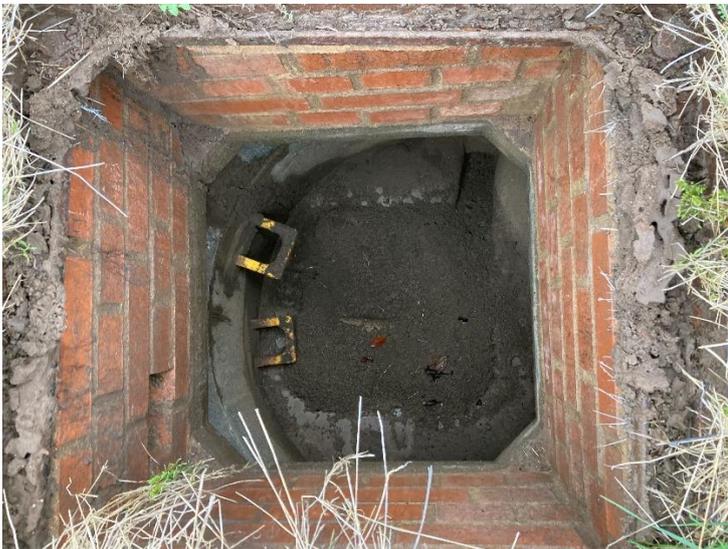
Figure 8-1: View of existing drainage

8.10.2□ Some drainage runs appeared to be clear although others included some soils/silts. No sampling or testing was undertaken due to possible risk to personnel. Further assessment of the materials within the drainage system may be required.

- 2.10.2□ Some drainage runs appeared to be clear although others included some soils/silts. No sampling or testing was undertaken due to possible risk to personnel. Further assessment of the materials within the drainage system may be required as part of any future investigations, which will typically be secured via planning conditions.
