Ground Investigation Report

Proposed Redevelopment

Lanwades Park, Kentford, Newmarket

Site: Lanwades Park, Kentford, Newmarket
Document Title: Ground Investigation Report
Document no.: STU5875-R01 Rev B
Date: February 2023
Client: Lochailort Investments Limited
Issuing office: Soiltechnics Ltd
Cedar Barn, White Lodge, Walgrave, Northampton. NN6 9PY
Tel: 01604 781 877 E-mail: mail@soiltechnics.net

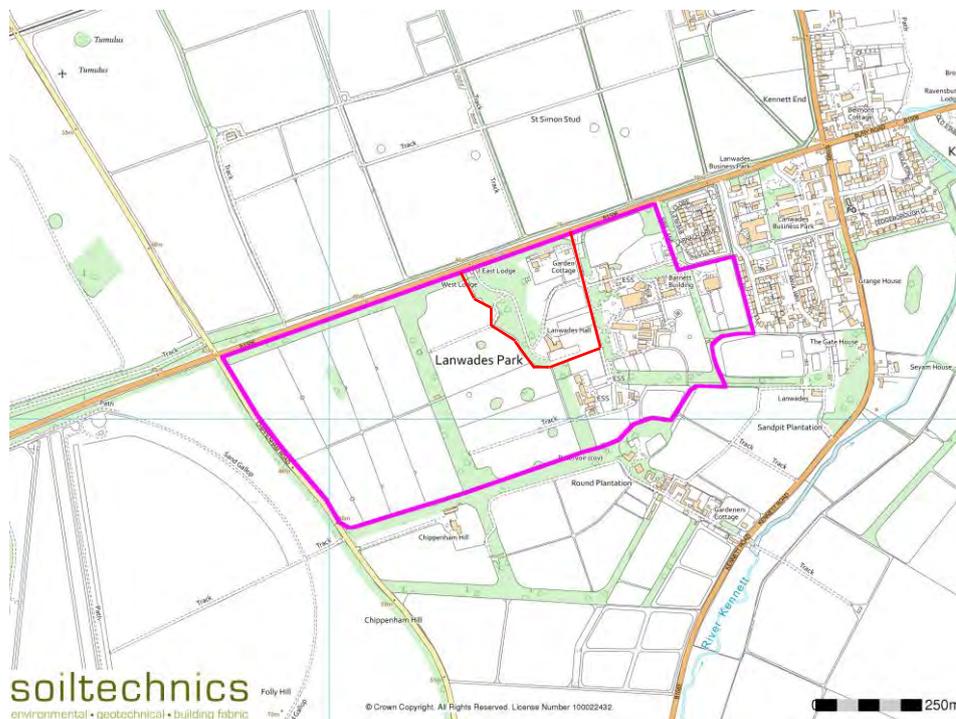
Figure 2-1: Site boundary

2.2.2 A map showing the approximate site boundary is presented below, marked in pink. Lanwades Hall and surrounding land is not part of the site (outlined in red). A table summarising the key site features is presented below. A site plan is provided within Appendix A.

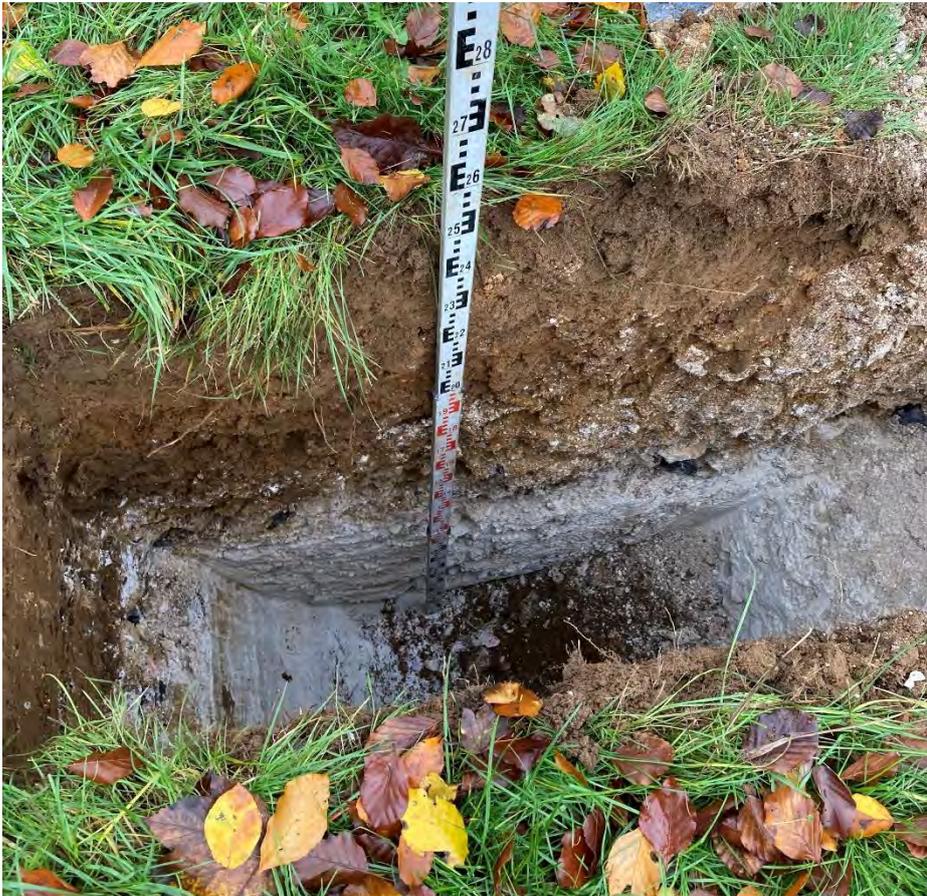
Figure 6-1: Topsoil within TP15

6.2.1 Topsoil was encountered in all exploratory holes, with the exception of HP02, HP03 and TP04. The base of the unit varied between 0.1m and 1.0m thick. The Topsoil comprises dark brown, gravelly, sandy clay with gravel consisting of flint.

6.2.2 A typical photograph of topsoil deposits encountered is presented below.

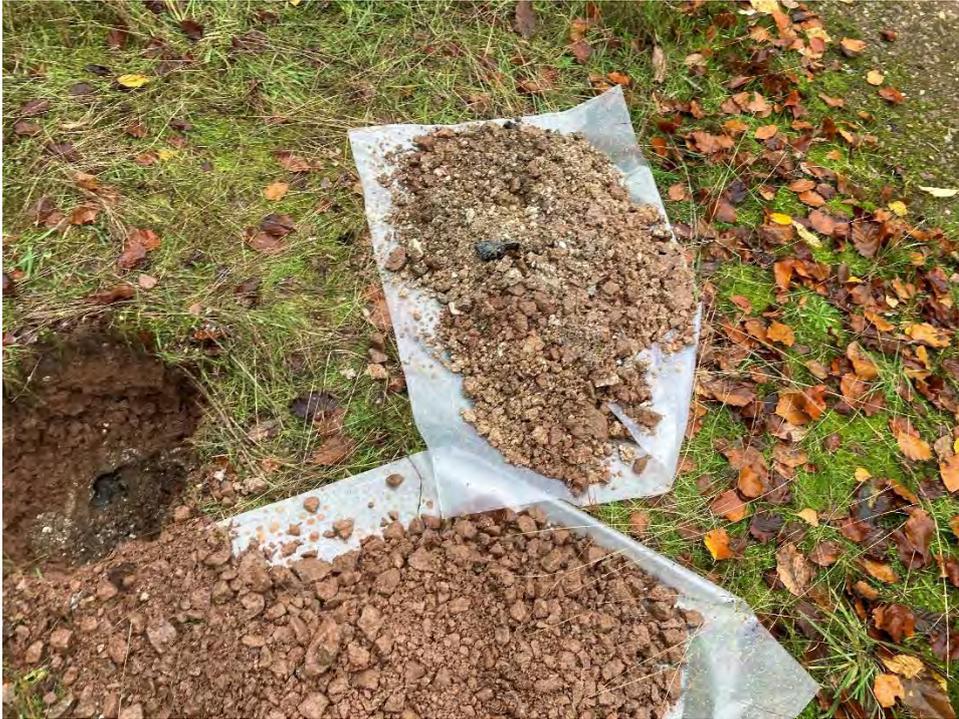
Figure 6-2: Made Ground in HP03

- 6.3.2 Made Ground is variable but generally comprises grey and light brown, slightly sandy to sandy, clayey gravel or gravelly, slightly clayey sand and light brown and light grey, slightly sandy, slightly gravelly clay. Gravels consist of chalk, flint, brick, clinker, concrete and sandstone. Occasional wood and fabric are present in the cohesive deposits in TP04 to the north of the incinerator building. Staining and a strong hydrocarbon odour were also noted between 0.6m and 1.20m in this area.

- 6.3.3 Photographs of the Made Ground encountered are presented below.

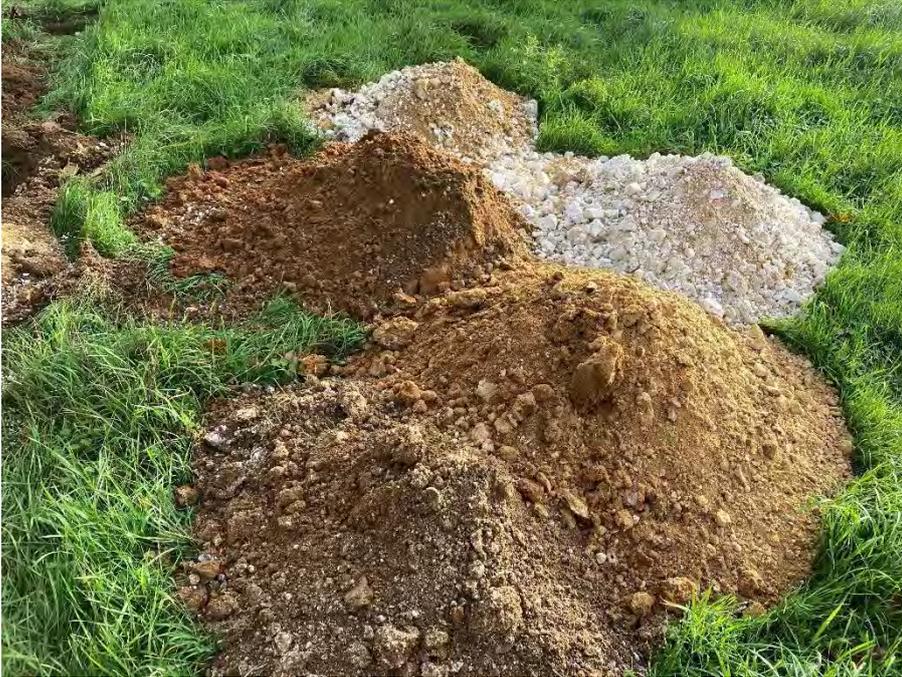
Figure 6-5 Quaternary Deposits taken from TP14.

- 6.4.3 Such deposits are likely to be part of the Lowestoft Formation, though the variability and locally low strength provides some doubt, with such deposits also reminiscent of alluvial and/or Head deposits and as such have been given the more generic term of Quaternary Deposits.

6.4.4 A typical photograph of the Quaternary Deposits encountered is presented below.

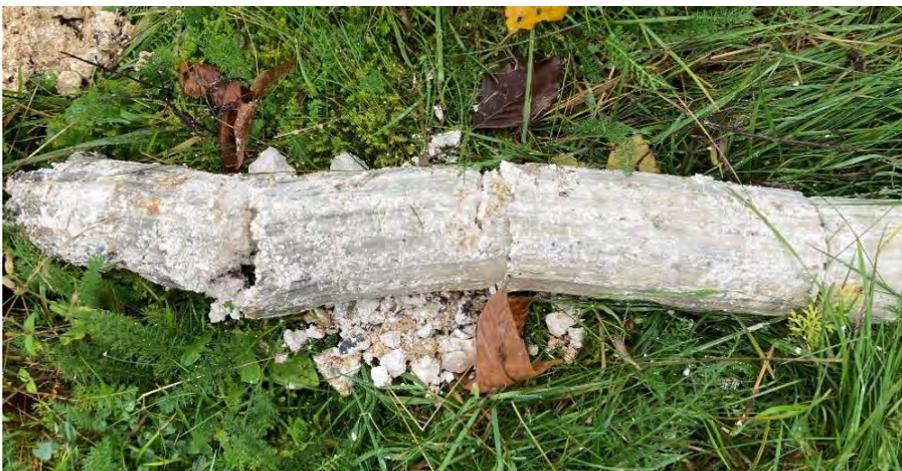
Figure 6-6: Chalk – Grade Dm from WS03

6.5.2 Generally, the Chalk Formation comprised structureless chalk composed of sandy gravel with varying concentrations of clay (Grade Dc). Gravels were weak to moderately weak, low to medium density and varied in colour from light brown to white. Occasional to frequent flint gravels were also present. In two boreholes, the Chalk comprised a gravelly sandy clay (Grade Dm). However, SPTs refused at the base of the boreholes suggesting more competent Grade Dc soils below.

6.5.3 A typical photograph of the Chalk encountered is presented below.

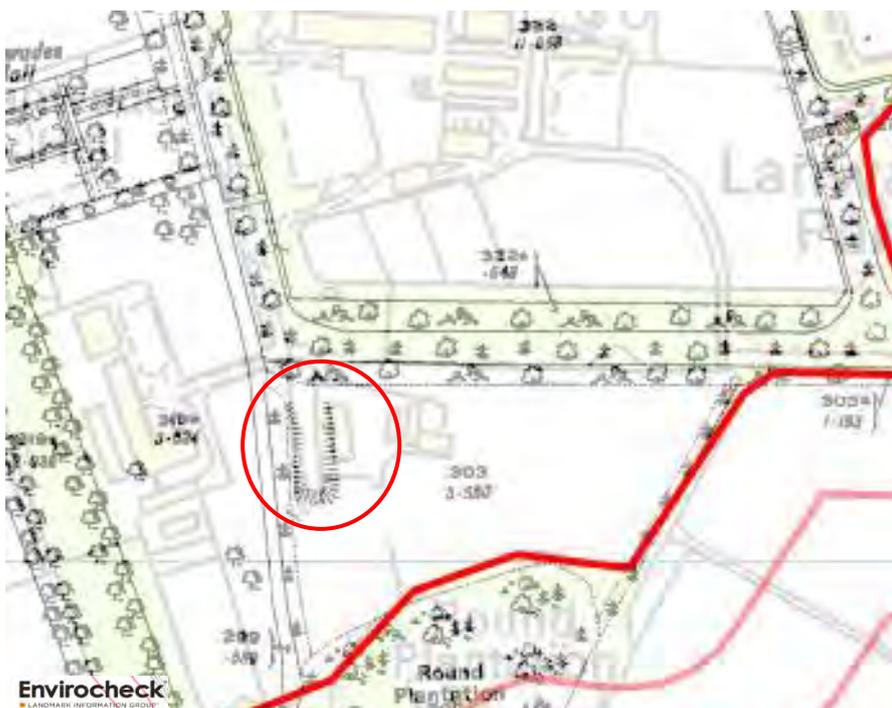
Figure 7-1: Mapping overlays from 1926 and 2006 showing existing layout and location of former quarry

- 7.4.2 Based on historical maps, a backfilled quarry is likely to be present on site as indicated by the red circle on Figure 7-1. This area lies below an existing building and access way and investigations have not been undertaken in this location at this time. This is likely to be an area of deep Made Ground and may require further investigation depending on development proposals. Again, a piled foundation solution may be required in this area should buildings be proposed over the former quarry.

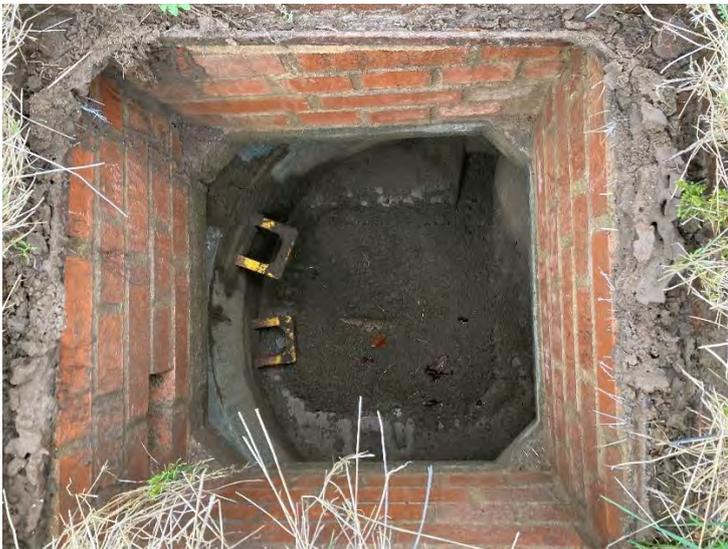
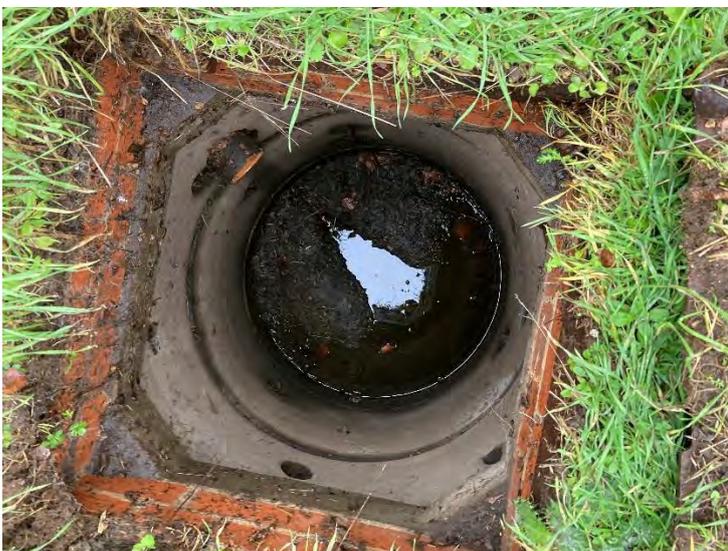
Figure 8-1: View of existing drainage

8.10.1 Based on the site reconnaissance, it was considered likely that any biohazard waste would likely be predominantly present in drainage at the site. On this basis, during fieldwork, manhole covers down gradient of the main site were lifted to assess the presence of any obvious silts or sludge material that could potentially indicate waste products within the drainage.

8.10.2 Some drainage runs appeared to be clear although others included some soils/silts. No sampling or testing was undertaken due to possible risk to personnel. Further assessment of the materials within the drainage system may be required.

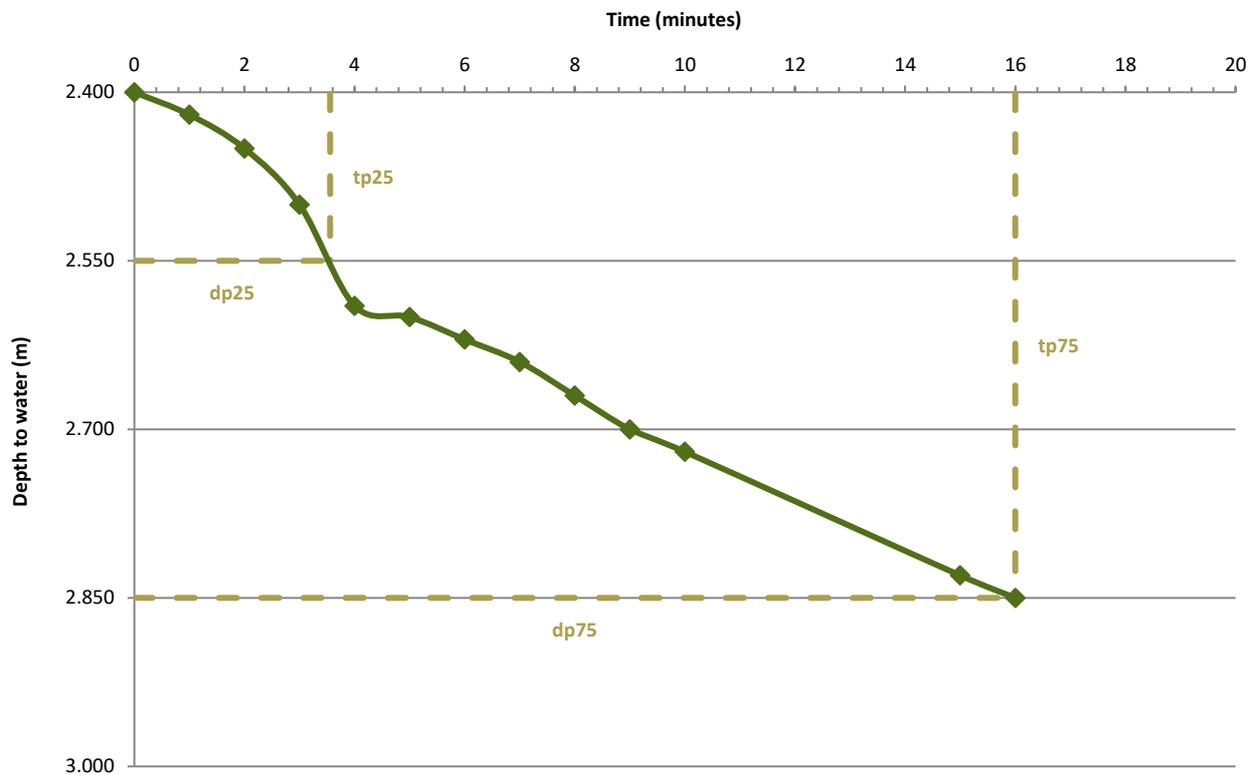
Location	Cycle	Test date	Dimensions (m)
TP01	1	21/11/2022	0.70m x 3.80m

$$f = \frac{V_{p75-25}}{A_{p50} \times t_{p75-25}}$$

V_{p75-25} Effective storage volume of water between 75% (dp75) and 25% (dp25) effective depth	0.798	m³
A_{p50} Internal surface area up to 50% effective depth and including the base	5	m²
$t_{p75} - t_{p25}$ Time for the water level to fall from 75% to 25% effective depth	747	s
f Soil infiltration rate	1.99E-04	m/s

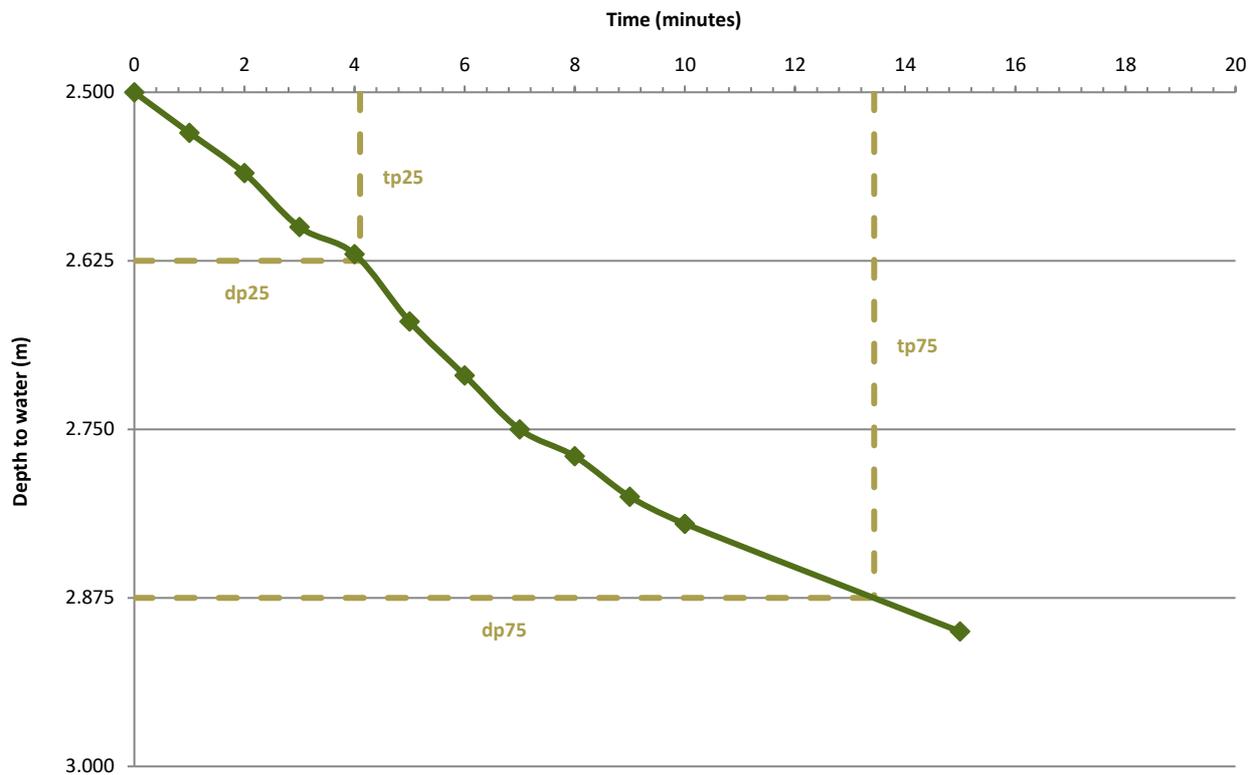
Location	Cycle	Test date	Dimensions (m)
TP01	2	21/11/2022	0.70m x 3.80m

$$f = \frac{V_{p75-25}}{A_{p50} \times t_{p75-25}}$$

V_{p75-25} Effective storage volume of water between 75% (dp75) and 25% (dp25) effective depth	0.665	m³
A_{p50} Internal surface area up to 50% effective depth and including the base	5	m²
$t_{p75} - t_{p25}$ Time for the water level to fall from 75% to 25% effective depth	560	s
f Soil infiltration rate	2.42E-04	m/s

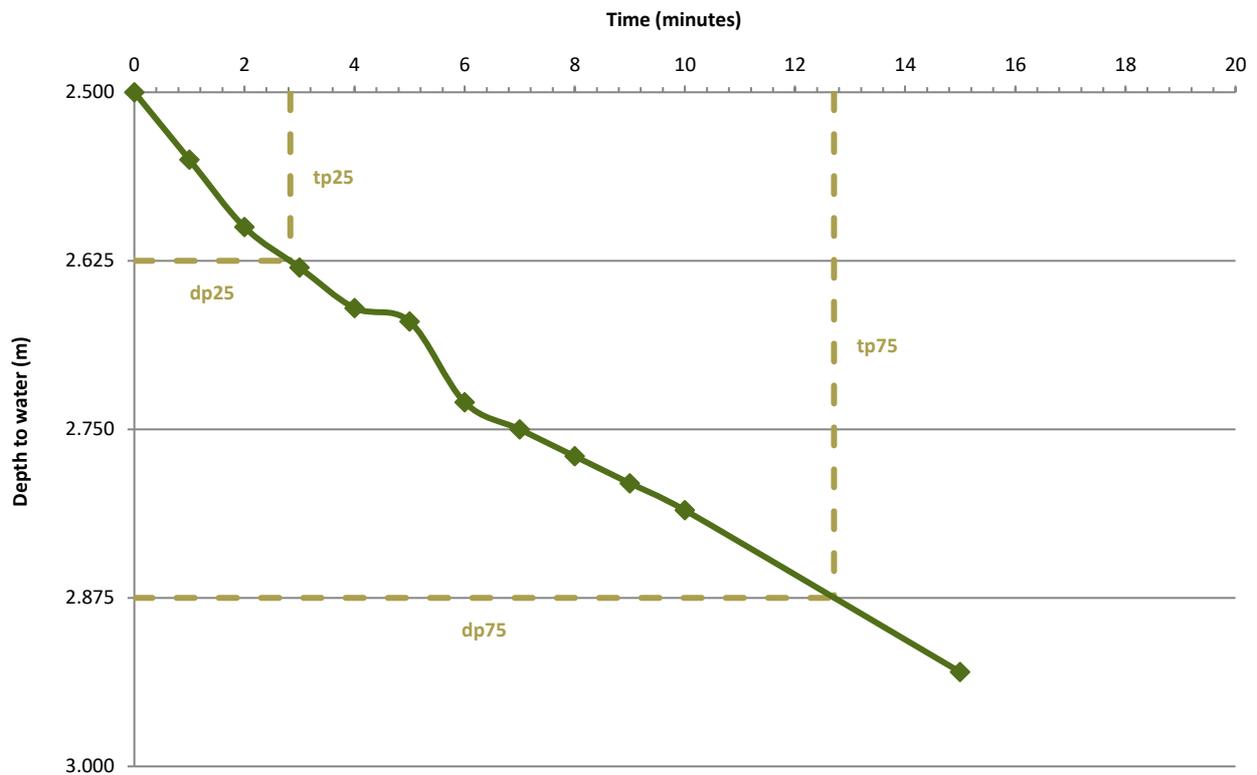
Location	Cycle	Test date	Dimensions (m)
TP01	3	21/11/2022	0.70m x 3.80m

$$f = \frac{V_{p75-25}}{A_{p50} \times t_{p75-25}}$$

V_{p75-25}	0.665	m^3
Effective storage volume of water between 75% (dp75) and 25% (dp25) effective depth		
A_{p50}	5	m^2
Internal surface area up to 50% effective depth and including the base		
$t_{p75} - t_{p25}$	593	s
Time for the water level to fall from 75% to 25% effective depth		
f	2.29E-04	m/s
Soil infiltration rate

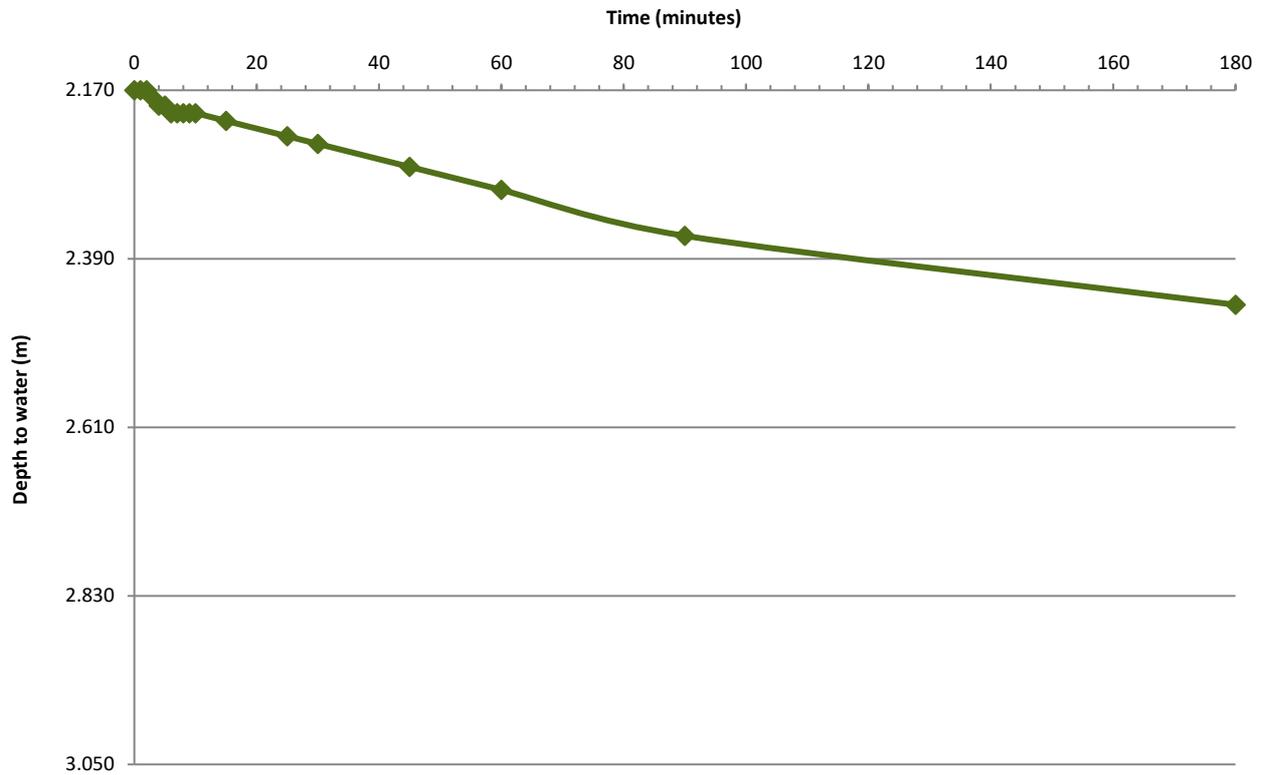
Location	Cycle	Test date	Dimensions (m)
TP02	1	21/11/2022	0.75m x 3.15m

Insufficient infiltration over 180 minutes of monitoring therefore unable to calculate soil infiltration rate.

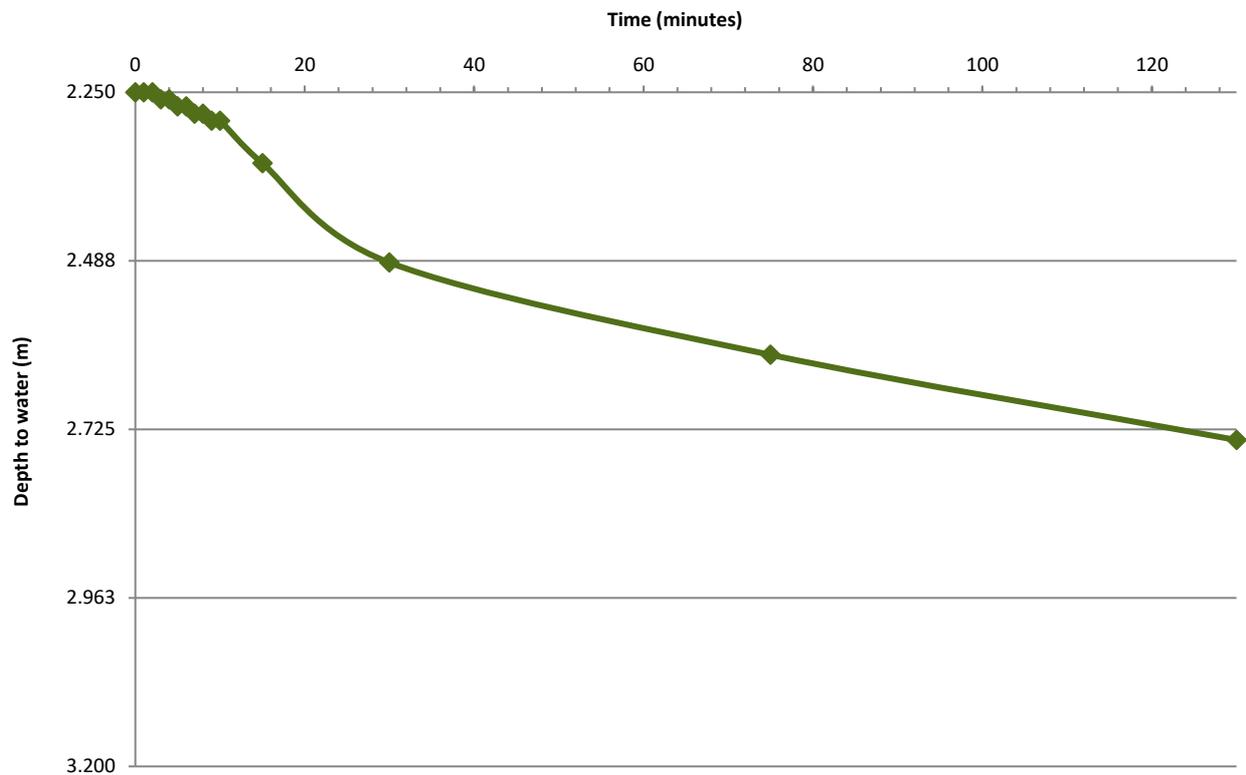
Location	Cycle	Test date	Dimensions (m)
TP03	1	21/11/2022	0.75m x 3.10m

Insufficient infiltration over 130 minutes of monitoring therefore unable to calculate soil infiltration rate.

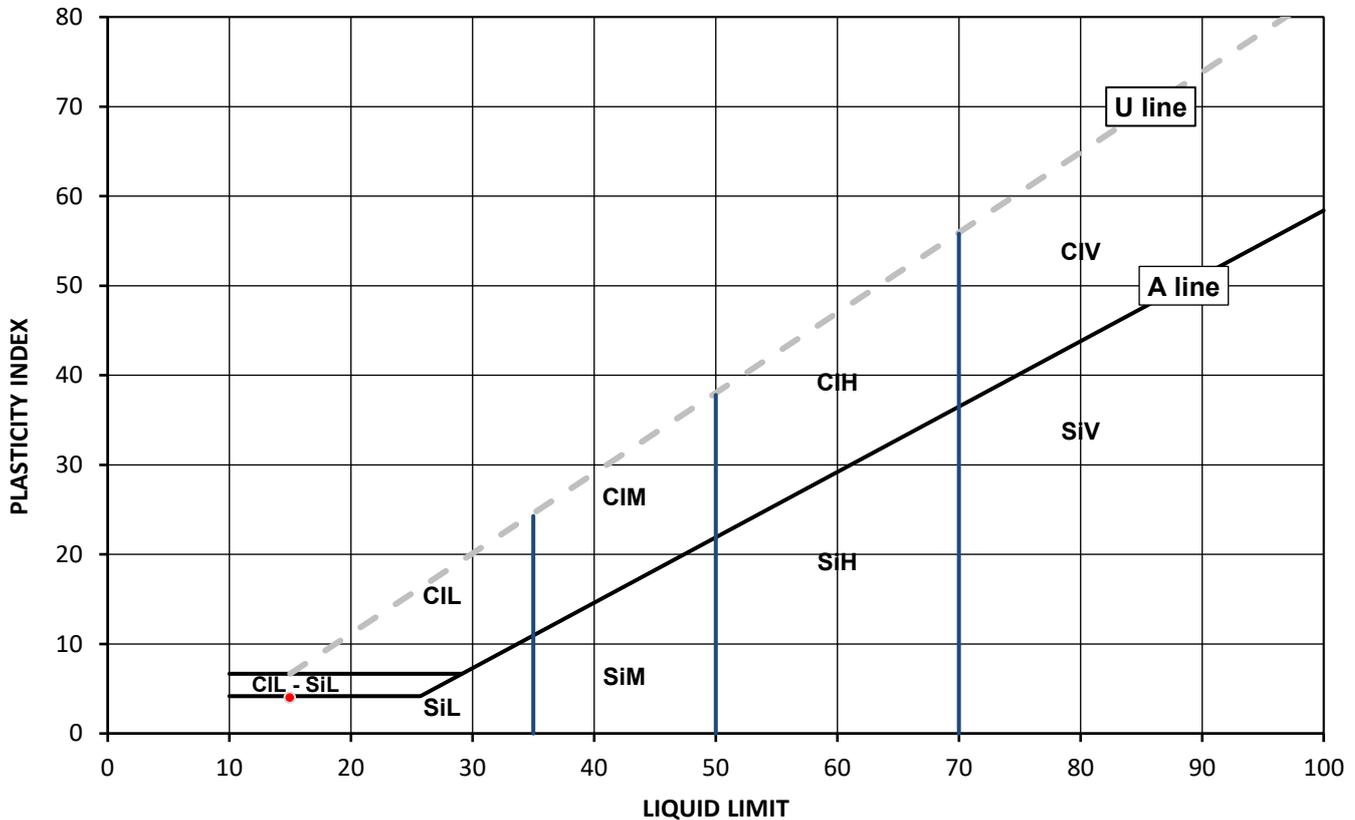
As Received Water Content [W] %	Liquid Limit [WL] %	Plastic Limit [Wp] %	Plasticity Index [Ip] %	% Passing 425µm BS Test Sieve
9.3	15	11	4	86

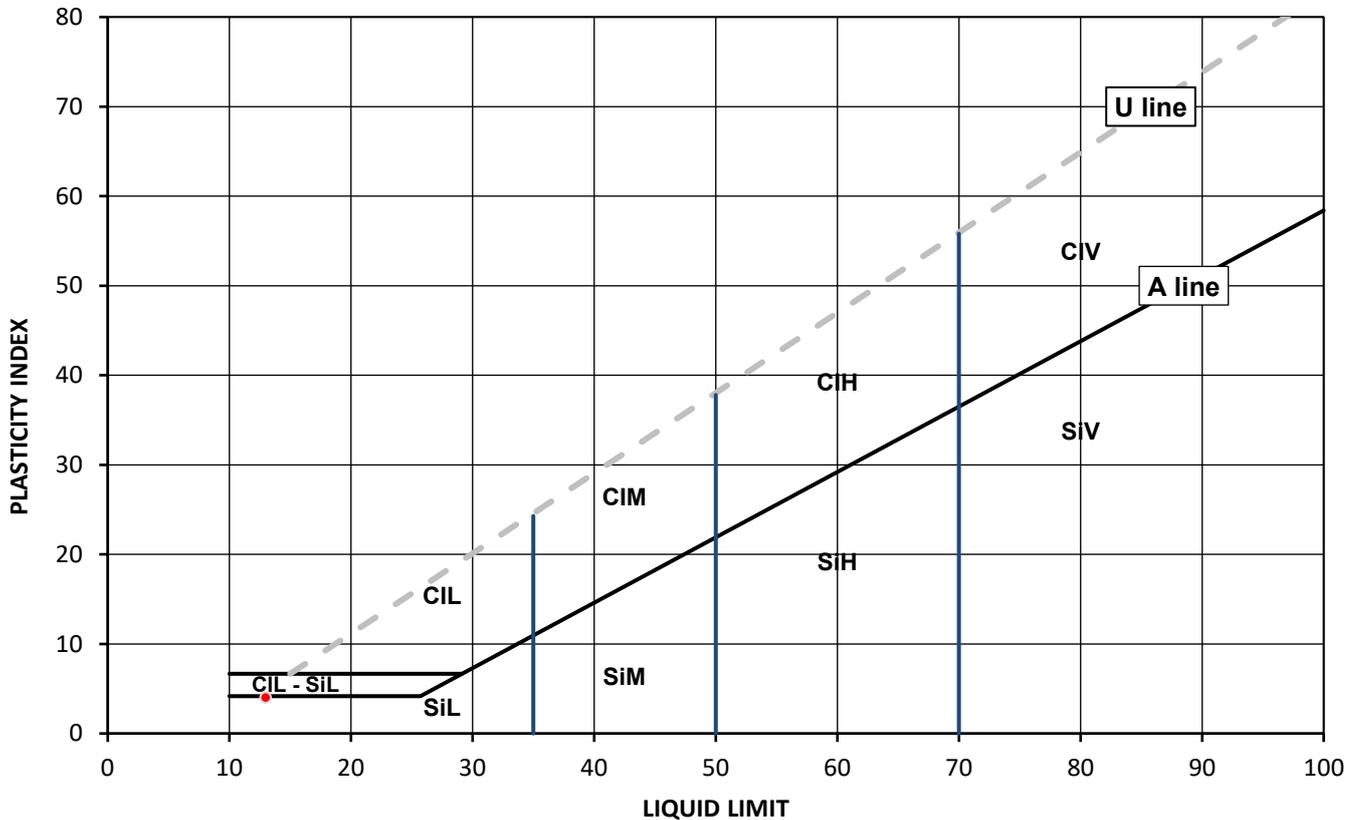
As Received Water Content [W] %	Liquid Limit [WL] %	Plastic Limit [Wp] %	Plasticity Index [Ip] %	% Passing 425µm BS Test Sieve
7.5	13	9	4	81

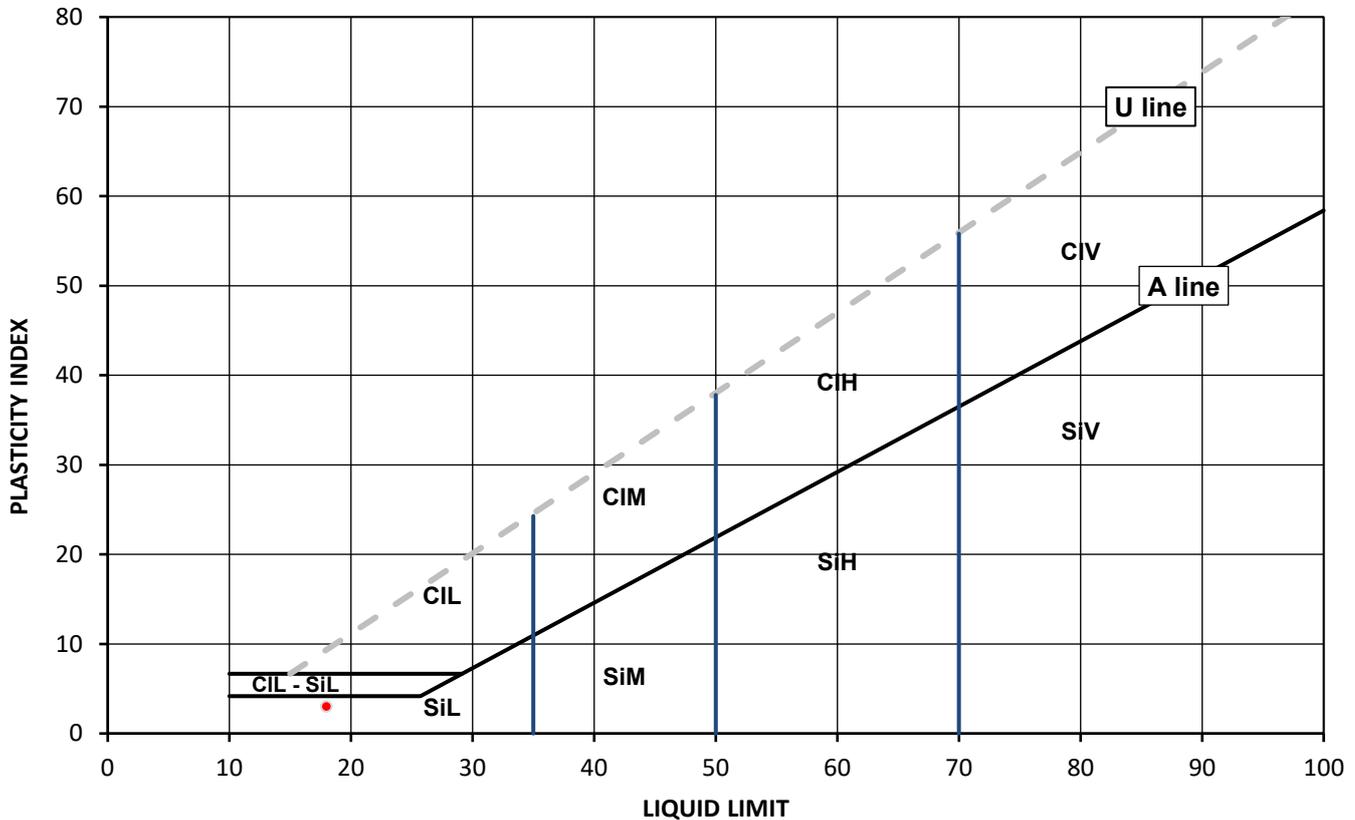
As Received Water Content [W] %	Liquid Limit [WL] %	Plastic Limit [Wp] %	Plasticity Index [Ip] %	% Passing 425µm BS Test Sieve
9.8	18	15	3	94

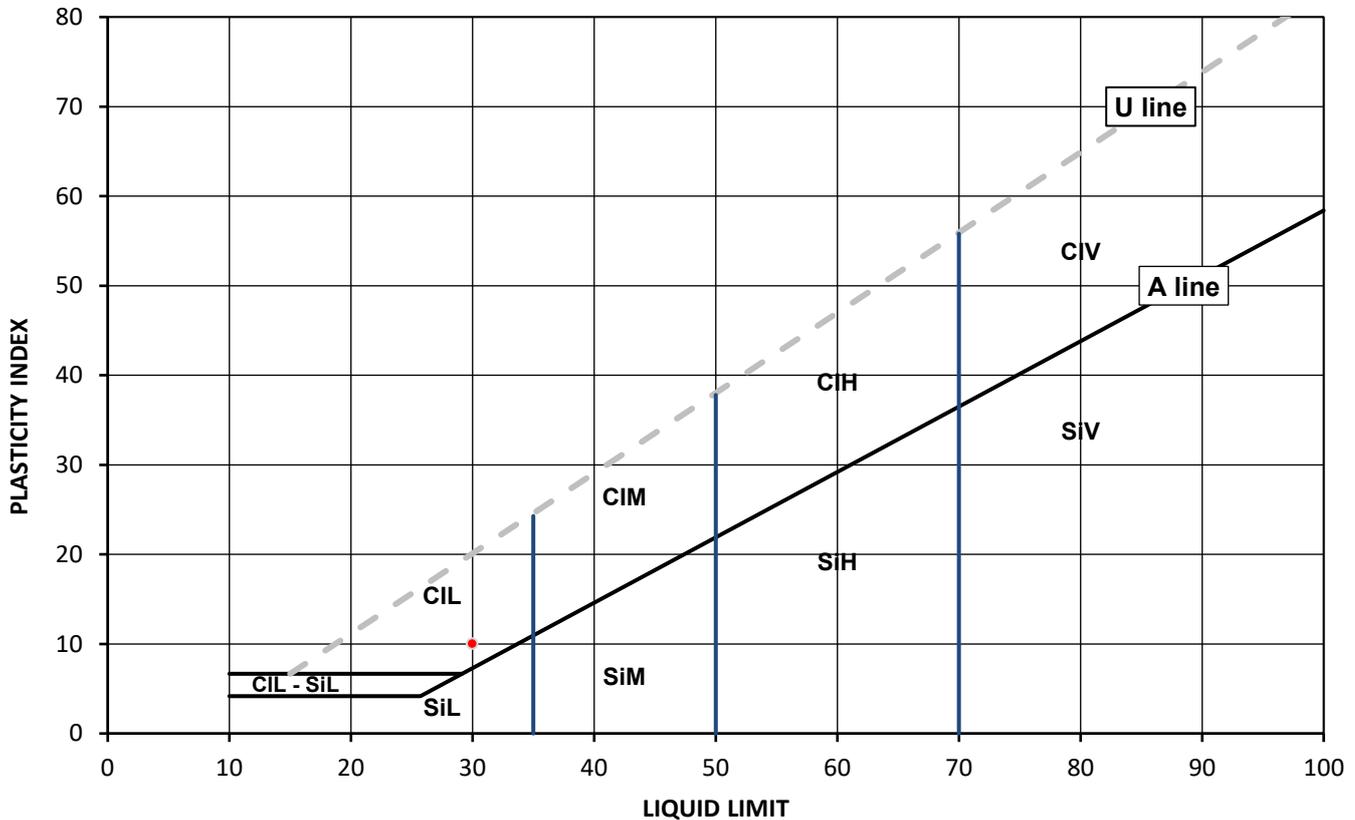
As Received Water Content [W] %	Liquid Limit [WL] %	Plastic Limit [Wp] %	Plasticity Index [Ip] %	% Passing 425µm BS Test Sieve
24	30	20	10	98

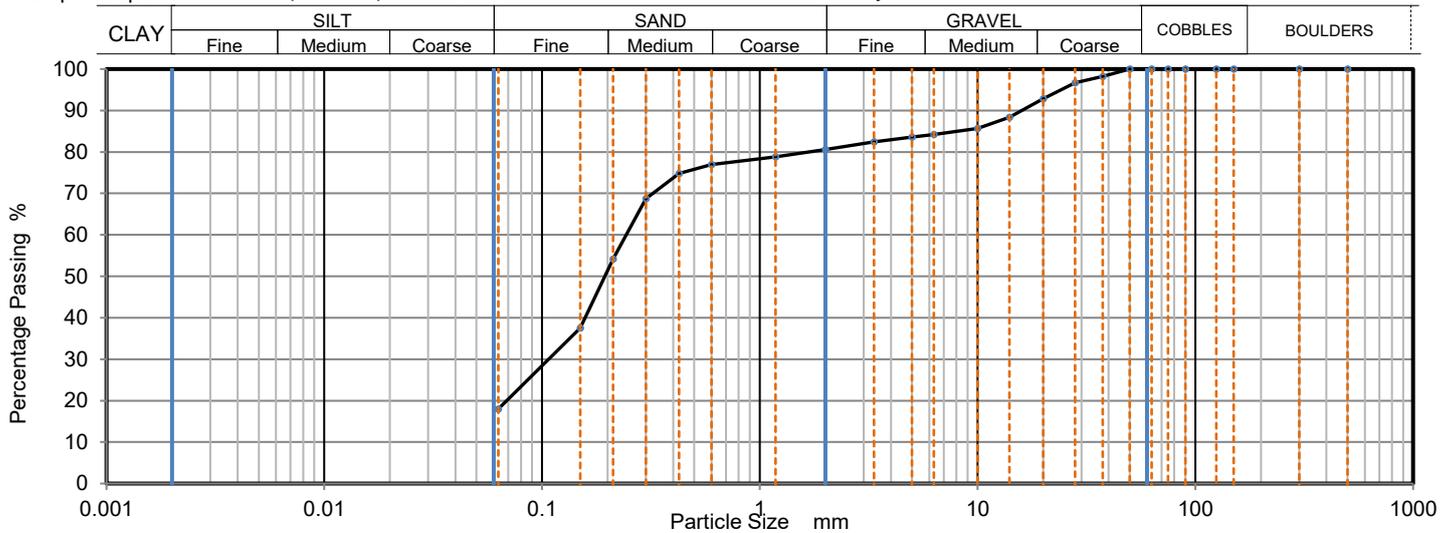
Laboratory Reference: 2520677
Hole No.: TP110.802
Sample Reference: 2
Sample Description: Yellowish brown clayey gravelly SAND
Sample Preparation: Sample was quartered, oven dried at 109.0 °C and broken down by hand.

Sieving		Sedimentation	
Particle Size mm	% Passing	Particle Size mm	% Passing
500	100		
300	100		
150	100		
125	100		
90	100		
75	100		
63	100		
50	100		
37.5	98		
28	97		
20	93		
14	88		
10	86		
6.3	84		
5	84		
3.35	82		
2	81		
1.18	79		
0.6	77		
0.425	75		
0.3	69		
0.212	54		
0.15	38		
0.063	19

Sample Proportions	% dry mass
Very coarse	0
Gravel	19
Sand	62
Fines <0.063mm	18
