Our Ref: 9153,SK,Ltr01,JK,RS,24-01-25,V1 - Draft

INFILTRATION TESTING AT LANWADES COUNTRY PARK, NEWMARKET, CB8 7UU

The primary objective of this ground investigation was to assess the infiltration potential of the natural soils beneath the site.

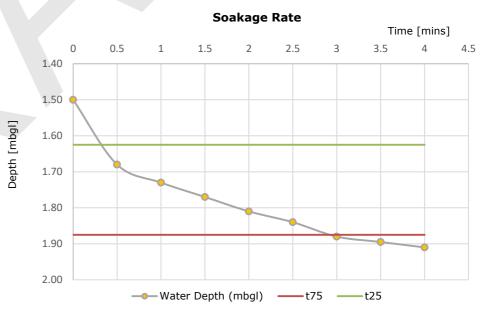
GEO Date: 22/01/2025 **Trial Pit** TP01 1 of 3 Run Test Date 08/01/2025

Pit Size [m]								
Length Width Depth								
1.70	0.40	2.00						
- ~								
Parameter	ion Rate Calcu Unit	lations Result						
Parameter	••	Result						
	height	1.875						
h ₇₅	[m]							
h ₂₅	[m]	1.625						
h ₇₅ -h ₂₅	[m]	0.250						
	time							
t ₇₅	[s]	174.00						
t ₂₅	[s]	19.80						
t ₇₅ - t ₂₅	[s]	154.20						
e	ffective volume							
V ₇₅₋₂₅	[m³]	0.051						
	effective area							
ap ₅₀	[m²]	1.730						
SO	il infiltration rate	e						
f	[m/s]	1.91E-04

Remarks: Backfilled with gravel. Effective volume multiplied by the voids ratio of the gravel (0.3).

Table 2 – S	Table 2 – Summary of Soil Infiltration Results							
Location	Test 1 (m/s)	Test 2 (m/s)	Test 3 (m/s)	Notes				
TP01	1.91×10-04	1.31x10-04	1.97x10-04	None				
TP02	5.83x10-04	7.04x10-04	5.80x10-04	None				
TP03	4.31×10-05	3.44x10-05	2.43x10-05	None				
TP04	1.77x10-05	1.42x10-05	9.56x10-06	None				
TP05	3.26x10-04	2.28x10-04	1.78x10-04	None

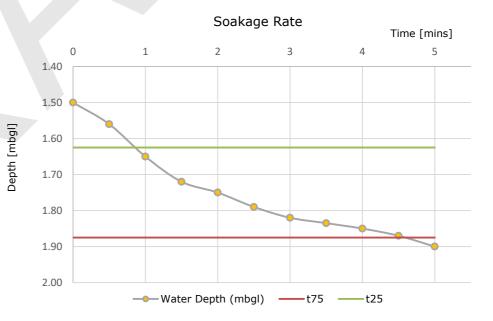
Trial Pit
 TP01

Pit Size [m]		
Length	Width	Depth
1.70	0.40	2.00
Infiltrat	ion Rate Calcu	lations
Parameter	Unit	Result
	height	
h ₇₅	[m]	1.875
h ₂₅	[m]	1.625
h ₇₅ -h ₂₅	[m]	0.250
	time	
t ₇₅	[s]	276.00
t ₂₅	[s]	51.00
t ₇₅ - t ₂₅	[s]	225.00
е	ffective volume	
V ₇₅₋₂₅	[m³]	0.051
	effective area	
ap ₅₀	[m²]	1.730
soil infiltration rate		
f	[m/s]	1.31E-04

Remarks: Backfilled with gravel. Effective volume multiplied by the voids ratio of the gravel (0.3).

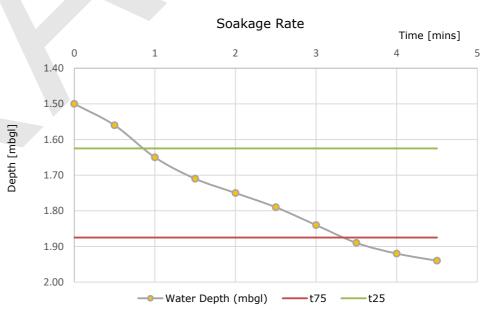
Trial Pit	TP01
Run	3 of 3
Test Date	09/01/2025
Groundwater Encountered:	N/A

Infiltration Rate Calculations		
Parameter	Unit	Result
	height	
h ₇₅	[m]	1.875
h ₂₅	[m]	1.625
h ₇₅ -h ₂₅	[m]	0.250
	time	
t ₇₅	[s]	198.00
t ₂₅	[s]	48.00
t ₇₅ - t ₂₅	[s]	150.00
e	effective volume	
V ₇₅₋₂₅	[m³]	0.051
	effective area	
ар ₅₀	[m²]	1.730
SO	il infiltration rat	e
f	[m/s]	1.97E-04

Remarks: Backfilled with gravel. Effective volume multiplied by the voids ratio of the gravel (0.3).

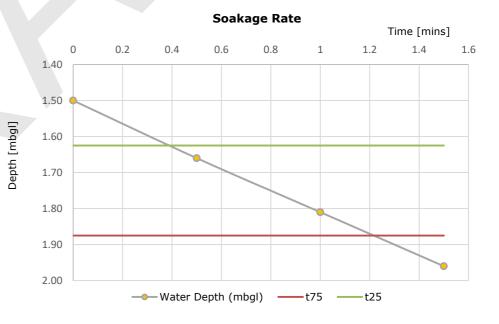
Date:22/01/2025Trial PitTP02Run1 of 3Test Date09/01/2025

Width	
	Depth
0.40	2.00
on Rate Calcu	lations
Unit	Result
height	
[m]	1.875
[m]	1.625
[m]	0.250
time	
[s]	73.50
[s]	22.80
[s]	50.70
[m³]	0.053
[m²]	1.775
infiltration rat	
[m/s]	5.83E-04
	0.40 on Rate Calcu Unit height [m] [m] [m] time [s] [s] [s] fective volume [m ³] effective area [m ²] infiltration rat

Remarks: Backfilled with gravel. Effective volume multiplied by the voids ratio of the gravel (0.3).

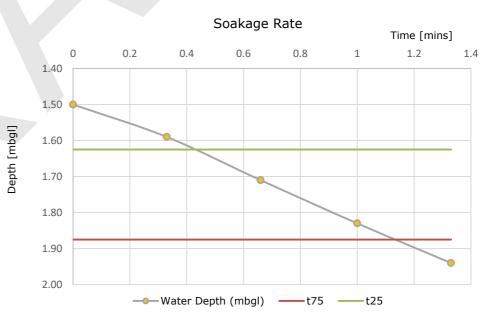
Trial Pit
 TP02

Pit Size [m]		
Length	Width	Depth
1.75	0.40	2.00
Infiltrati	on Rate Calcu	lations
Parameter	Unit	Result
	height	
h ₇₅	[m]	1.875
h ₂₅	[m]	1.625
h ₇₅ -h ₂₅	[m]	0.250
	time	
t ₇₅	[s]	67.20
t ₂₅	[s]	25.20
t ₇₅ - t ₂₅	[s]	42.00
ef	fective volume	
V75-25	[m³]	0.053
(effective area	
ap ₅₀	[m²]	1.775
soil infiltration rate		
f	[m/s]	7.04E-04

Remarks: Backfilled with gravel. Effective volume multiplied by the voids ratio of the gravel (0.3).

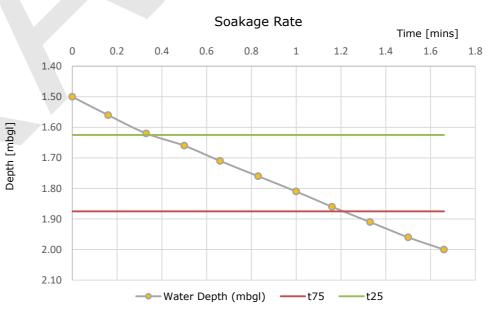
Trial Pit	TP02
Run	3 of 3
Test Date	09/01/2025
Groundwater Encountered:	N/A

Pit Size [m]			
Length	Width	Depth	
1.75	0.40	2.00	
Infiltrati	on Rate Calcu	llations	
Parameter	Unit	Result	
	height		
h ₇₅	[m]	1.875	
h ₂₅	[m]	1.625	
h ₇₅ -h ₂₅	[m]	0.250	
	time		
t ₇₅	[s]	72.00	
t ₂₅	[s]	21.00	
t ₇₅ - t ₂₅	[s]	51.00	
ef	fective volume		
V ₇₅₋₂₅	[m³]	0.053	
	effective area		
ap ₅₀	[m²]	1.775	
soil infiltration rate			
f	[m/s]	5.80E-04

Remarks: Backfilled with gravel. Effective volume multiplied by the voids ratio of the gravel (0.3).

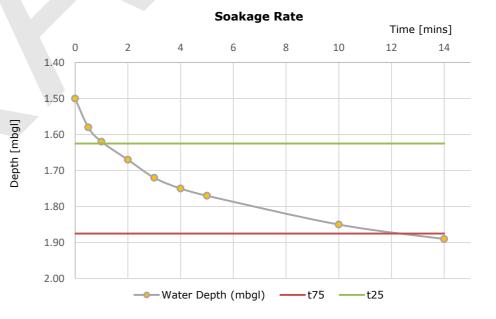
Date: 22/01/2025 Trial Pit TP03 Run 1 of 3 Test Date 09/01/2025 Groundwater Encountered: N/A

Length	Width	Depth	
1.70	0.40	2.00	
	ion Rate Calcu		
Parameter	Unit	Result	
	height		
h ₇₅	[m]	1.875	
h ₂₅	[m]	1.625	
h ₇₅ -h ₂₅	[m]	0.250	
	time		
t ₇₅	[s]	750.00	
t ₂₅	[s]	66.00	
t ₇₅ - t ₂₅	[s]	684.00	
е	ffective volume		
V ₇₅₋₂₅	[m³]	0.051	
	effective area		
ap ₅₀	[m ²]	1.730	
soil infiltration rate			
f	[m/s]	4.31E-05

Remarks: Backfilled with gravel. Effective volume multiplied by the voids ratio of the gravel (0.3).

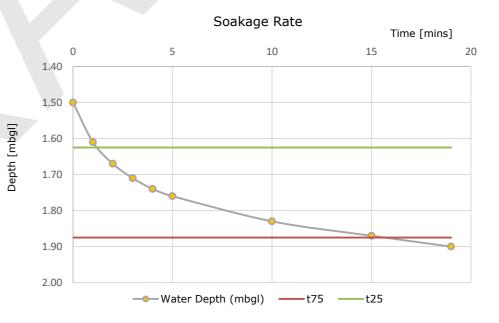
Trial Pit
 TP03

Pit Size [m]		
Length	Width	Depth
1.70	0.40	2.00
Infiltrati	on Rate Calcu	llations
Parameter	Unit	Result
	height	
h ₇₅	[m]	1.875
h ₂₅	[m]	1.625
h ₇₅ -h ₂₅	[m]	0.250
	time	
t ₇₅	[s]	930.00
t ₂₅	[s]	72.00
t ₇₅ - t ₂₅	[s]	858.00
e	ffective volume	
V ₇₅₋₂₅	[m³]	0.051
	effective area	
ap ₅₀	[m²]	1.730
soi	l infiltration rat	e
f	[m/s]	3.44E-05

Remarks: Backfilled with gravel. Effective volume multiplied by the voids ratio of the gravel (0.3).

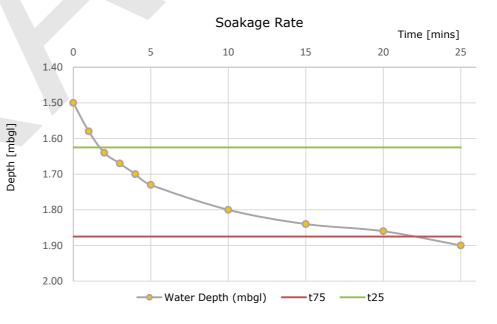
Trial Pit	ТР03
Run	3 of 3
Test Date	09/01/2025
Groundwater Encountered:	N/A

h ₂₅	[m]	1.625
h ₇₅ -h ₂₅	[m]	0.250
	time	
t ₇₅	[s]	1320.00
t ₂₅	[s]	108.00
t ₇₅ - t ₂₅	[s]	1212.00
	effective volume	
V ₇₅₋₂₅	[m³]	0.051
	effective area	
ap ₅₀	[m²]	1.730
S	oil infiltration rat	e
f	[m/s]	2.43E-05

Remarks: Backfilled with gravel. Effective volume multiplied by the voids ratio of the gravel (0.3).

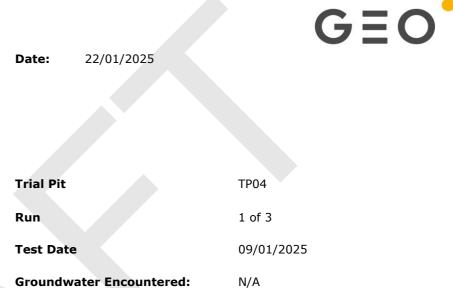
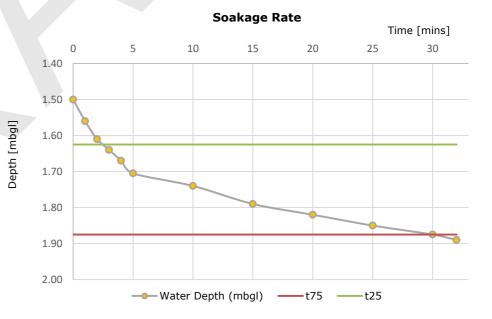
Pit Size [m]		
Length	Width	Depth
1.60	0.40	2.00
	on Rate Calcu	
Parameter	Unit	Result
	height	
h ₇₅	[m]	1.875
h ₂₅	[m]	1.625
h ₇₅ -h ₂₅	[m]	0.250
	time	
t ₇₅	[s]	1800.00
t ₂₅	[s]	150.00
t ₇₅ - t ₂₅	[s]	1650.00
e	ffective volume	
V ₇₅₋₂₅	[m³]	0.048
	effective area	
ap ₅₀	[m²]	1.640
soil infiltration rate		
f	[m/s]	1.77E-05

Remarks: Backfilled with gravel. Effective volume multiplied by the voids ratio of the gravel (0.3).

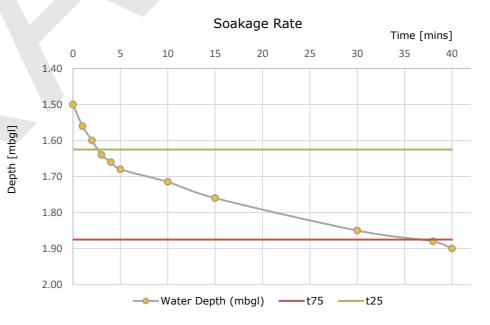
Trial Pit
 TP04

Pit Size [m]		
Length	Width	Depth
1.60	0.40	2.00
Infiltrati	on Rate Calcı	lations
Parameter	Unit	Result
	height	
h ₇₅	[m]	1.875
h ₂₅	[m]	1.625
h ₇₅ -h ₂₅	[m]	0.250
	time	
t ₇₅	[s]	2220.00
t ₂₅	[s]	156.00
t ₇₅ - t ₂₅	[s]	2064.00
e	ffective volume	
V ₇₅₋₂₅	[m³]	0.048
	effective area	
ap ₅₀	[m²]	1.640
	l infiltration rat	
f	[m/s]	1.42E-05

Remarks: Backfilled with gravel. Effective volume multiplied by the voids ratio of the gravel (0.3).

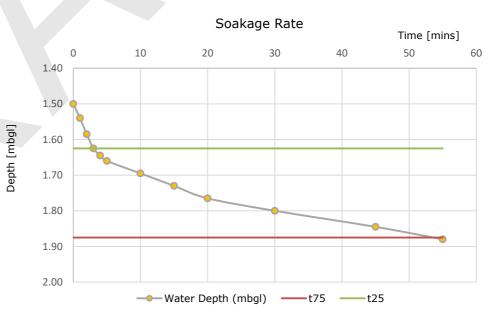
22/01/2025 Date: **Trial Pit TP04** 3 of 3 Run Test Date 09/01/2025

Width	Depth
0.40	2.00
on Rate Calcu	
	Result
[m]	1.875
[m]	1.625
[m]	0.250
time	
1	3240.00
	180.00
[s]	3060.00
[m³]	0.048
offective area	
	1.640
	1.040
l infiltration rat	e
[m/s]	9.56E-06
	0.40 on Rate Calcu Unit height [m] [m] time [s] [s] [s] ffective volume [m ³] effective area [m ²] l infiltration rat

Remarks: Backfilled with gravel. Effective volume multiplied by the voids ratio of the gravel (0.3).

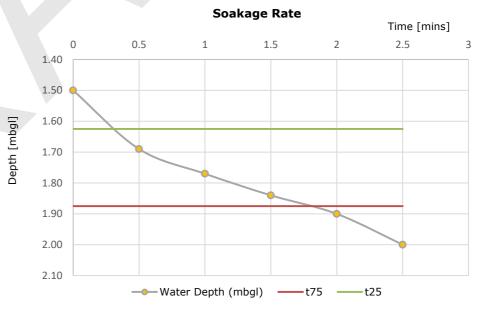
GEO Date: 22/01/2025 **Trial Pit** TP05 1 of 3 Run Test Date 08/01/2025 **Groundwater Encountered:** N/A

Width	Depth		
0.40	2.00		
on Rate Calcu	lations		
Unit	Result		
height			
[m]	1.875		
[m]	1.625		
[m]	0.250		
time			
[s]	108.00		
[s]	18.00		
[s]	90.00		
fective volume			
[m³]	0.050		
effective area			
[m²]	1.685		
infiltration rat	e		
[m/s]	3.26E-04		
	0.40 on Rate Calcu Unit height [m] [m] [m] time [s] [s] [s] [s] fective volume [m ³] effective area [m ²] l infiltration rat

Remarks: Backfilled with gravel. Effective volume multiplied by the voids ratio of the gravel (0.3).

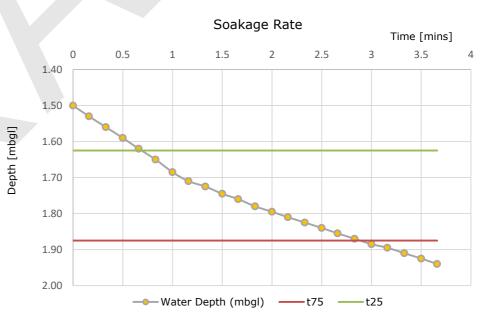
GEO Date: 22/01/2025 **Trial Pit** TP05 2 of 3 Run Test Date 09/01/2025

-	-	
Pit Size [m]			
Length	Width	Depth	
1.65	0.40	2.00	
	ion Rate Calcu		
Parameter	Unit	Result	
	height		
1 ₇₅	[m]	1.875	
1 ₂₅	[m]	1.625	
1 ₇₅ -h ₂₅	[m]	0.250	
	time		
75	[s]	171.00	
25	[s]	42.00	
: ₇₅ - t ₂₅	[s]	129.00	
e	effective volume		
75-25	[m³]	0.050	
	effective area		
ap ₅₀	[m²]	1.685	
SC	il infiltration rate	e	
	[m/s]	2.28E-04

Remarks: Backfilled with gravel. Effective volume multiplied by the voids ratio of the gravel (0.3).

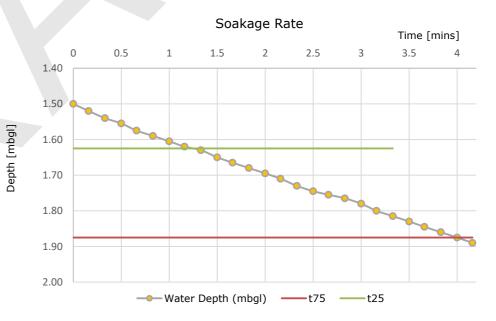
Trial Pit	TP05
Run	3 of 3
Test Date	09/01/2025
Groundwater Encountered:	N/A

Pit Size [m]		
Length	Width	Depth
1.65	0.40	2.00
Infiltrati	on Rate Calcu	lations
Parameter	Unit	Result
	height	
h ₇₅	[m]	1.875
h ₂₅	[m]	1.625
h ₇₅ -h ₂₅	[m]	0.250
	time	
t ₇₅	[s]	240.00
t ₂₅	[s]	74.70
t ₇₅ - t ₂₅	[s]	165.30
	fective volume	
V75-25	[m³]	0.050
	effective area	
	[m ²]	1.685
ap ₅₀	1 1	1.005
soi	l infiltration rat	e
f	[m/s]	1.78E-04
	L, + J

Remarks: Backfilled with gravel. Effective volume multiplied by the voids ratio of the gravel (0.3).

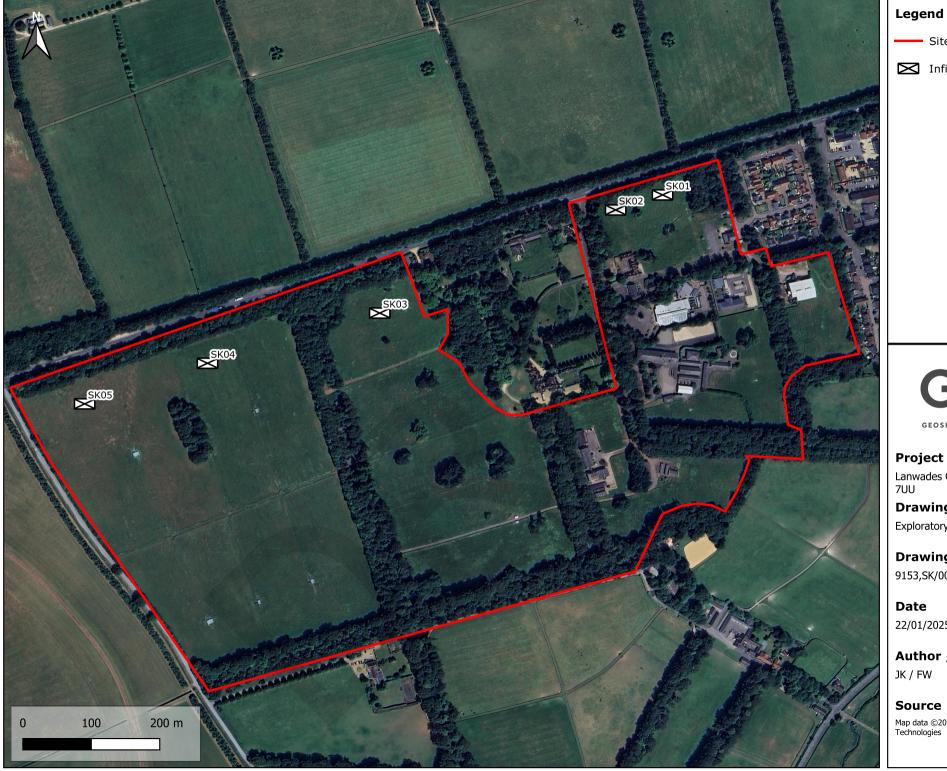
Exploratory Hole Location Plan – Drawing ref. 9153,SK/001/Rev0

Drawing Title Exploratory Hole Location Plan

An Exploratory Hole Location Plan, Drawing ref. 9153,SK/001/Rev0, is presented at the end of this letter report in Appendix 4.
