Project Number A-01988 (6947)

**Refurbishment and Demolition
Asbestos Survey Report**

**Laboratory Buildings
Lanwades Park
Newmarket
CB8 7UA**

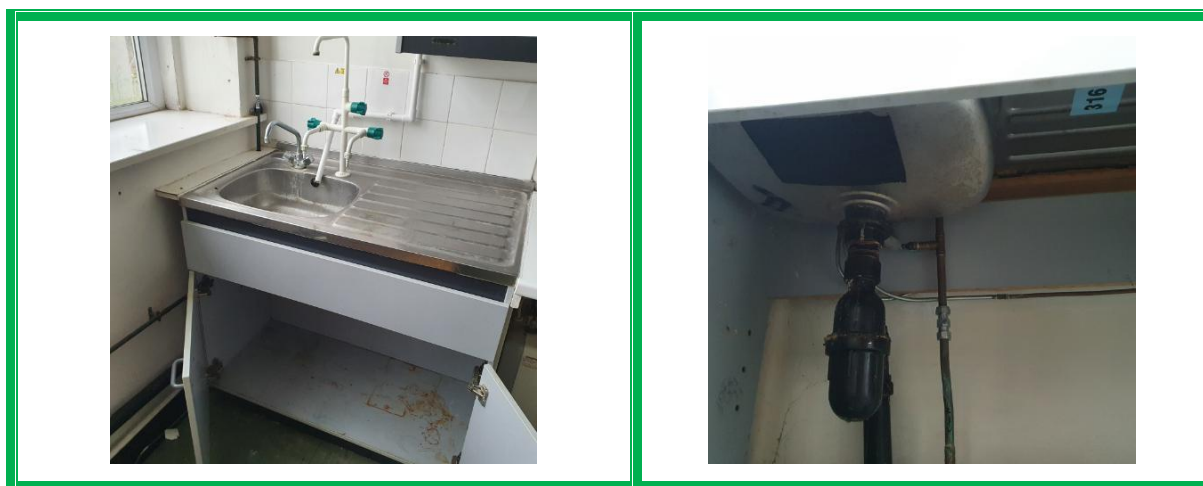
Item No:	1	Sample No:	DK/01
Location:	Laboratory Buildings, First Floor - Room 58 001

Material Description:	Sink Pad - Bituminous Product	
Identification:	Sampled - No Asbestos Found	
Approx. quantity:	N/A	
Accessibility	N/A	<i>Assessment Score</i>
Product type:	N/A	N/A
Extent of Damage:	N/A	N/A
Surface Treatment:	N/A	N/A
Asbestos type:	N/A	N/A
Material Assessment Score:		N/A
Risk Assessment Score:		N/A
Action:	N/A	
Comments:	Solid walls, concrete ceiling, concrete under lino, plasterboard boxing with plastic pipework.

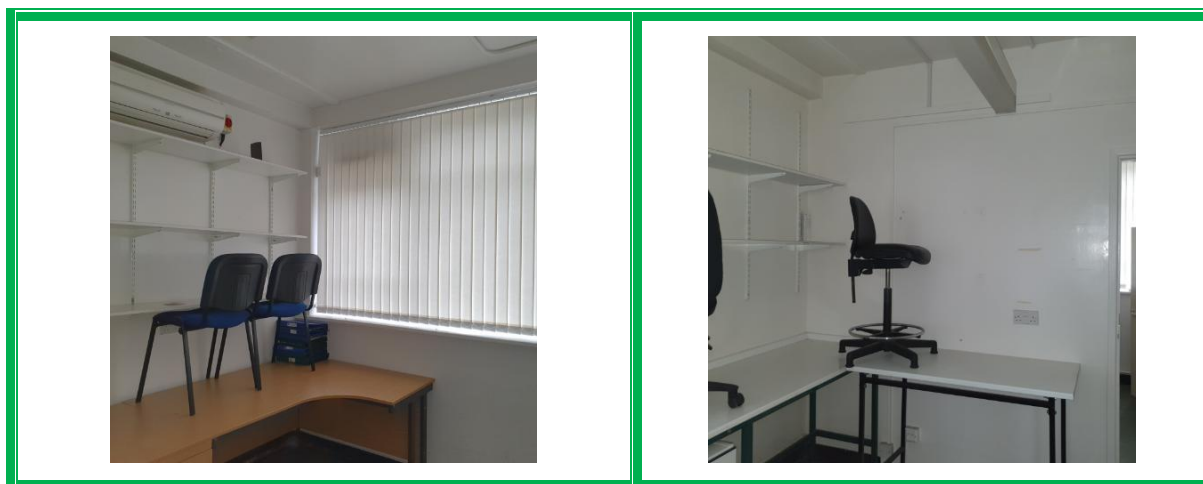
Item No:	2	Sample No:	N/A
Location:	Laboratory Buildings, First Floor - Rooms 56 and 57 002

Material Description:	No Suspect Materials Found	
Identification:	N/A	
Approx. quantity:	N/A	
Accessibility	N/A	<i>Assessment Score</i>
Product type:	N/A	N/A
Extent of Damage:	N/A	N/A
Surface Treatment:	N/A	N/A
Asbestos type:	N/A	N/A
Material Assessment Score:		N/A
Risk Assessment Score:		N/A
Action:	N/A	
Comments:	Plastic pipe in timber boxing. Concrete under lino

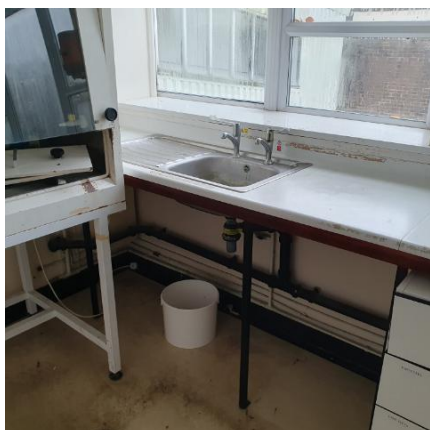
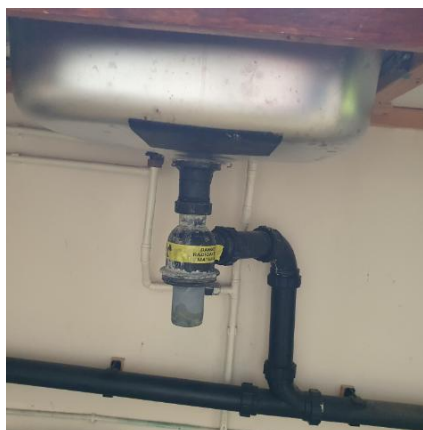
Location: Laboratory Buildings, First Floor - Room 62 007

Material Description:	Sink Pad - Bituminous Product	
Identification:	Sampled - No Asbestos Found	
Approx. quantity:	N/A	
Accessibility	N/A	<i>Assessment Score</i>
Product type:	N/A	N/A
Extent of Damage:	N/A	N/A
Surface Treatment:	N/A	N/A
Asbestos type:	N/A	N/A
Material Assessment Score:		N/A
Risk Assessment Score:		N/A
Action:	N/A	
Comments:	Plasterboard and concrete ceiling. Concrete under lino. Plasterboard and solid walls.

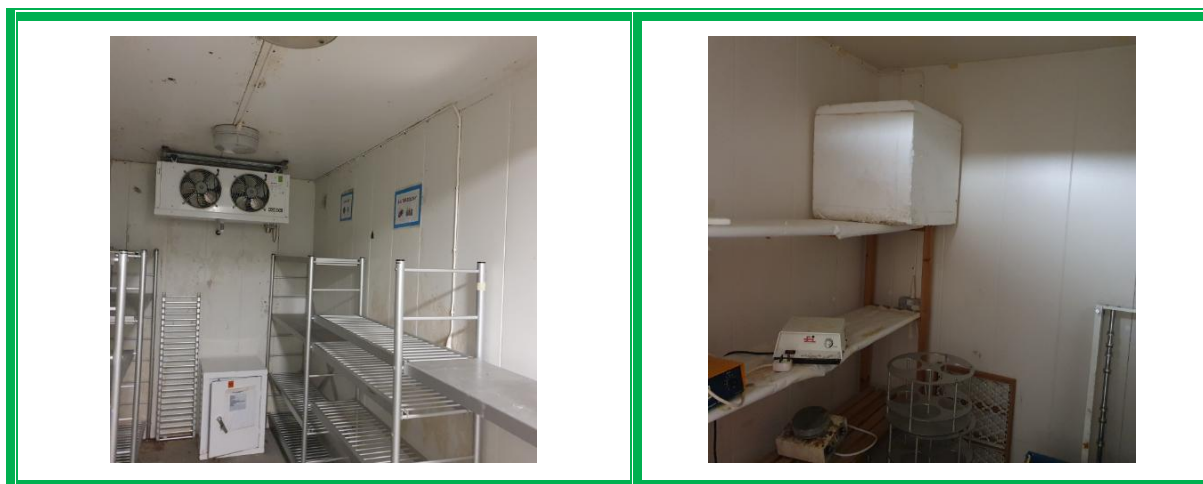
Item No:	10	Sample No:	N/A
Location:	Laboratory Buildings, First Floor - Cold Stores x 2 010

Material Description:	No Suspect Materials Found	
Identification:	N/A	
Approx. quantity:	N/A	
Accessibility	N/A	<i>Assessment Score</i>
Product type:	N/A	N/A
Extent of Damage:	N/A	N/A
Surface Treatment:	N/A	N/A
Asbestos type:	N/A	N/A
Material Assessment Score:		N/A
Risk Assessment Score:		N/A
Action:	N/A	
Comments:	Metal walls and ceiling. No access within freezer casings.

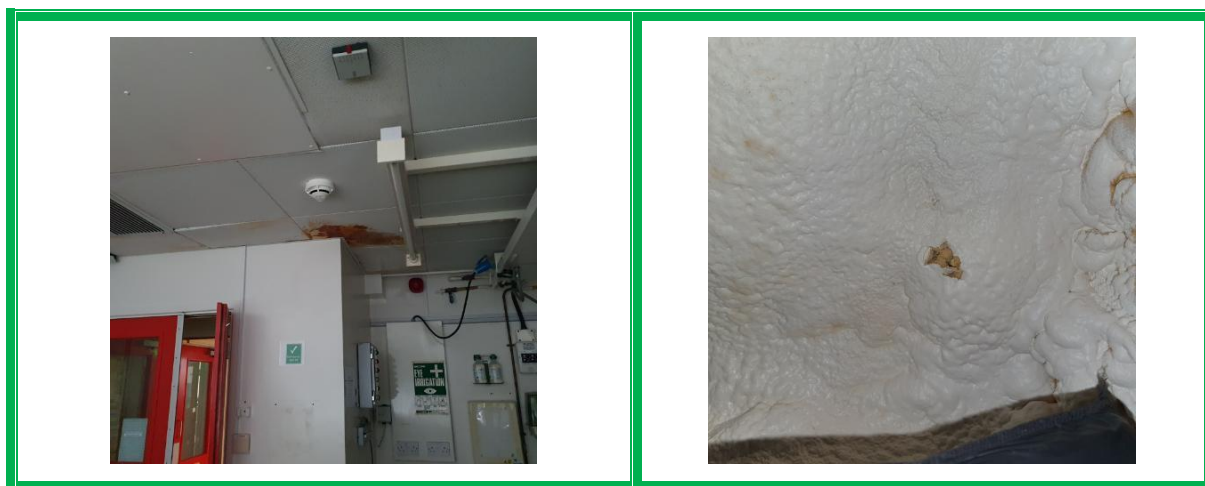
Location: Laboratory Buildings, First Floor - Room 68 011

Material Description:	Foam Insulation to Ceiling - Insulation	
Identification:	Sampled - No Asbestos Found	
Approx. quantity:	N/A	
Accessibility	N/A	<i>Assessment Score</i>
Product type:	N/A	N/A
Extent of Damage:	N/A	N/A
Surface Treatment:	N/A	N/A
Asbestos type:	N/A	N/A
Material Assessment Score:		N/A
Risk Assessment Score:		N/A
Action:	N/A	
Comments:	Found throughout ceiling voids.

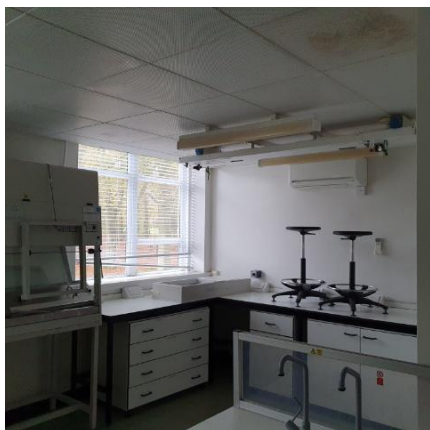
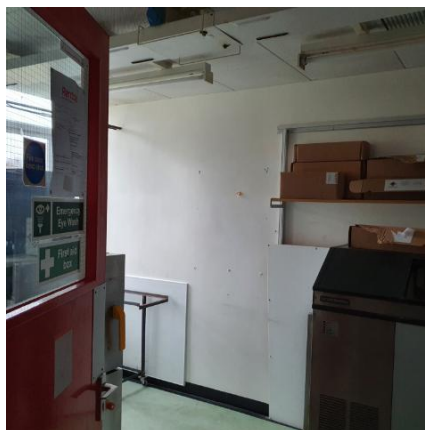
Location: Laboratory Buildings, First Floor - Rooms 70, 73 and 74 013

Material Description:	No Suspect Materials Found	
Identification:	N/A	
Approx. quantity:	N/A	
Accessibility	N/A	<i>Assessment Score</i>
Product type:	N/A	N/A
Extent of Damage:	N/A	N/A
Surface Treatment:	N/A	N/A
Asbestos type:	N/A	N/A
Material Assessment Score:		N/A
Risk Assessment Score:		N/A
Action:	N/A	
Comments:	Non asbestos electrical boxes

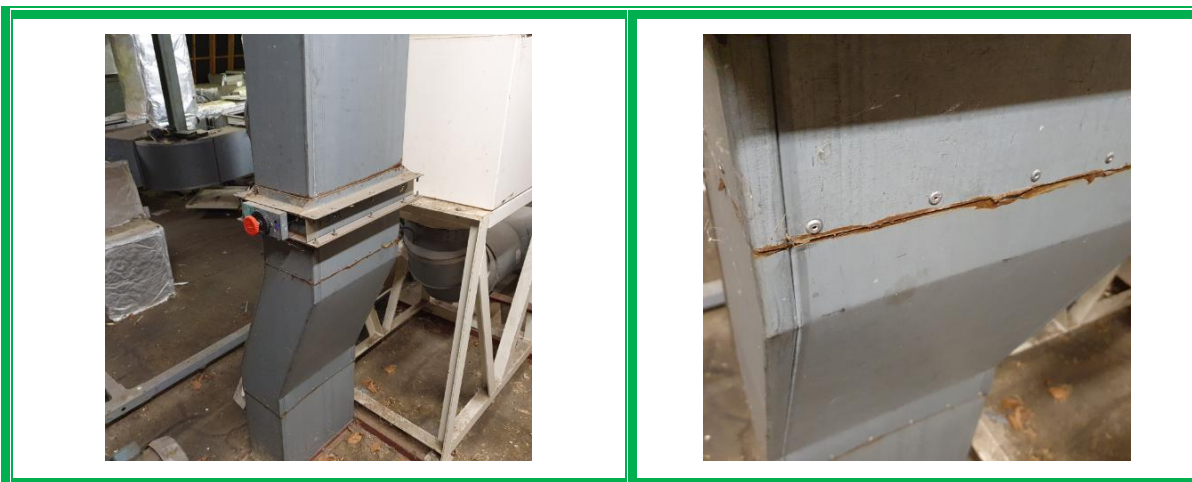
Item No:	14	Sample No:	DK/07
Location:	Laboratory Buildings, Second Floor - Boiler Room 014

Material Description:	Putty to Ductwork Joints - PVC / Reinforced Plastics	
Identification:	Sampled - No Asbestos Found	
Approx. quantity:	N/A	
Accessibility	N/A	<i>Assessment Score</i>
Product type:	N/A	N/A
Extent of Damage:	N/A	N/A
Surface Treatment:	N/A	N/A
Asbestos type:	N/A	N/A
Material Assessment Score:		N/A
Risk Assessment Score:		N/A
Action:	N/A	
Comments:	Treat as uniform to ductwork throughout

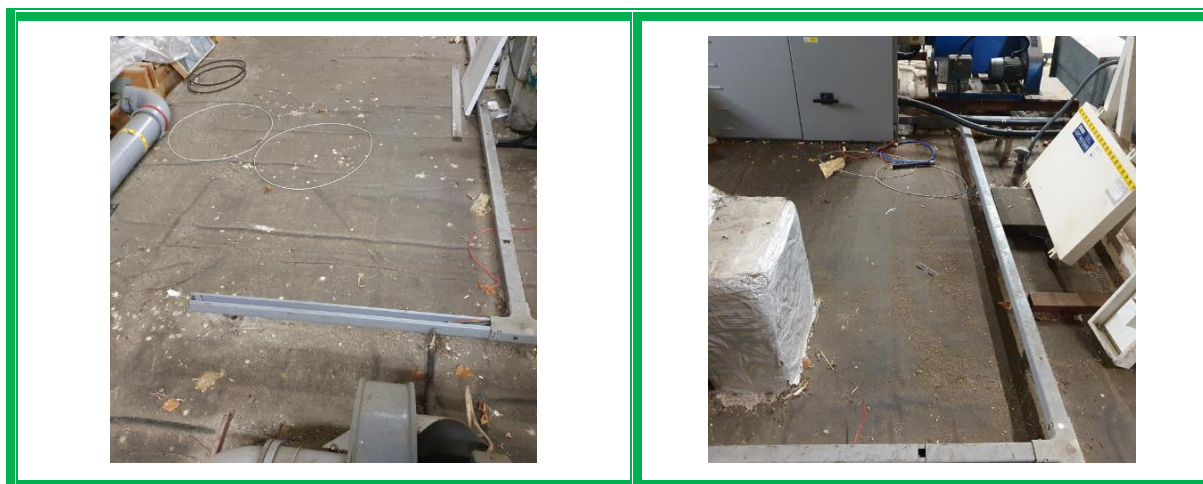
Item No:	15	Sample No:	DK/08
Location:	Laboratory Buildings, Second Floor - Boiler Room 015

Material Description:	Bitumen Coating to Floor - Bituminous Product	
Identification:	Sampled - No Asbestos Found	
Approx. quantity:	N/A	
Accessibility	N/A	<i>Assessment Score</i>
Product type:	N/A	N/A
Extent of Damage:	N/A	N/A
Surface Treatment:	N/A	N/A
Asbestos type:	N/A	N/A
Material Assessment Score:		N/A
Risk Assessment Score:		N/A
Action:	N/A	
Comments:	Non asbestos felt to underside of roof

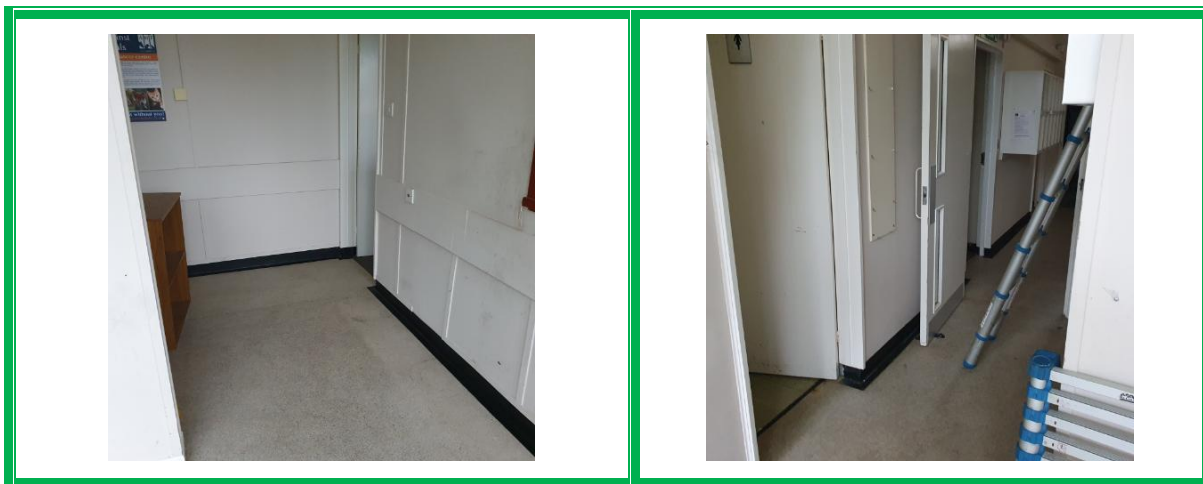
Location: Laboratory Buildings, Ground Floor - Entrance Lobby
019

Material Description:	No Suspect Materials Found	
Identification:	N/A	
Approx. quantity:	N/A	
Accessibility	N/A	<i>Assessment Score</i>
Product type:	N/A	N/A
Extent of Damage:	N/A	N/A
Surface Treatment:	N/A	N/A
Asbestos type:	N/A	N/A
Material Assessment Score:		N/A
Risk Assessment Score:		N/A
Action:	N/A	
Comments:	Non asbestos acoustic ceiling tiles on concrete. Concrete below lino. Plasterboard, timber, and solid walls.

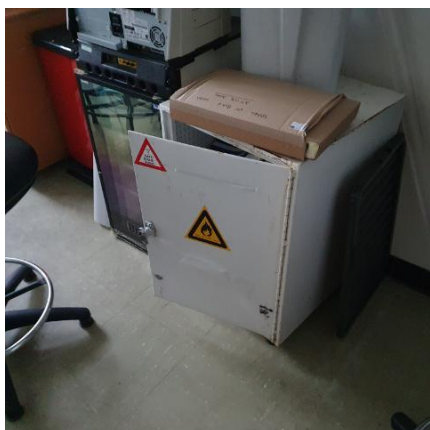
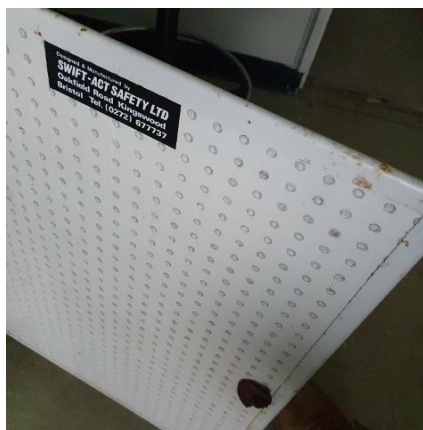
Location: Laboratory Buildings, Ground Floor - Room 40 021

Material Description:	Inner Lining Panels to Cabinet - Insulating Board	
Identification:	Sampled - No Asbestos Found	
Approx. quantity:	N/A	
Accessibility	N/A	Assessment Score
Product type:	N/A	N/A
Extent of Damage:	N/A	N/A
Surface Treatment:	N/A	N/A
Asbestos type:	N/A	N/A
Material Assessment Score:		N/A
Risk Assessment Score:		N/A
Action:	N/A	
Comments:	Limited access within ductwork

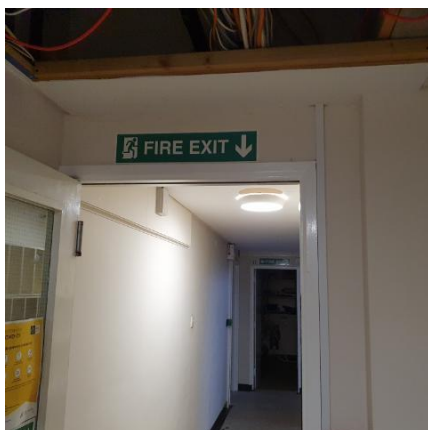
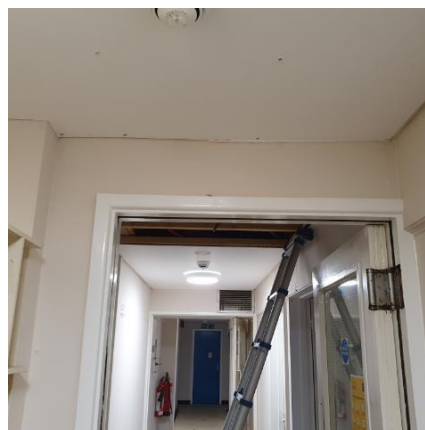
Location: Laboratory Buildings, Ground Floor - Corridor 023

Material Description:	Surrounds to Door - Insulating Board	
Identification:	Sampled - No Asbestos Found	
Approx. quantity:	N/A	
Accessibility	N/A	<i>Assessment Score</i>
Product type:	N/A	N/A
Extent of Damage:	N/A	N/A
Surface Treatment:	N/A	N/A
Asbestos type:	N/A	N/A
Material Assessment Score:		N/A
Risk Assessment Score:		N/A
Action:	N/A	
Comments:	Timber ductwork boxing.

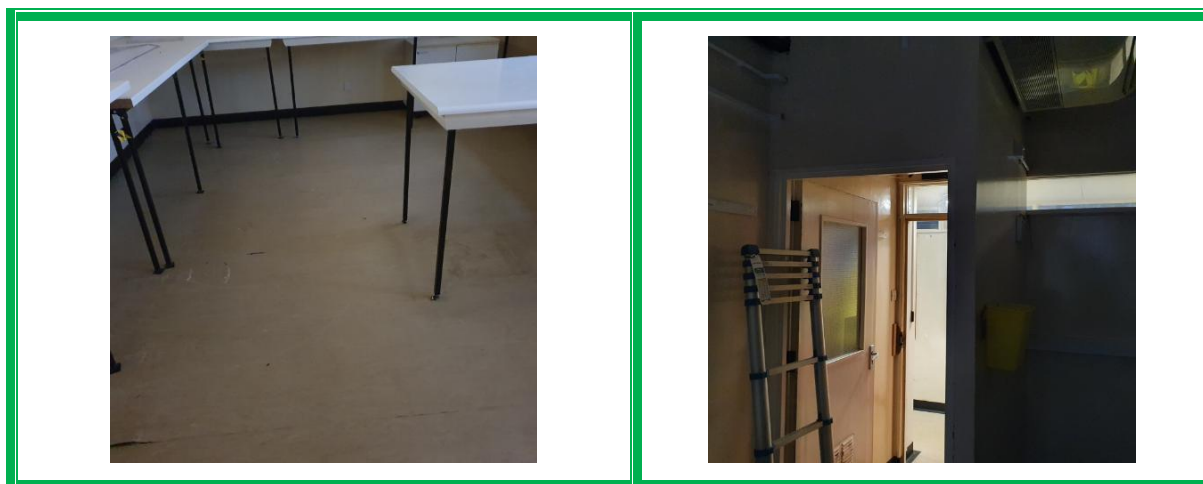
Item No:	27	Sample No:	N/A
Location:	Laboratory Buildings, First Floor - Block A - Room 1027

Material Description:	No Suspect Materials Found	
Identification:	N/A	
Approx. quantity:	N/A	
Accessibility	N/A	<i>Assessment Score</i>
Product type:	N/A	N/A
Extent of Damage:	N/A	N/A
Surface Treatment:	N/A	N/A
Asbestos type:	N/A	N/A
Material Assessment Score:		N/A
Risk Assessment Score:		N/A
Action:	N/A	
Comments:	Concrete under lino. Solid and plasterboard walls

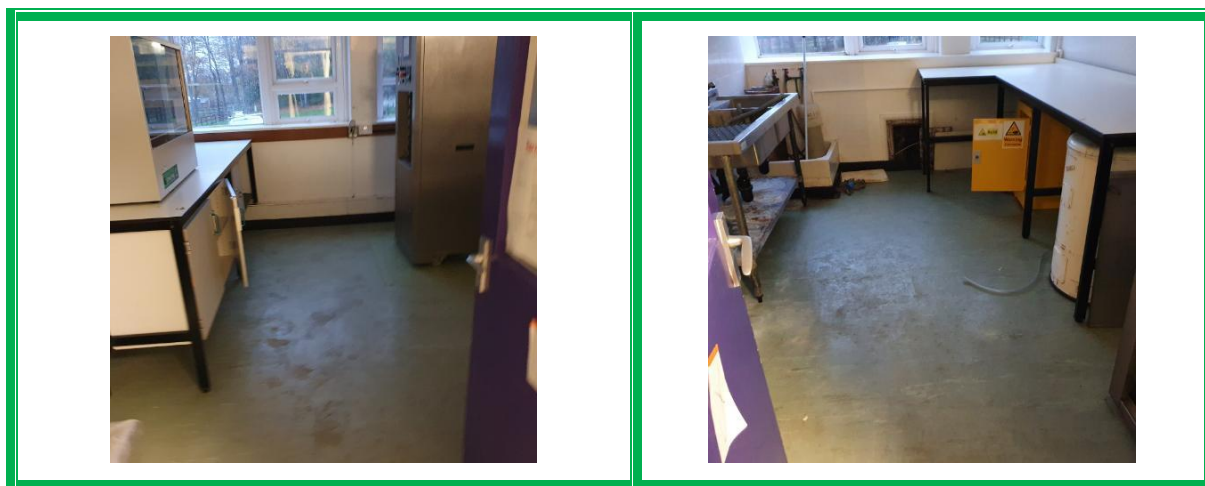
Location: Laboratory Buildings, Ground Floor - Block A -
Rooms 30 and 31 036

Material Description:	No Suspect Materials Found	
Identification:	N/A	
Approx. quantity:	N/A	
Accessibility	N/A	<i>Assessment Score</i>
Product type:	N/A	N/A
Extent of Damage:	N/A	N/A
Surface Treatment:	N/A	N/A
Asbestos type:	N/A	N/A
Material Assessment Score:		N/A
Risk Assessment Score:		N/A
Action:	N/A	
Comments:	Non asbestos electrics, pipework, and equipment

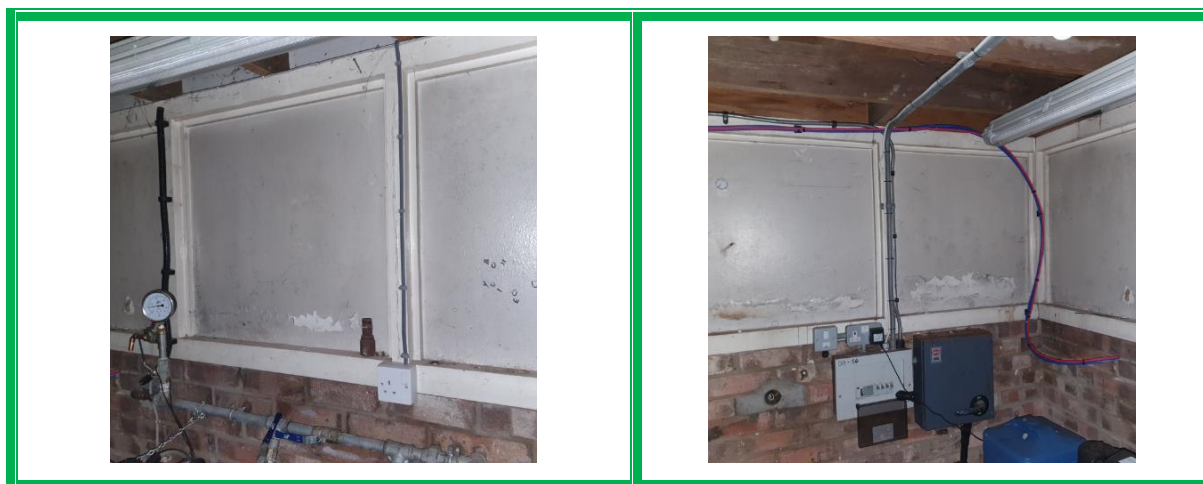
Item No:	42	Sample No:	DK/15
Location:	Laboratory Buildings, Ground Floor - Water Shack 042

Material Description:	Wall Panels - Insulating Board	
Identification:	Sampled - No Asbestos Found	
Approx. quantity:	N/A	
Accessibility	N/A	Assessment Score
Product type:	N/A	N/A
Extent of Damage:	N/A	N/A
Surface Treatment:	N/A	N/A
Asbestos type:	N/A	N/A
Material Assessment Score:		N/A
Risk Assessment Score:		N/A
Action:	N/A	
Comments:	Timber ceiling, non-asbestos electrics

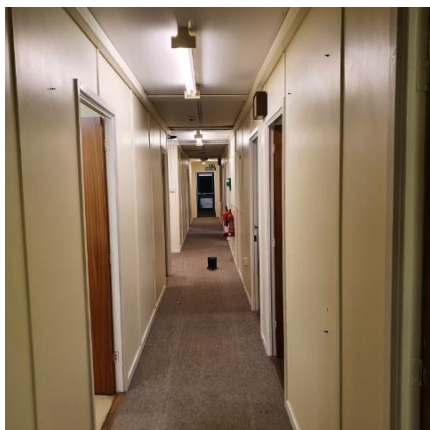
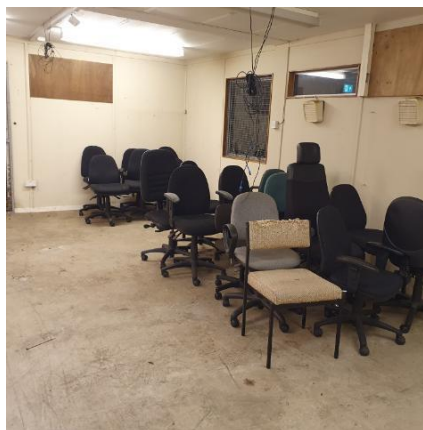
Location: Laboratory Buildings, Ground Floor - Kirkham
Building - All Rooms 043

Material Description:	No Suspect Materials Found	
Identification:	N/A	
Approx. quantity:	N/A	
Accessibility	N/A	<i>Assessment Score</i>
Product type:	N/A	N/A
Extent of Damage:	N/A	N/A
Surface Treatment:	N/A	N/A
Asbestos type:	N/A	N/A
Material Assessment Score:		N/A
Risk Assessment Score:		N/A
Action:	N/A	
Comments:	Plasterboard ceilings and walls. Concrete under non asbestos floorings. Fiberglass external wall cladding.

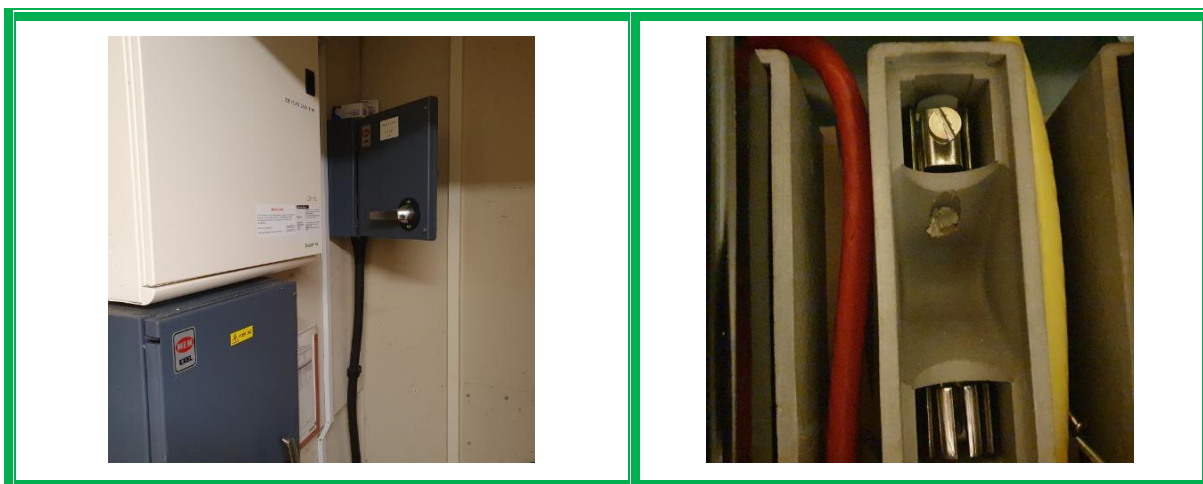
Location: Laboratory Buildings, Ground Floor - Kirkham
Building - Switchroom 044

Material Description:	Putty Flashguards - PVC / Reinforced Plastics	
Identification:	Sampled - No Asbestos Found	
Approx. quantity:	N/A	
Accessibility	N/A	Assessment Score
Product type:	N/A	N/A
Extent of Damage:	N/A	N/A
Surface Treatment:	N/A	N/A
Asbestos type:	N/A	N/A
Material Assessment Score:		N/A
Risk Assessment Score:		N/A
Action:	N/A	
Comments:	Withing electrical boxes

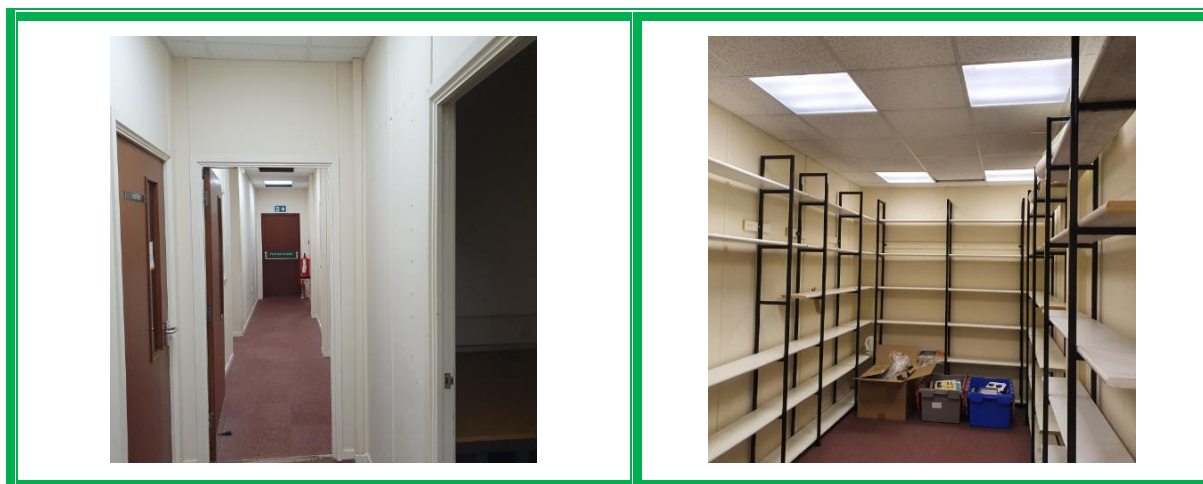
Item No:	45	Sample No:	N/A
Location:	Laboratory Buildings, Ground Floor - Terrapin Building - All Rooms 045

Material Description:	No Suspect Materials Found	
Identification:	N/A	
Approx. quantity:	N/A	
Accessibility	N/A	<i>Assessment Score</i>
Product type:	N/A	N/A
Extent of Damage:	N/A	N/A
Surface Treatment:	N/A	N/A
Asbestos type:	N/A	N/A
Material Assessment Score:		N/A
Risk Assessment Score:		N/A
Action:	N/A	
Comments:	Modern ceiling tiles with timber above. Plasterboard walls, timber floors and timber and rockwool to outer walls.

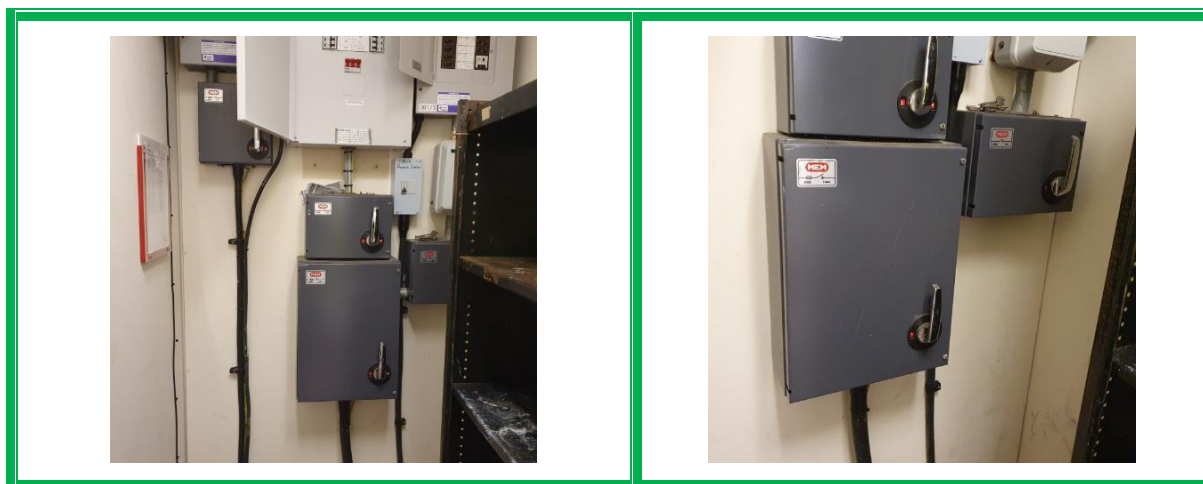
Item No:	46	Sample No:	N/A
Location:	Laboratory Buildings, Ground Floor - Terrapin Building - Switchroom 046

Material Description:	Putty Flashguards - PVC / Reinforced Plastics	
Identification:	As per sample DK/16 - No Asbestos Found	
Approx. quantity:	N/A	
Accessibility	N/A	Assessment Score
Product type:	N/A	N/A
Extent of Damage:	N/A	N/A
Surface Treatment:	N/A	N/A
Asbestos type:	N/A	N/A
Material Assessment Score:		N/A
Risk Assessment Score:		N/A
Action:	N/A	
Comments:	Within electrical boxes

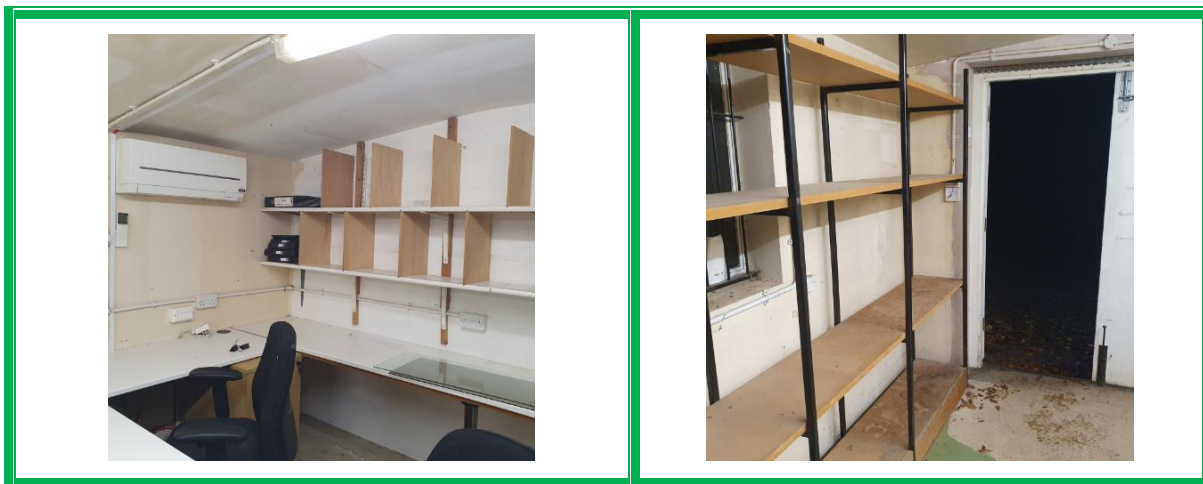
Location: Laboratory Buildings, Ground Floor - Stores
Building- Store 047

Material Description:	No Suspect Materials Found	
Identification:	N/A	
Approx. quantity:	N/A	
Accessibility	N/A	<i>Assessment Score</i>
Product type:	N/A	N/A
Extent of Damage:	N/A	N/A
Surface Treatment:	N/A	N/A
Asbestos type:	N/A	N/A
Material Assessment Score:		N/A
Risk Assessment Score:		N/A
Action:	N/A	
Comments:	Plasterboard ceiling with timber above

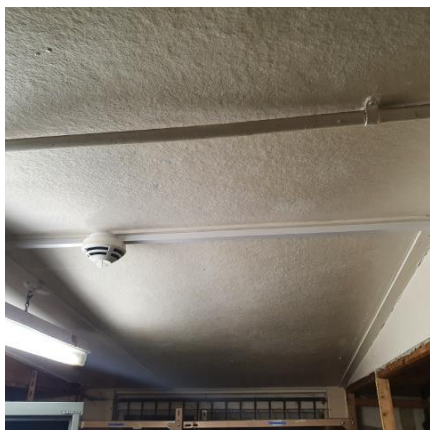
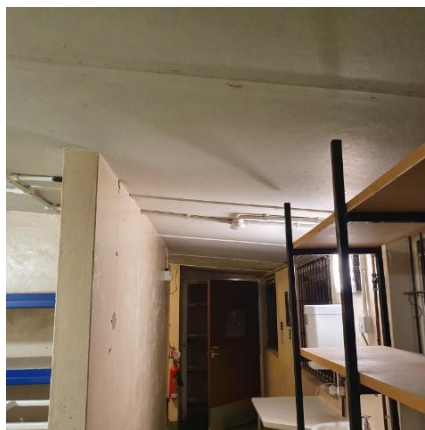
Location: Laboratory Buildings, Ground Floor - Stores
Building- Stores x 3 048

Material Description:	Fiberboard Ceiling Panels - Paper Product	
Identification:	Sampled - No Asbestos Found	
Approx. quantity:	N/A	
Accessibility	N/A	Assessment Score
Product type:	N/A	N/A
Extent of Damage:	N/A	N/A
Surface Treatment:	N/A	N/A
Asbestos type:	N/A	N/A
Material Assessment Score:		N/A
Risk Assessment Score:		N/A
Action:	N/A	
Comments:	Solid and plasterboard walls. Non asbestos coating to floor

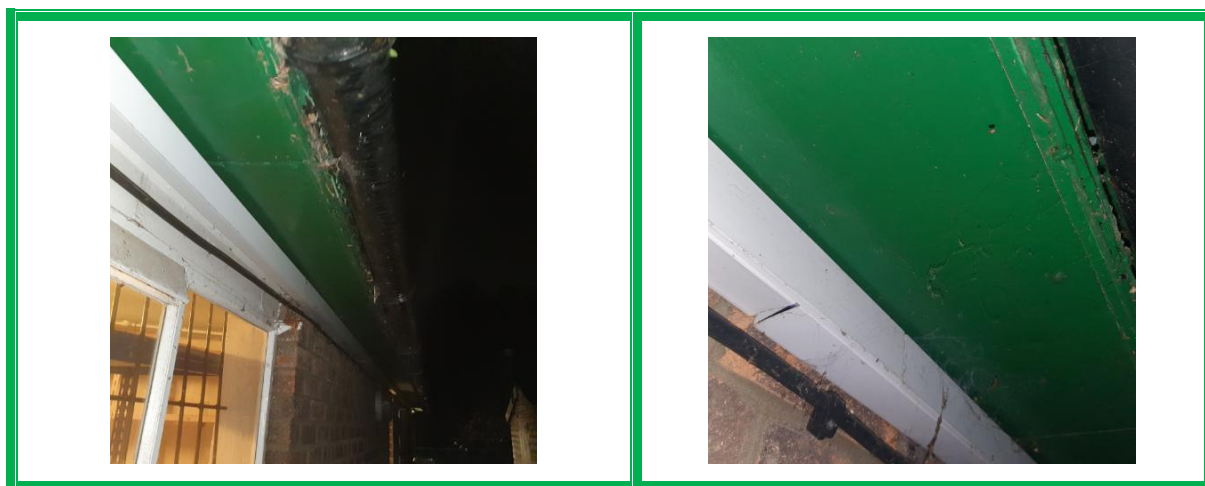
Sample No: DK/18

Location: Laboratory Buildings, External - Stores Building 049

Material Description:	Soffit - Cement Product	
Identification:	Sampled - No Asbestos Found	
Approx. quantity:	N/A	
Accessibility	N/A	<i>Assessment Score</i>
Product type:	N/A	N/A
Extent of Damage:	N/A	N/A
Surface Treatment:	N/A	N/A
Asbestos type:	N/A	N/A
Material Assessment Score:		N/A
Risk Assessment Score:		N/A
Action:	N/A	
Comments:	N/A

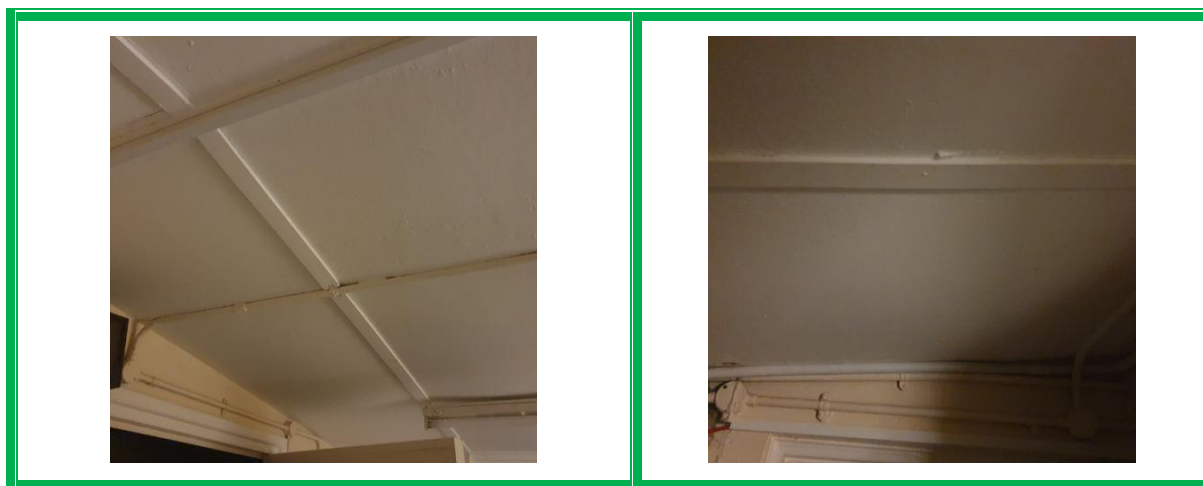
Item No:	50	Sample No:	N/A
Location:	Laboratory Buildings, Ground Floor - Stores Building- Stores x 3 and Lobby 050

Material Description:	Fiberboard Ceiling Panels - Paper Product	
Identification:	As per sample DK/17 - No Asbestos Found	
Approx. quantity:	N/A	
Accessibility	N/A	<i>Assessment Score</i>
Product type:	N/A	N/A
Extent of Damage:	N/A	N/A
Surface Treatment:	N/A	N/A
Asbestos type:	N/A	N/A
Material Assessment Score:		N/A
Risk Assessment Score:		N/A
Action:	N/A	
Comments:	N/A

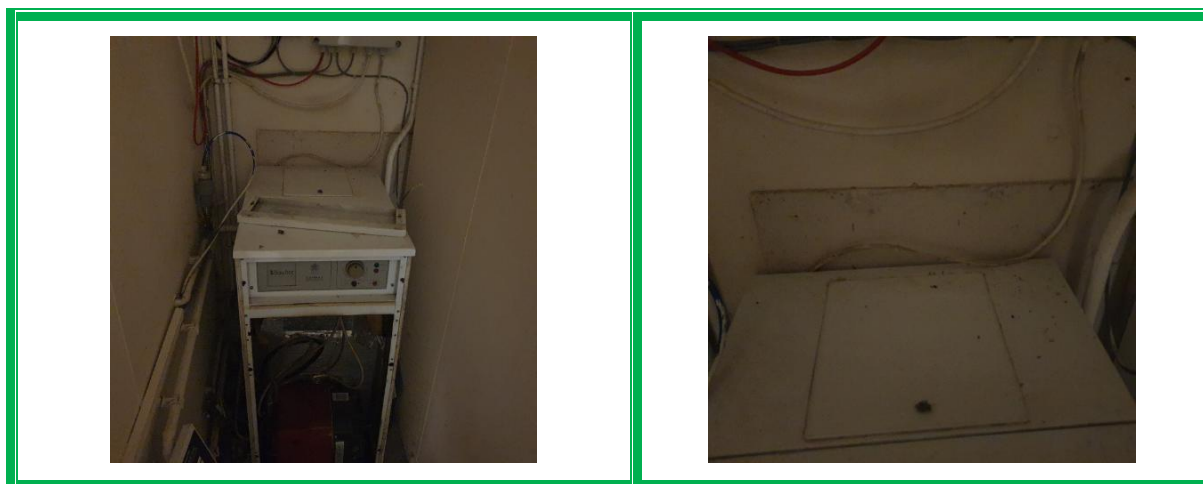
Item No:	52	Sample No:	DK/20
Location:	Laboratory Buildings, Ground Floor - Office Hut - Boiler Room 052

Material Description:	Panel behind Boiler - Insulating Board	
Identification:	Sampled - No Asbestos Found	
Approx. quantity:	N/A	
Accessibility	N/A	<i>Assessment Score</i>
Product type:	N/A	N/A
Extent of Damage:	N/A	N/A
Surface Treatment:	N/A	N/A
Asbestos type:	N/A	N/A
Material Assessment Score:		N/A
Risk Assessment Score:		N/A
Action:	N/A	
Comments:	N/A

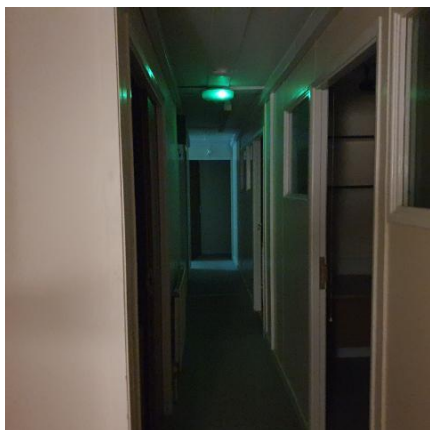
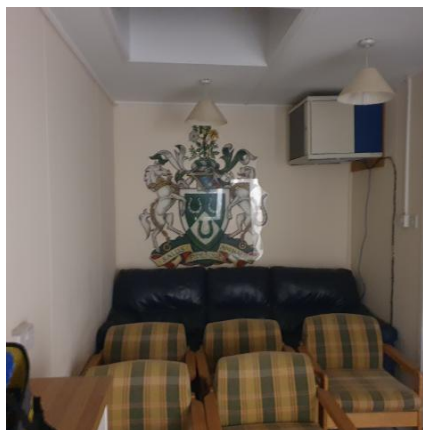
Item No: 53

Location: Laboratory Buildings, Ground Floor - Office Hut - All Rooms 053

Material Description:	No Suspect Materials Found	
Identification:	N/A	
Approx. quantity:	N/A	
Accessibility	N/A	<i>Assessment Score</i>
Product type:	N/A	N/A
Extent of Damage:	N/A	N/A
Surface Treatment:	N/A	N/A
Asbestos type:	N/A	N/A
Material Assessment Score:		N/A
Risk Assessment Score:		N/A
Action:	N/A	
Comments:	Plasterboard walls and ceilings. Rockwool in roof void and within external walls.
