Project Number A-02002 (6724)

**Refurbishment and Demolition
Asbestos Survey Report**

**Visitor Centre
Lanwades Park
Newmarket
CN8 7UA**

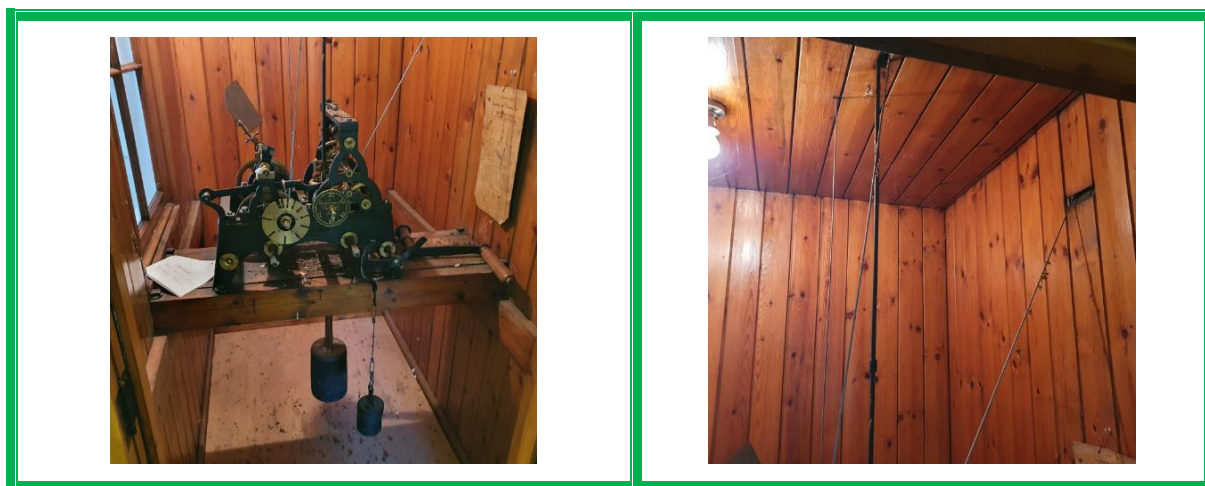
Location: First Floor - Winding Clock Room 006

Material Description:	No Suspect Materials Found	
Identification:	N/A	
Approx. quantity:	N/A	
Accessibility	N/A	<i>Assessment Score</i>
Product type:	N/A	N/A
Extent of Damage:	N/A	N/A
Surface Treatment:	N/A	N/A
Asbestos type:	N/A	N/A
Material Assessment Score:		N/A
Risk Assessment Score:		N/A
Action:	N/A	
Comments:	Timber walls and ceiling

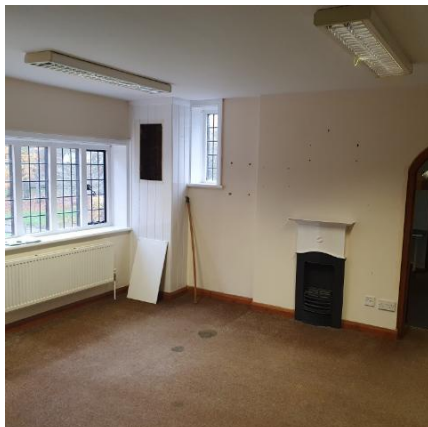
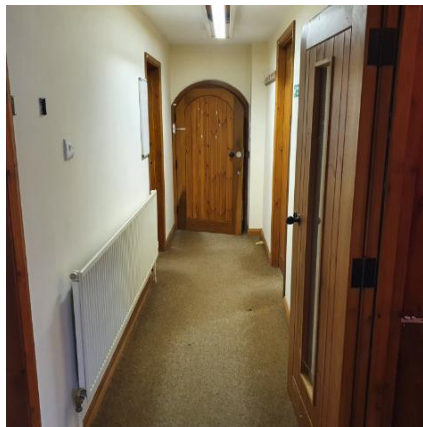
Location: First Floor - Winding Clock Room 007

Material Description:	No Suspect Materials Found	
Identification:	N/A	
Approx. quantity:	N/A	
Accessibility	N/A	<i>Assessment Score</i>
Product type:	N/A	N/A
Extent of Damage:	N/A	N/A
Surface Treatment:	N/A	N/A
Asbestos type:	N/A	N/A
Material Assessment Score:		N/A
Risk Assessment Score:		N/A
Action:	N/A	
Comments:	Plasterboard and solid walls. Solid panel fireplace. Plasterboard ceiling with loft space above

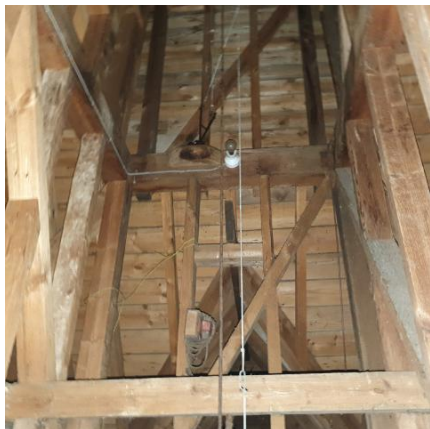
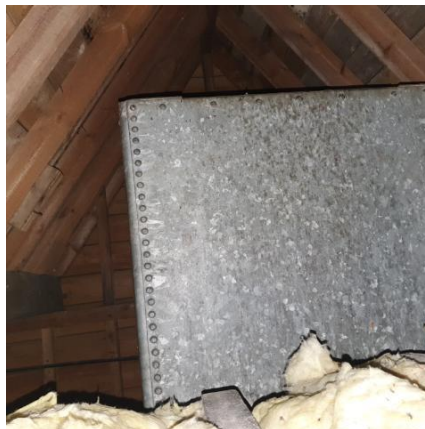
Location: First Floor - Loft Space 008

Material Description:	No Suspect Materials Found	
Identification:	N/A	
Approx. quantity:	N/A	
Accessibility	N/A	<i>Assessment Score</i>
Product type:	N/A	N/A
Extent of Damage:	N/A	N/A
Surface Treatment:	N/A	N/A
Asbestos type:	N/A	N/A
Material Assessment Score:		N/A
Risk Assessment Score:		N/A
Action:	N/A	
Comments:	Timber to underside of roof, metal water tank, limited access to clock tower but no suspect materials visible. Fiberglass insulation

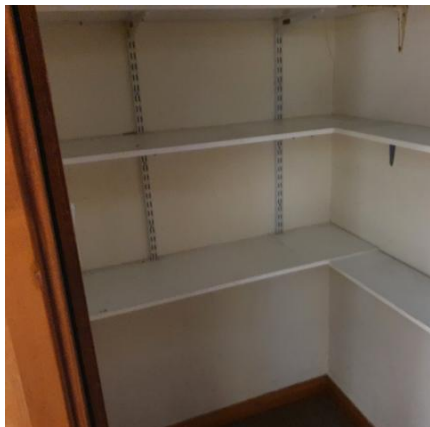
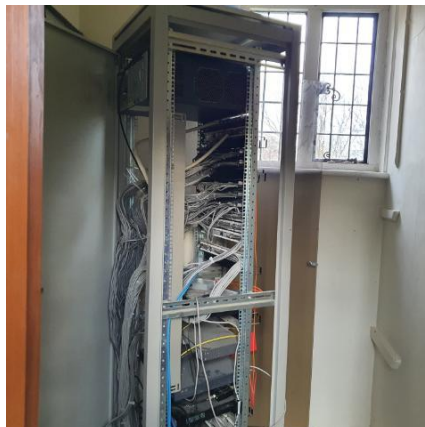
Location: First Floor - Store, Stairwell and Server Room 009

Material Description:	No Suspect Materials Found	
Identification:	N/A	
Approx. quantity:	N/A	
Accessibility	N/A	<i>Assessment Score</i>
Product type:	N/A	N/A
Extent of Damage:	N/A	N/A
Surface Treatment:	N/A	N/A
Asbestos type:	N/A	N/A
Material Assessment Score:		N/A
Risk Assessment Score:		N/A
Action:	N/A	
Comments:	Plasterboard and lath and plaster walls, plasterboard ceiling, timber floor, rubber stair nosing

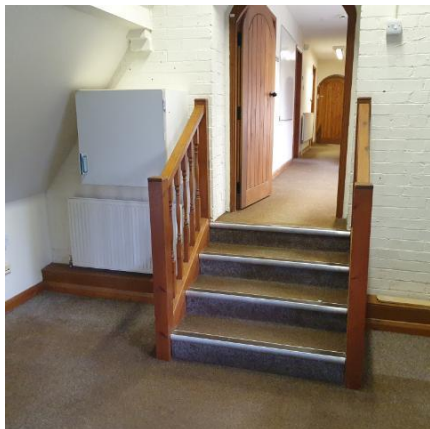
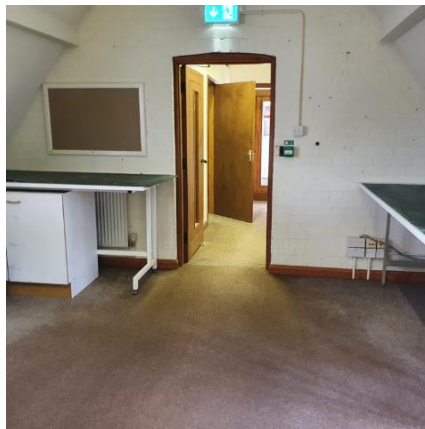
Location: First Floor - Store, Stairwell and Server Room 010

Material Description:	No Suspect Materials Found	
Identification:	N/A	
Approx. quantity:	N/A	
Accessibility	N/A	<i>Assessment Score</i>
Product type:	N/A	N/A
Extent of Damage:	N/A	N/A
Surface Treatment:	N/A	N/A
Asbestos type:	N/A	N/A
Material Assessment Score:		N/A
Risk Assessment Score:		N/A
Action:	N/A	
Comments:	Plasterboard walls, timber floor

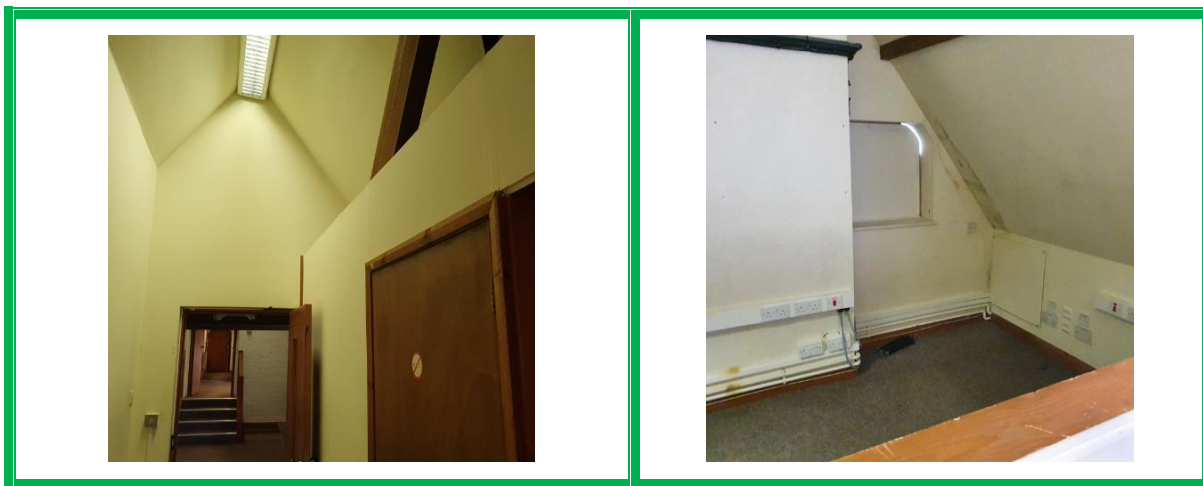
Location: First Floor - Server Room 011

Material Description:	No Suspect Materials Found	
Identification:	N/A	
Approx. quantity:	N/A	
Accessibility	N/A	<i>Assessment Score</i>
Product type:	N/A	N/A
Extent of Damage:	N/A	N/A
Surface Treatment:	N/A	N/A
Asbestos type:	N/A	N/A
Material Assessment Score:		N/A
Risk Assessment Score:		N/A
Action:	N/A	
Comments:	Plasterboard walls, timber floor

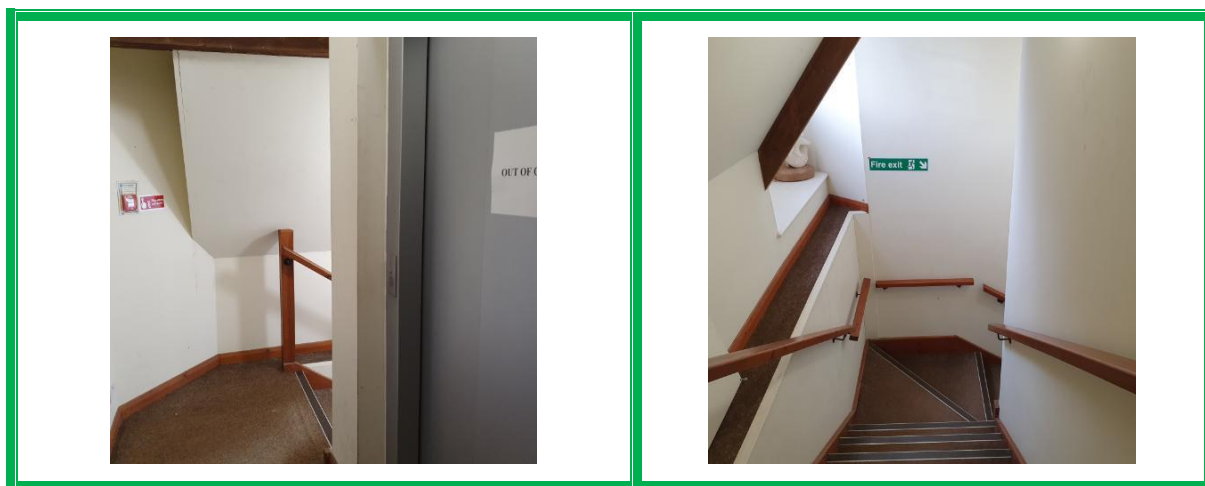
Location: First Floor - Landing and Stairwell 012

Material Description:	No Suspect Materials Found	
Identification:	N/A	
Approx. quantity:	N/A	
Accessibility	N/A	<i>Assessment Score</i>
Product type:	N/A	N/A
Extent of Damage:	N/A	N/A
Surface Treatment:	N/A	N/A
Asbestos type:	N/A	N/A
Material Assessment Score:		N/A
Risk Assessment Score:		N/A
Action:	N/A	
Comments:	Plasterboard walls, timber floor, rubber stair nosing

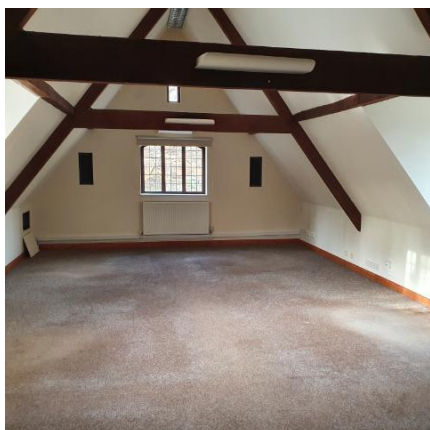
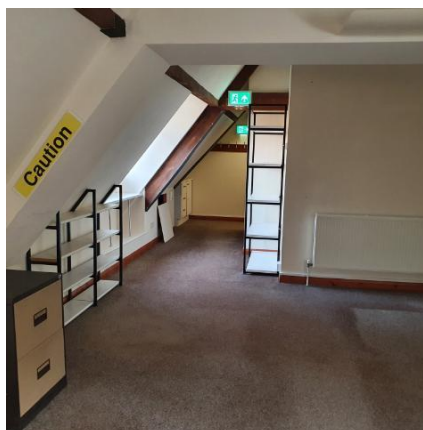
Location: First Floor - Office 013

Material Description:	No Suspect Materials Found	
Identification:	N/A	
Approx. quantity:	N/A	
Accessibility	N/A	<i>Assessment Score</i>
Product type:	N/A	N/A
Extent of Damage:	N/A	N/A
Surface Treatment:	N/A	N/A
Asbestos type:	N/A	N/A
Material Assessment Score:		N/A
Risk Assessment Score:		N/A
Action:	N/A	
Comments:	Plasterboard walls, timber floor

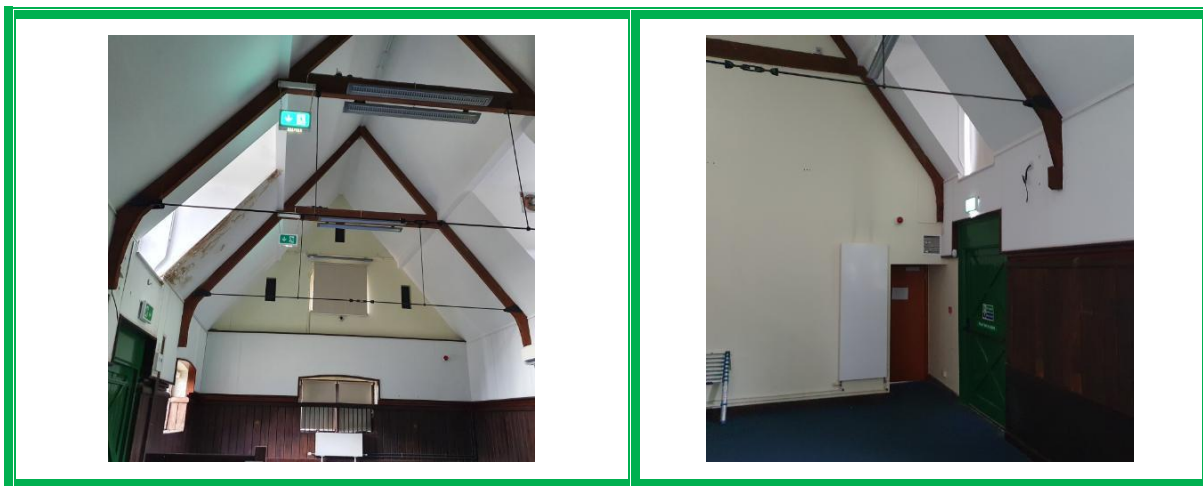
Location: Ground Floor - Lecture Theatre 015

Material Description:	No Suspect Materials Found	
Identification:	N/A	
Approx. quantity:	N/A	
Accessibility	N/A	<i>Assessment Score</i>
Product type:	N/A	N/A
Extent of Damage:	N/A	N/A
Surface Treatment:	N/A	N/A
Asbestos type:	N/A	N/A
Material Assessment Score:		N/A
Risk Assessment Score:		N/A
Action:	N/A	
Comments:	Modern foam wall panels and plaster ceiling. Rubber stair nosing. Modern electrics

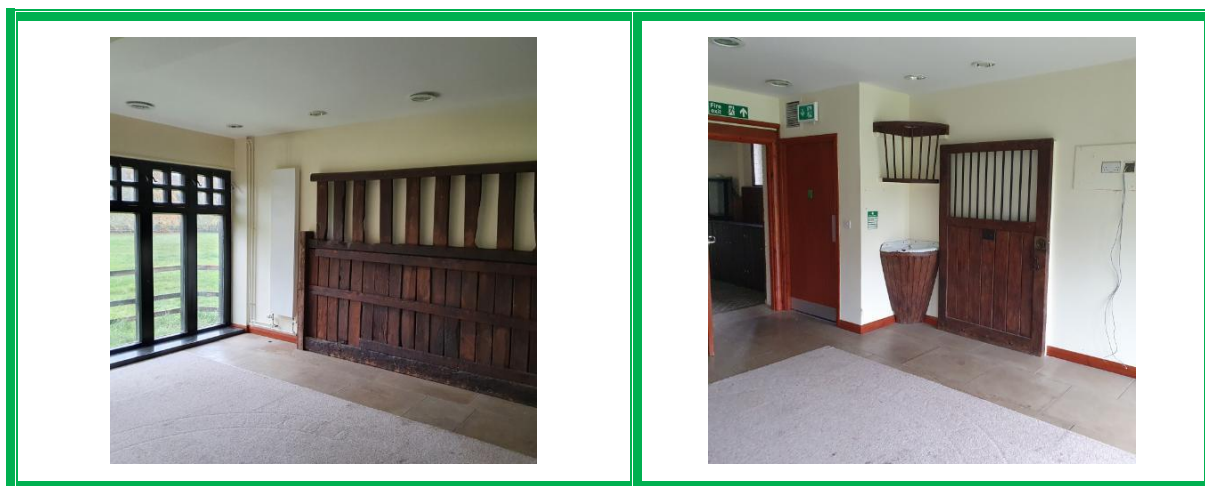
Location: Ground Floor - Breakout Area 016

Material Description:	No Suspect Materials Found	
Identification:	N/A	
Approx. quantity:	N/A	
Accessibility	N/A	<i>Assessment Score</i>
Product type:	N/A	N/A
Extent of Damage:	N/A	N/A
Surface Treatment:	N/A	N/A
Asbestos type:	N/A	N/A
Material Assessment Score:		N/A
Risk Assessment Score:		N/A
Action:	N/A	
Comments:	Plasterboard ceiling with lath and plaster ceiling above

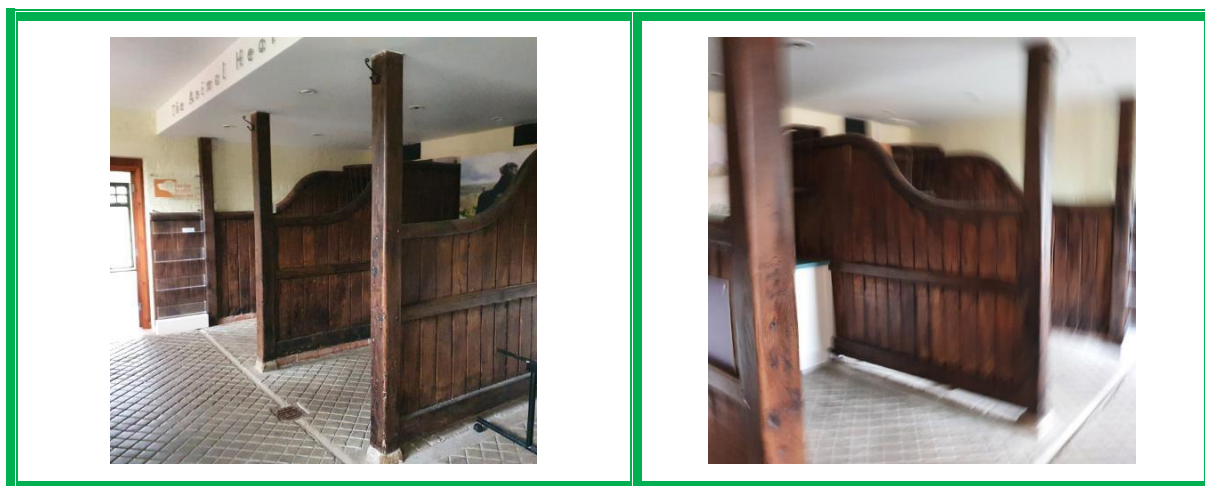
Location: Ground Floor - Stables 017

Material Description:	No Suspect Materials Found	
Identification:	N/A	
Approx. quantity:	N/A	
Accessibility	N/A	<i>Assessment Score</i>
Product type:	N/A	N/A
Extent of Damage:	N/A	N/A
Surface Treatment:	N/A	N/A
Asbestos type:	N/A	N/A
Material Assessment Score:		N/A
Risk Assessment Score:		N/A
Action:	N/A	
Comments:	Plasterboard ceiling with lath and plaster ceiling above

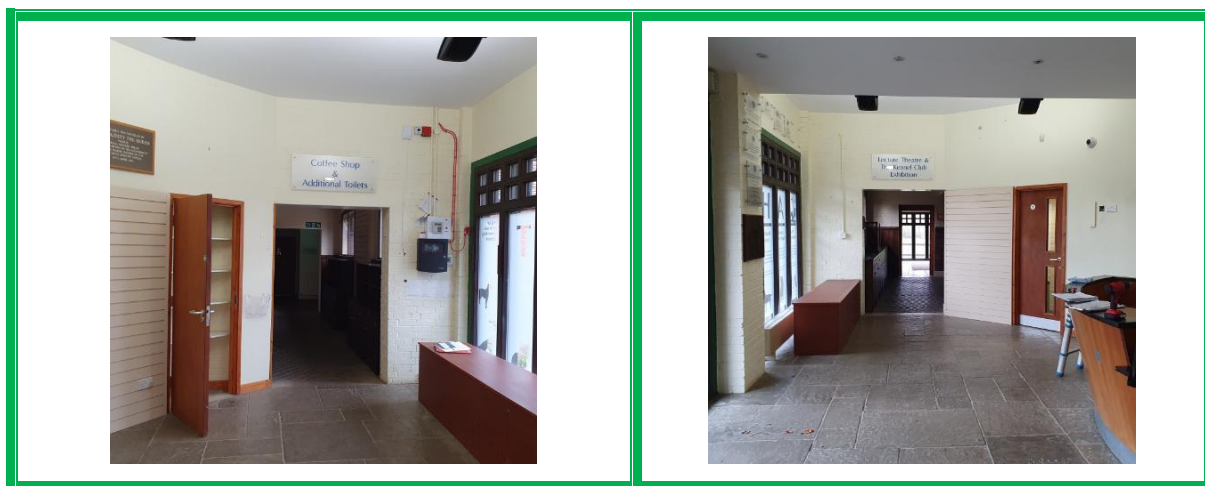
Location: Ground Floor - Reception 018

Material Description:	No Suspect Materials Found	
Identification:	N/A	
Approx. quantity:	N/A	
Accessibility	N/A	<i>Assessment Score</i>
Product type:	N/A	N/A
Extent of Damage:	N/A	N/A
Surface Treatment:	N/A	N/A
Asbestos type:	N/A	N/A
Material Assessment Score:		N/A
Risk Assessment Score:		N/A
Action:	N/A	
Comments:	Plasterboard ceiling with lath and plaster ceiling above

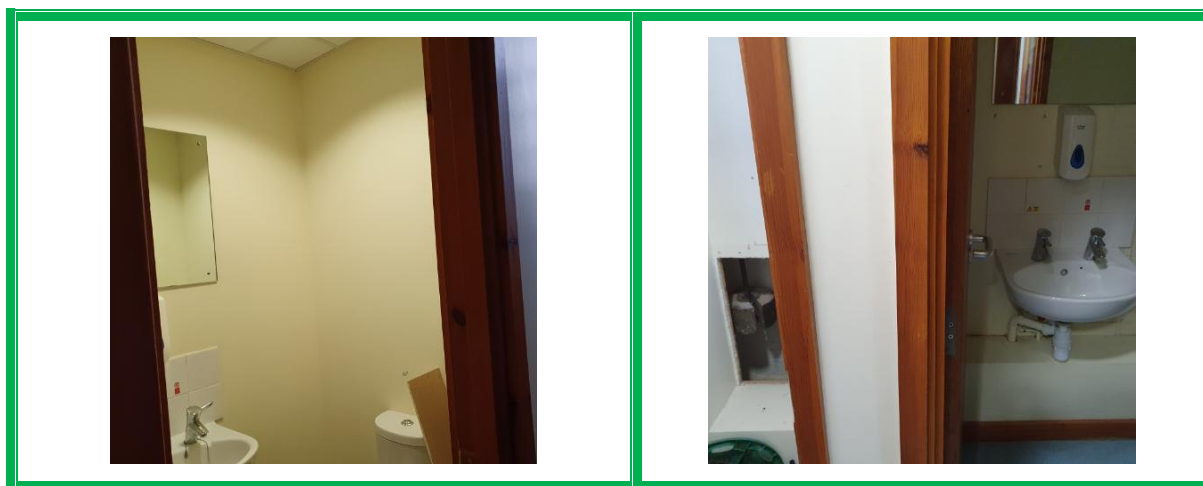
Item No:	20	Sample No:	N/A
Location:	Ground Floor - Ladies WC and Cupboard 020

Material Description:	No Suspect Materials Found	
Identification:	N/A	
Approx. quantity:	N/A	
Accessibility	N/A	<i>Assessment Score</i>
Product type:	N/A	N/A
Extent of Damage:	N/A	N/A
Surface Treatment:	N/A	N/A
Asbestos type:	N/A	N/A
Material Assessment Score:		N/A
Risk Assessment Score:		N/A
Action:	N/A	
Comments:	Toilets built in 1994. Plasterboard walls and ceiling.

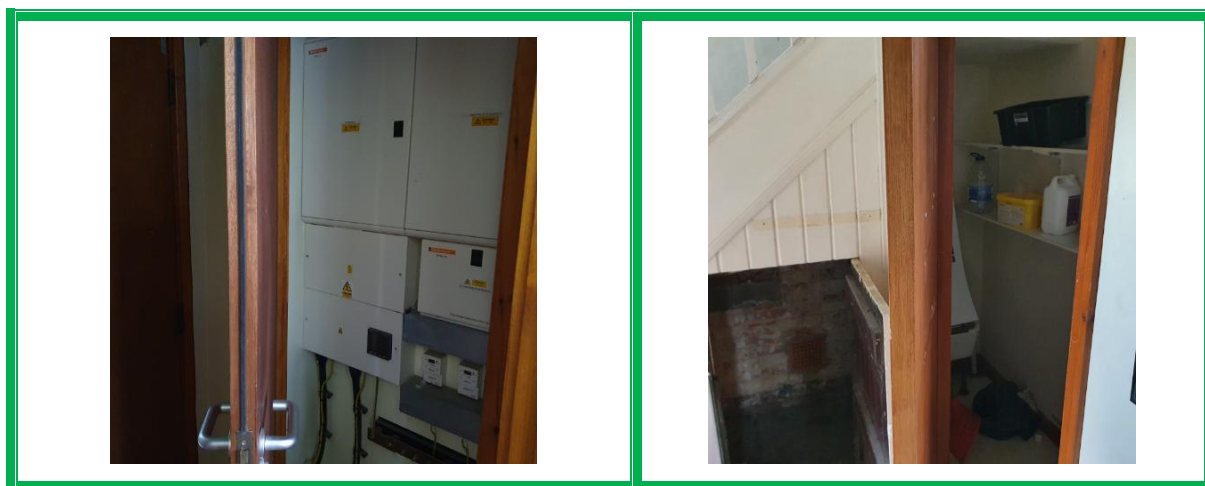
Location: Ground Floor - Cupboards x 2, Lobby 021

Material Description:	No Suspect Materials Found	
Identification:	N/A	
Approx. quantity:	N/A	
Accessibility	N/A	<i>Assessment Score</i>
Product type:	N/A	N/A
Extent of Damage:	N/A	N/A
Surface Treatment:	N/A	N/A
Asbestos type:	N/A	N/A
Material Assessment Score:		N/A
Risk Assessment Score:		N/A
Action:	N/A	
Comments:	N/A

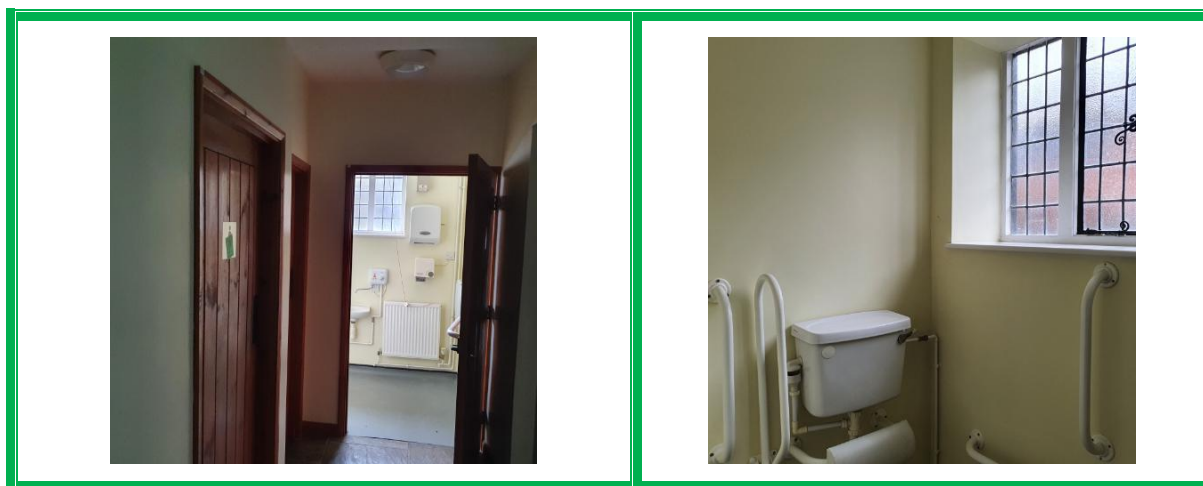
Location: Ground Floor - WC's x 3 and Lobby 024

Material Description:	No Suspect Materials Found	
Identification:	N/A	
Approx. quantity:	N/A	
Accessibility	N/A	<i>Assessment Score</i>
Product type:	N/A	N/A
Extent of Damage:	N/A	N/A
Surface Treatment:	N/A	N/A
Asbestos type:	N/A	N/A
Material Assessment Score:		N/A
Risk Assessment Score:		N/A
Action:	N/A	
Comments:	Plasterboard ceilings, solid and plasterboard walls

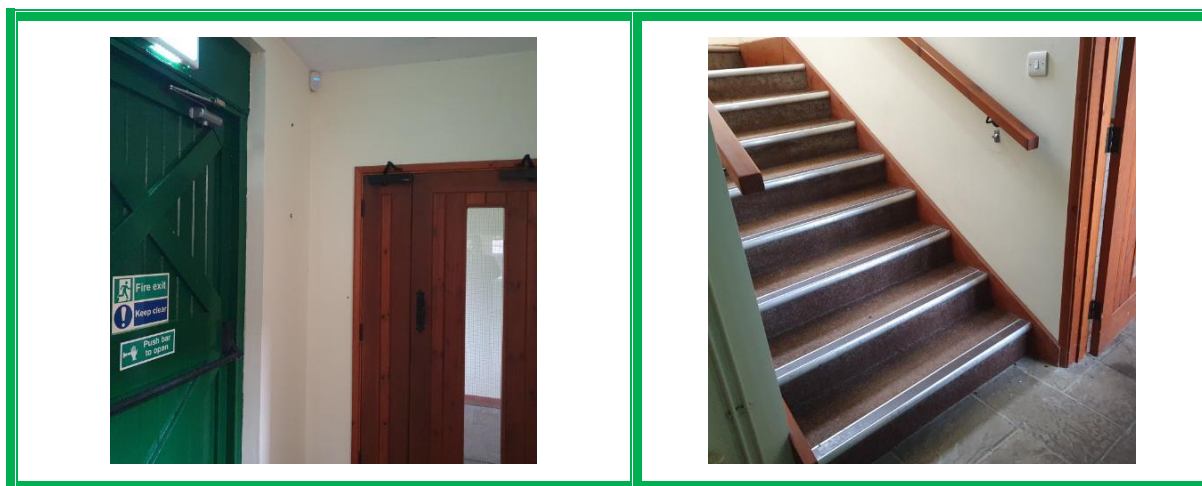
Item No:	25	Sample No:	N/A
Location:	Ground Floor - Lobby 025

Material Description:	No Suspect Materials Found	
Identification:	N/A	
Approx. quantity:	N/A	
Accessibility	N/A	<i>Assessment Score</i>
Product type:	N/A	N/A
Extent of Damage:	N/A	N/A
Surface Treatment:	N/A	N/A
Asbestos type:	N/A	N/A
Material Assessment Score:		N/A
Risk Assessment Score:		N/A
Action:	N/A	
Comments:	Plasterboard ceilings, solid and plasterboard walls

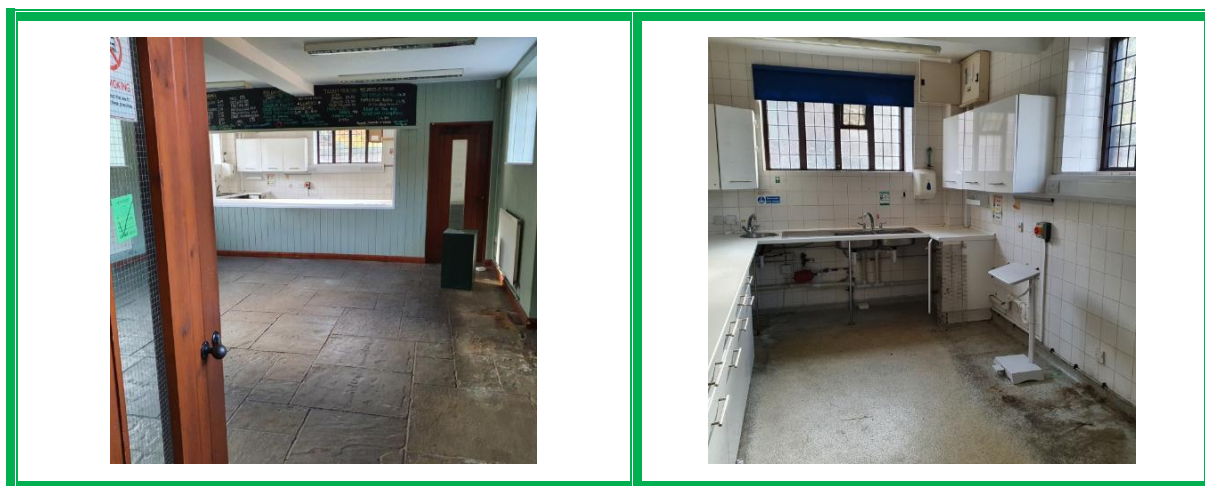
Location: Ground Floor - Dining Room/Kitchen 027

Material Description:	No Suspect Materials Found	
Identification:	N/A	
Approx. quantity:	N/A	
Accessibility	N/A	<i>Assessment Score</i>
Product type:	N/A	N/A
Extent of Damage:	N/A	N/A
Surface Treatment:	N/A	N/A
Asbestos type:	N/A	N/A
Material Assessment Score:		N/A
Risk Assessment Score:		N/A
Action:	N/A	
Comments:	Plasterboard ceilings, solid and plasterboard walls. Modern sink pads. Modern electrics
